SERVICE DIGEST

issue **14** August 1966

CORROSION AND THE P-3 ORION

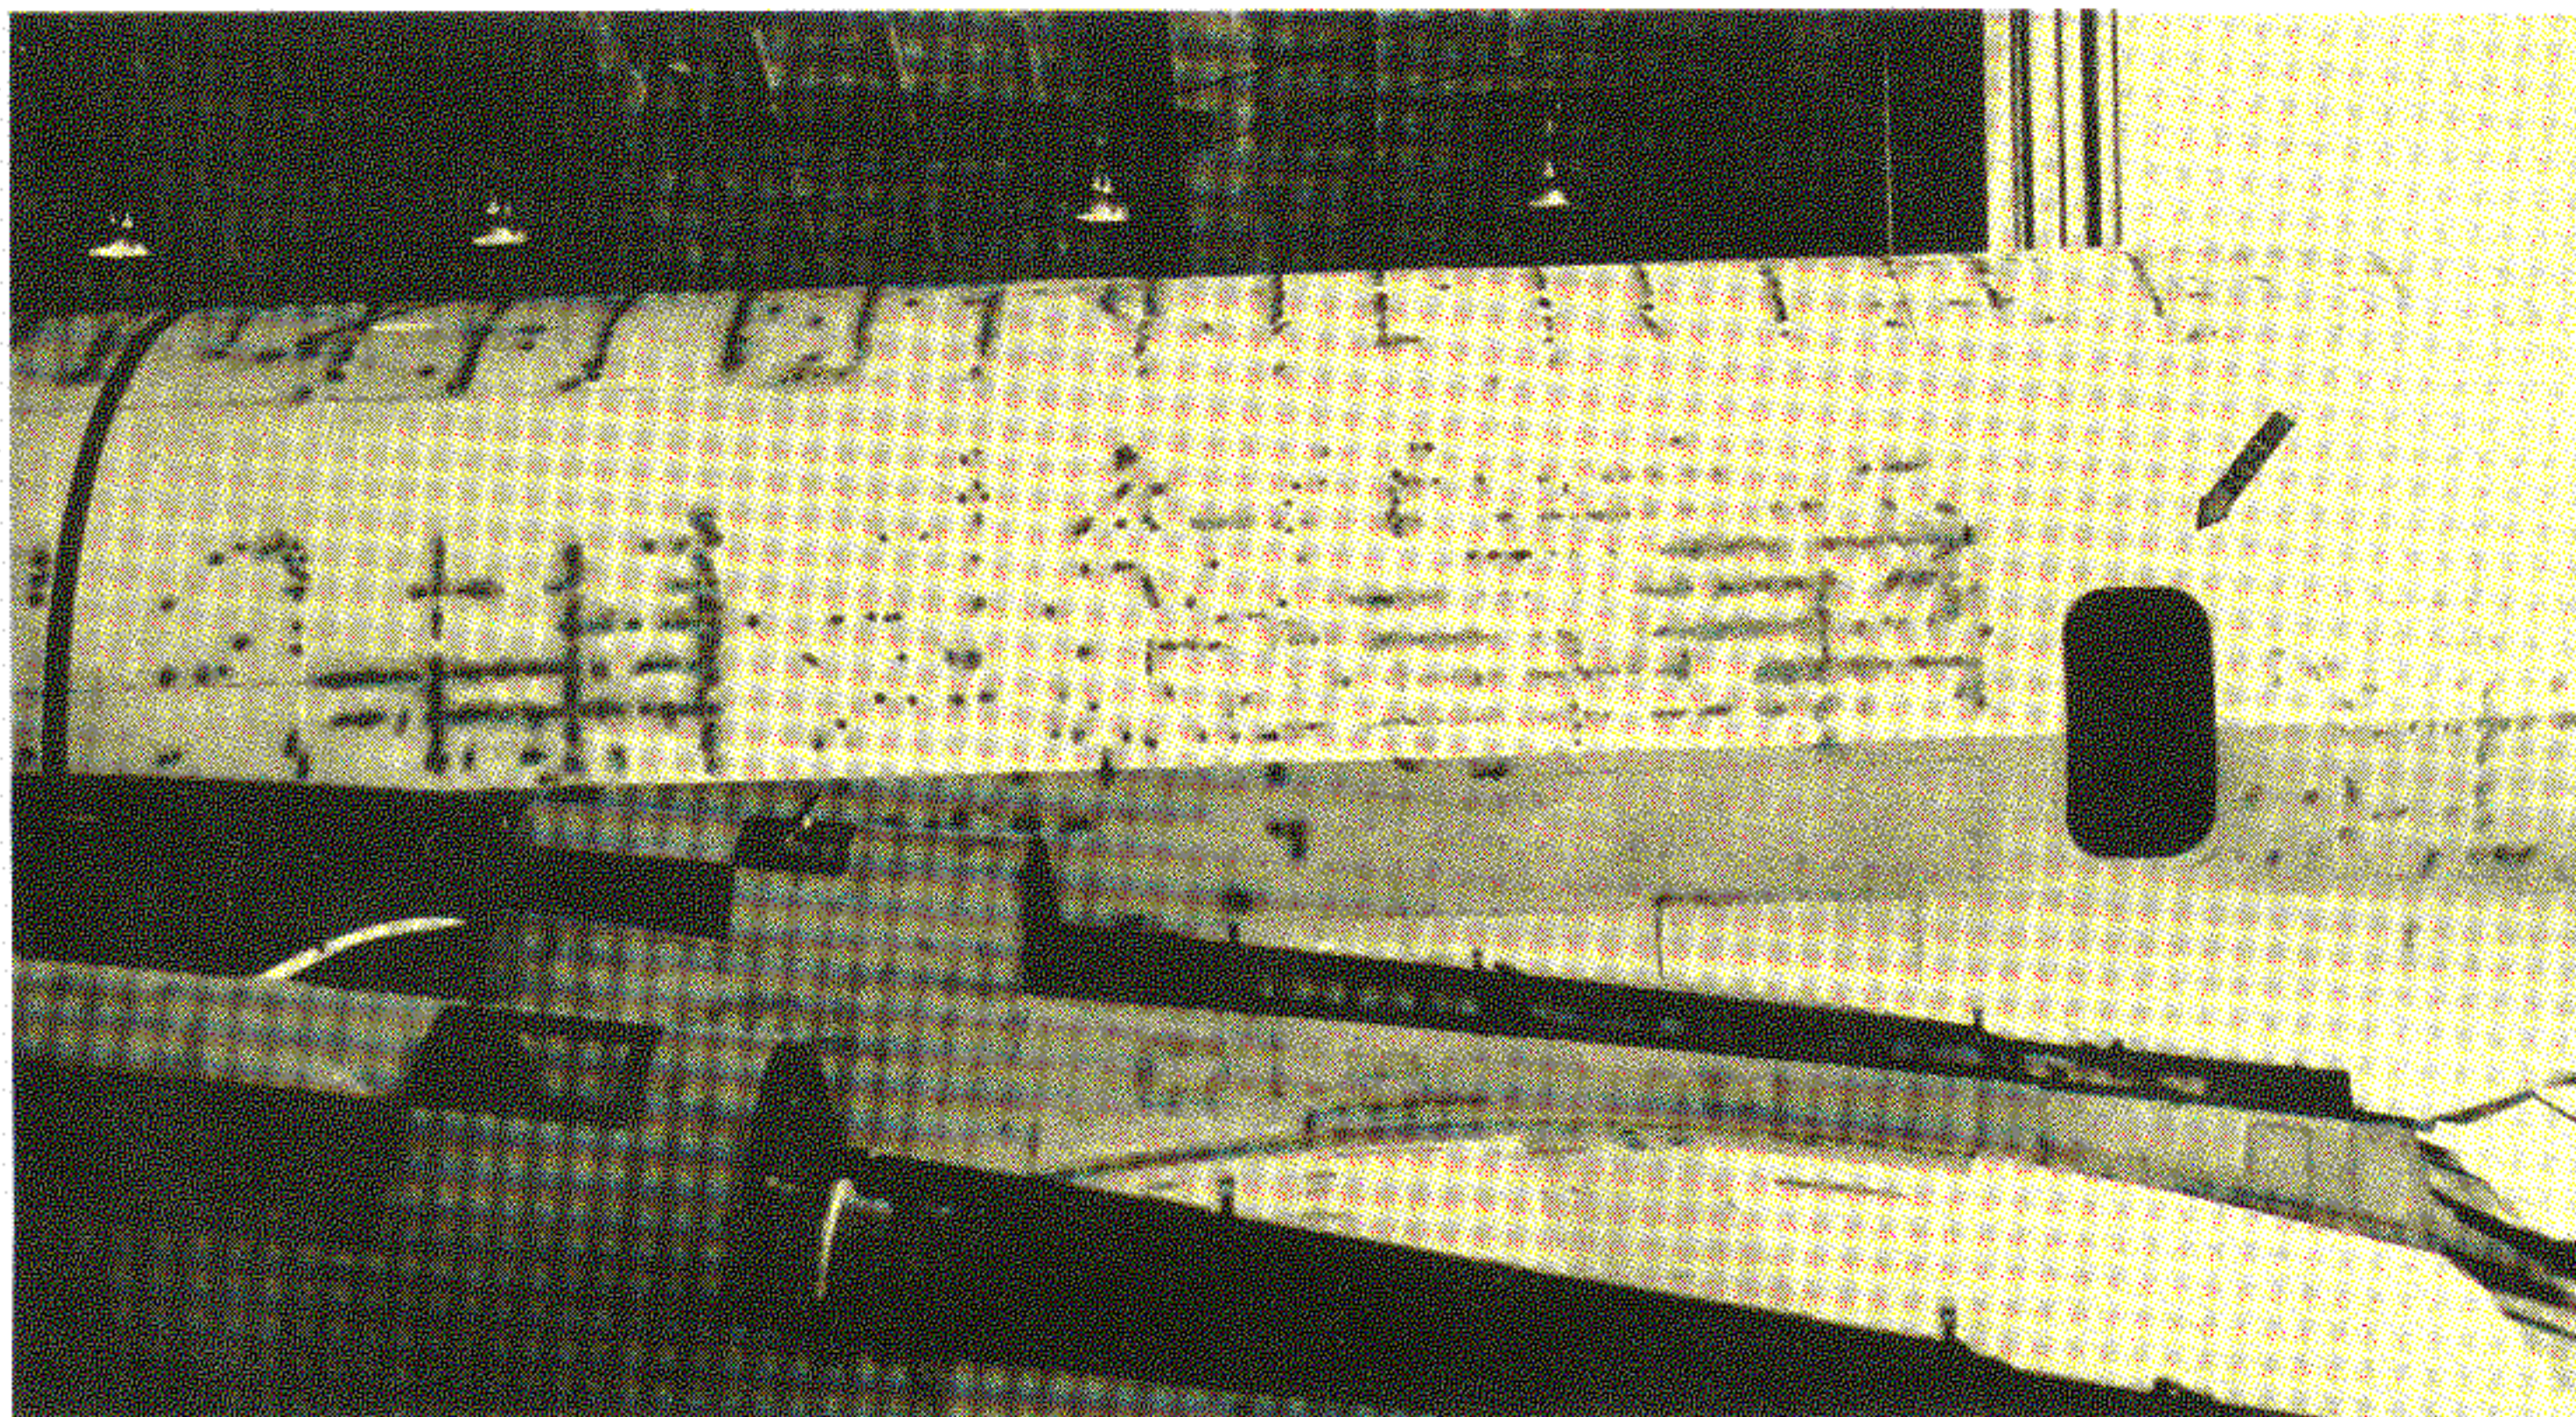
Figure 1
Fuselage After
Vacu-Blast
Treatment of
Areas with
Filiform
Corrosion

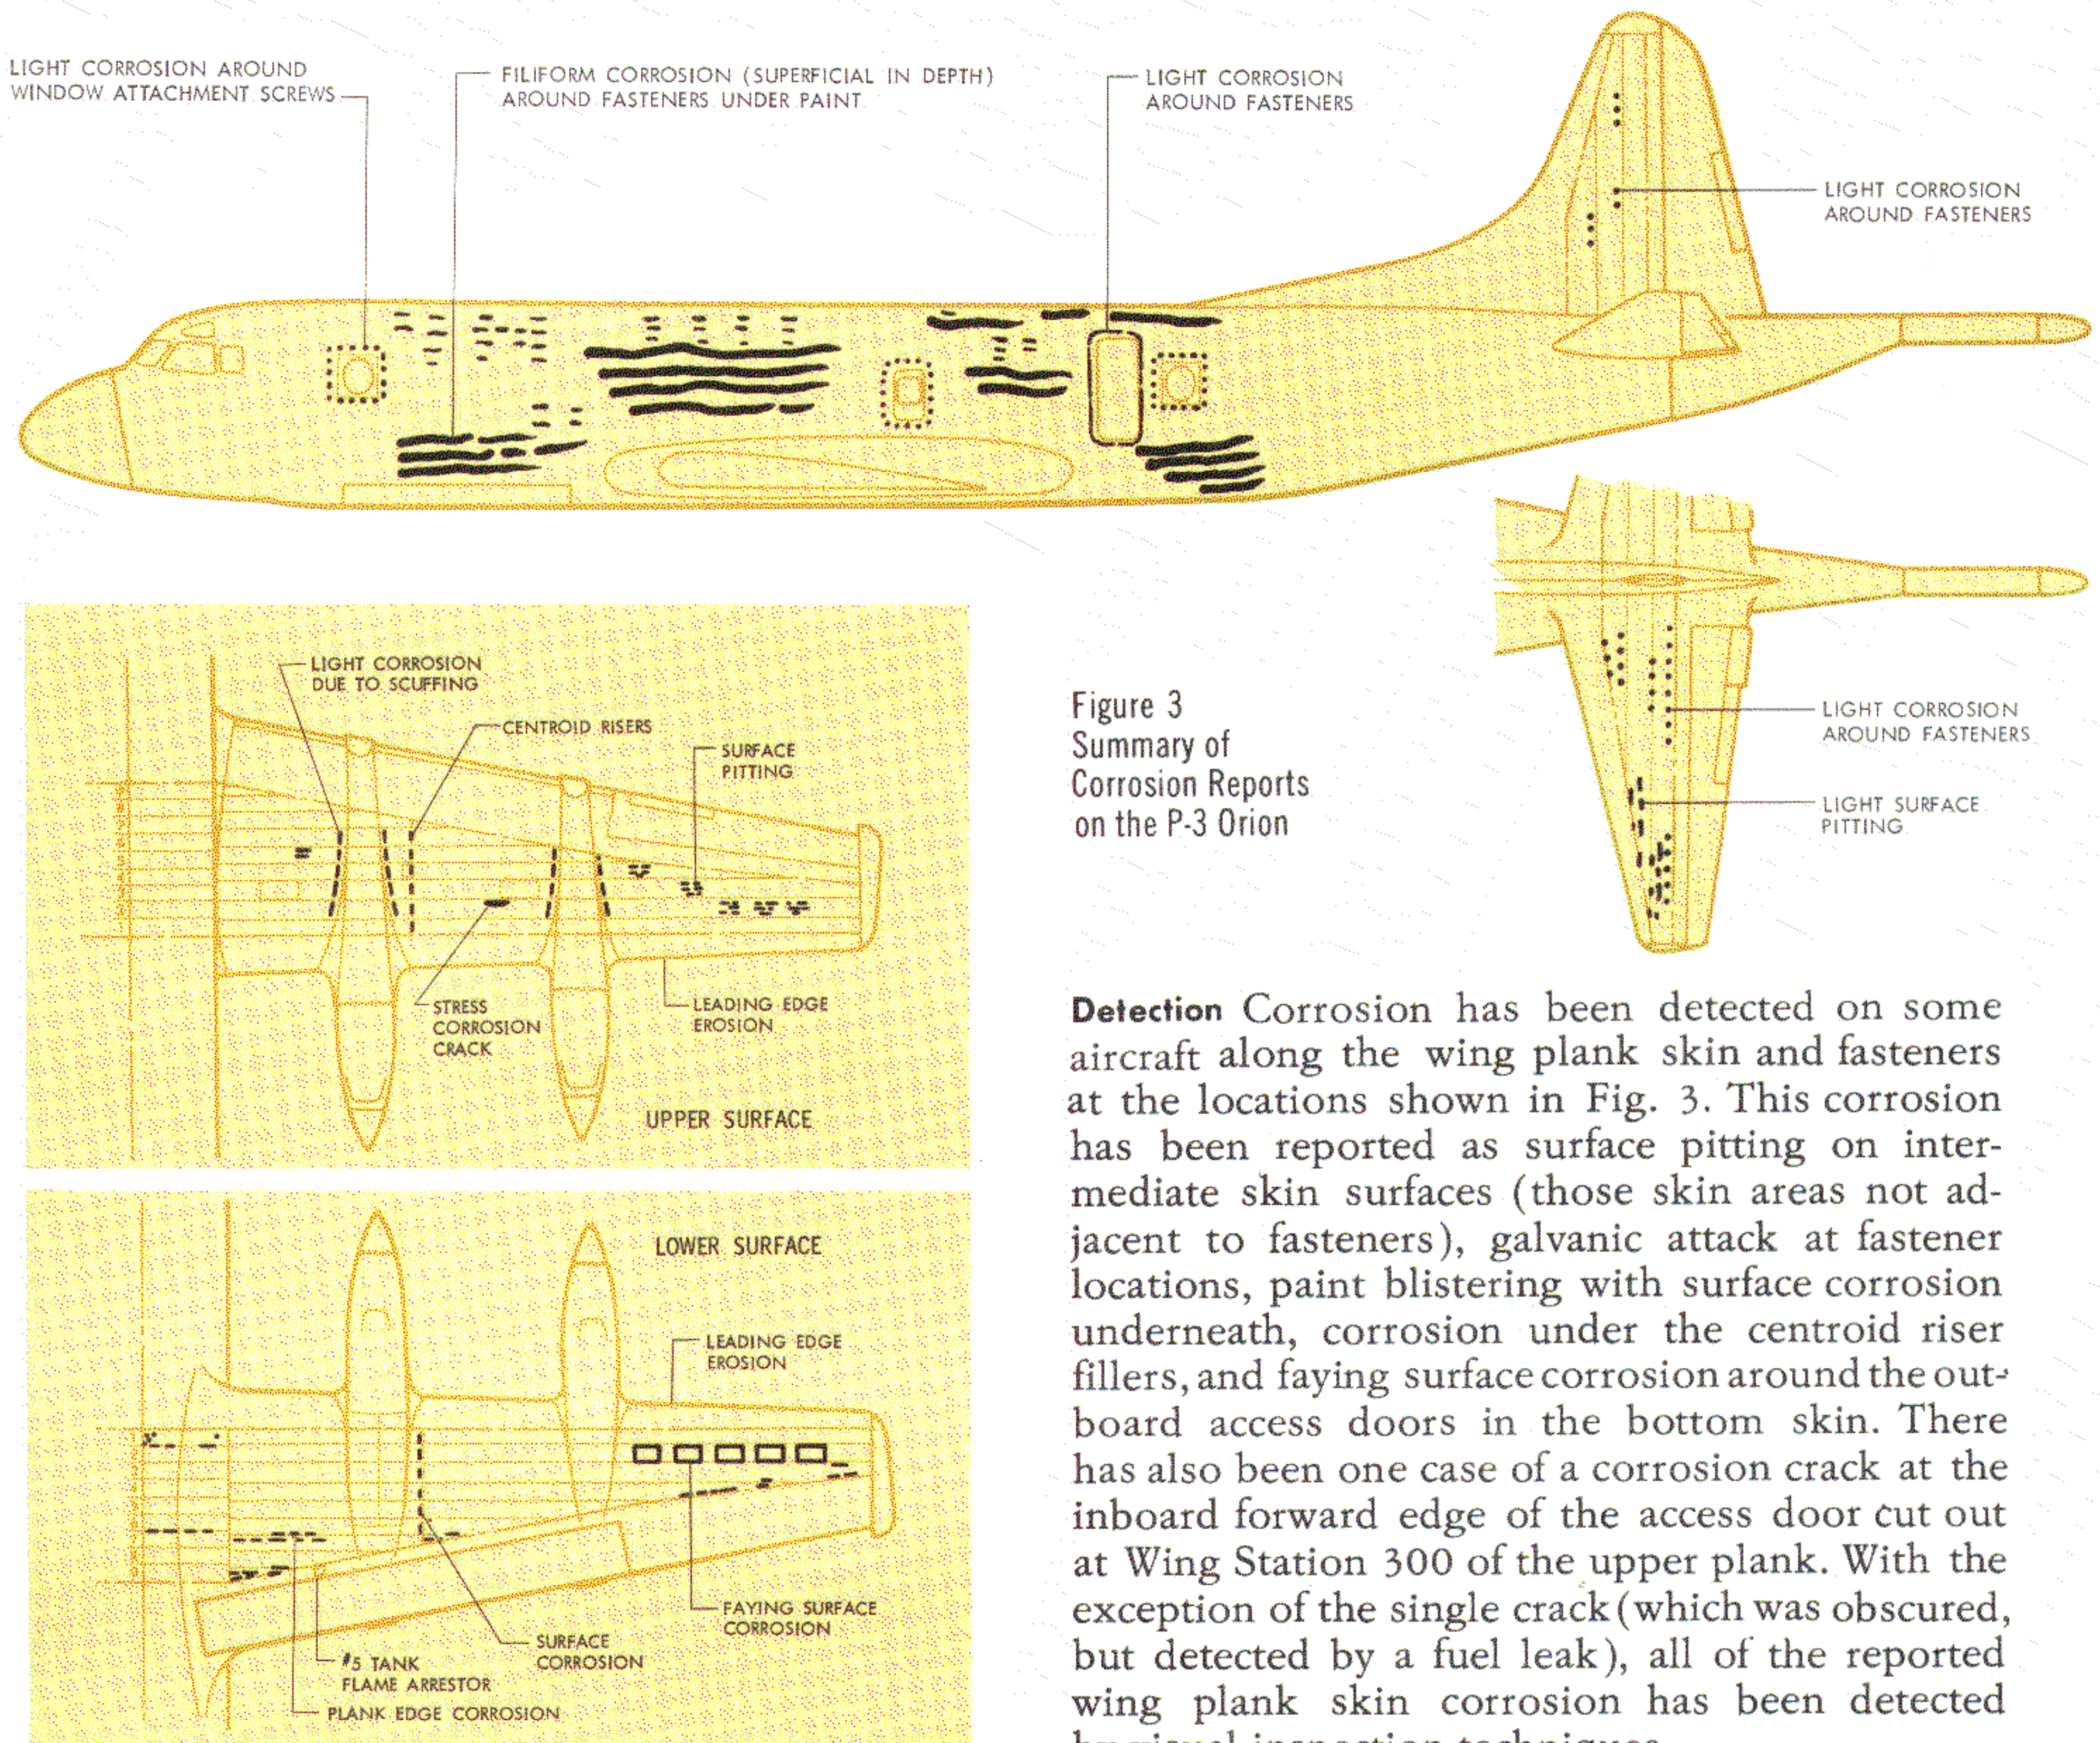
Figure 3
Summary of
Corrosion Reports
on the P-3 Orion

Detection Corrosion has been detected on some aircraft along the wing plank skin and fasteners at the locations shown in Fig. 3. This corrosion has been reported as surface pitting on intermediate skin surfaces (those skin areas not adjacent to fasteners), galvanic attack at fastener locations, paint blistering with surface corrosion underneath, corrosion under the centroid riser fillers, and faying surface corrosion around the outboard access doors in the bottom skin. There has also been one case of a corrosion crack at the inboard forward edge of the access door cut out at Wing Station 300 of the upper plank. With the exception of the single crack (which was obscured, but detected by a fuel leak), all of the reported wing plank skin corrosion has been detected by visual inspection techniques.

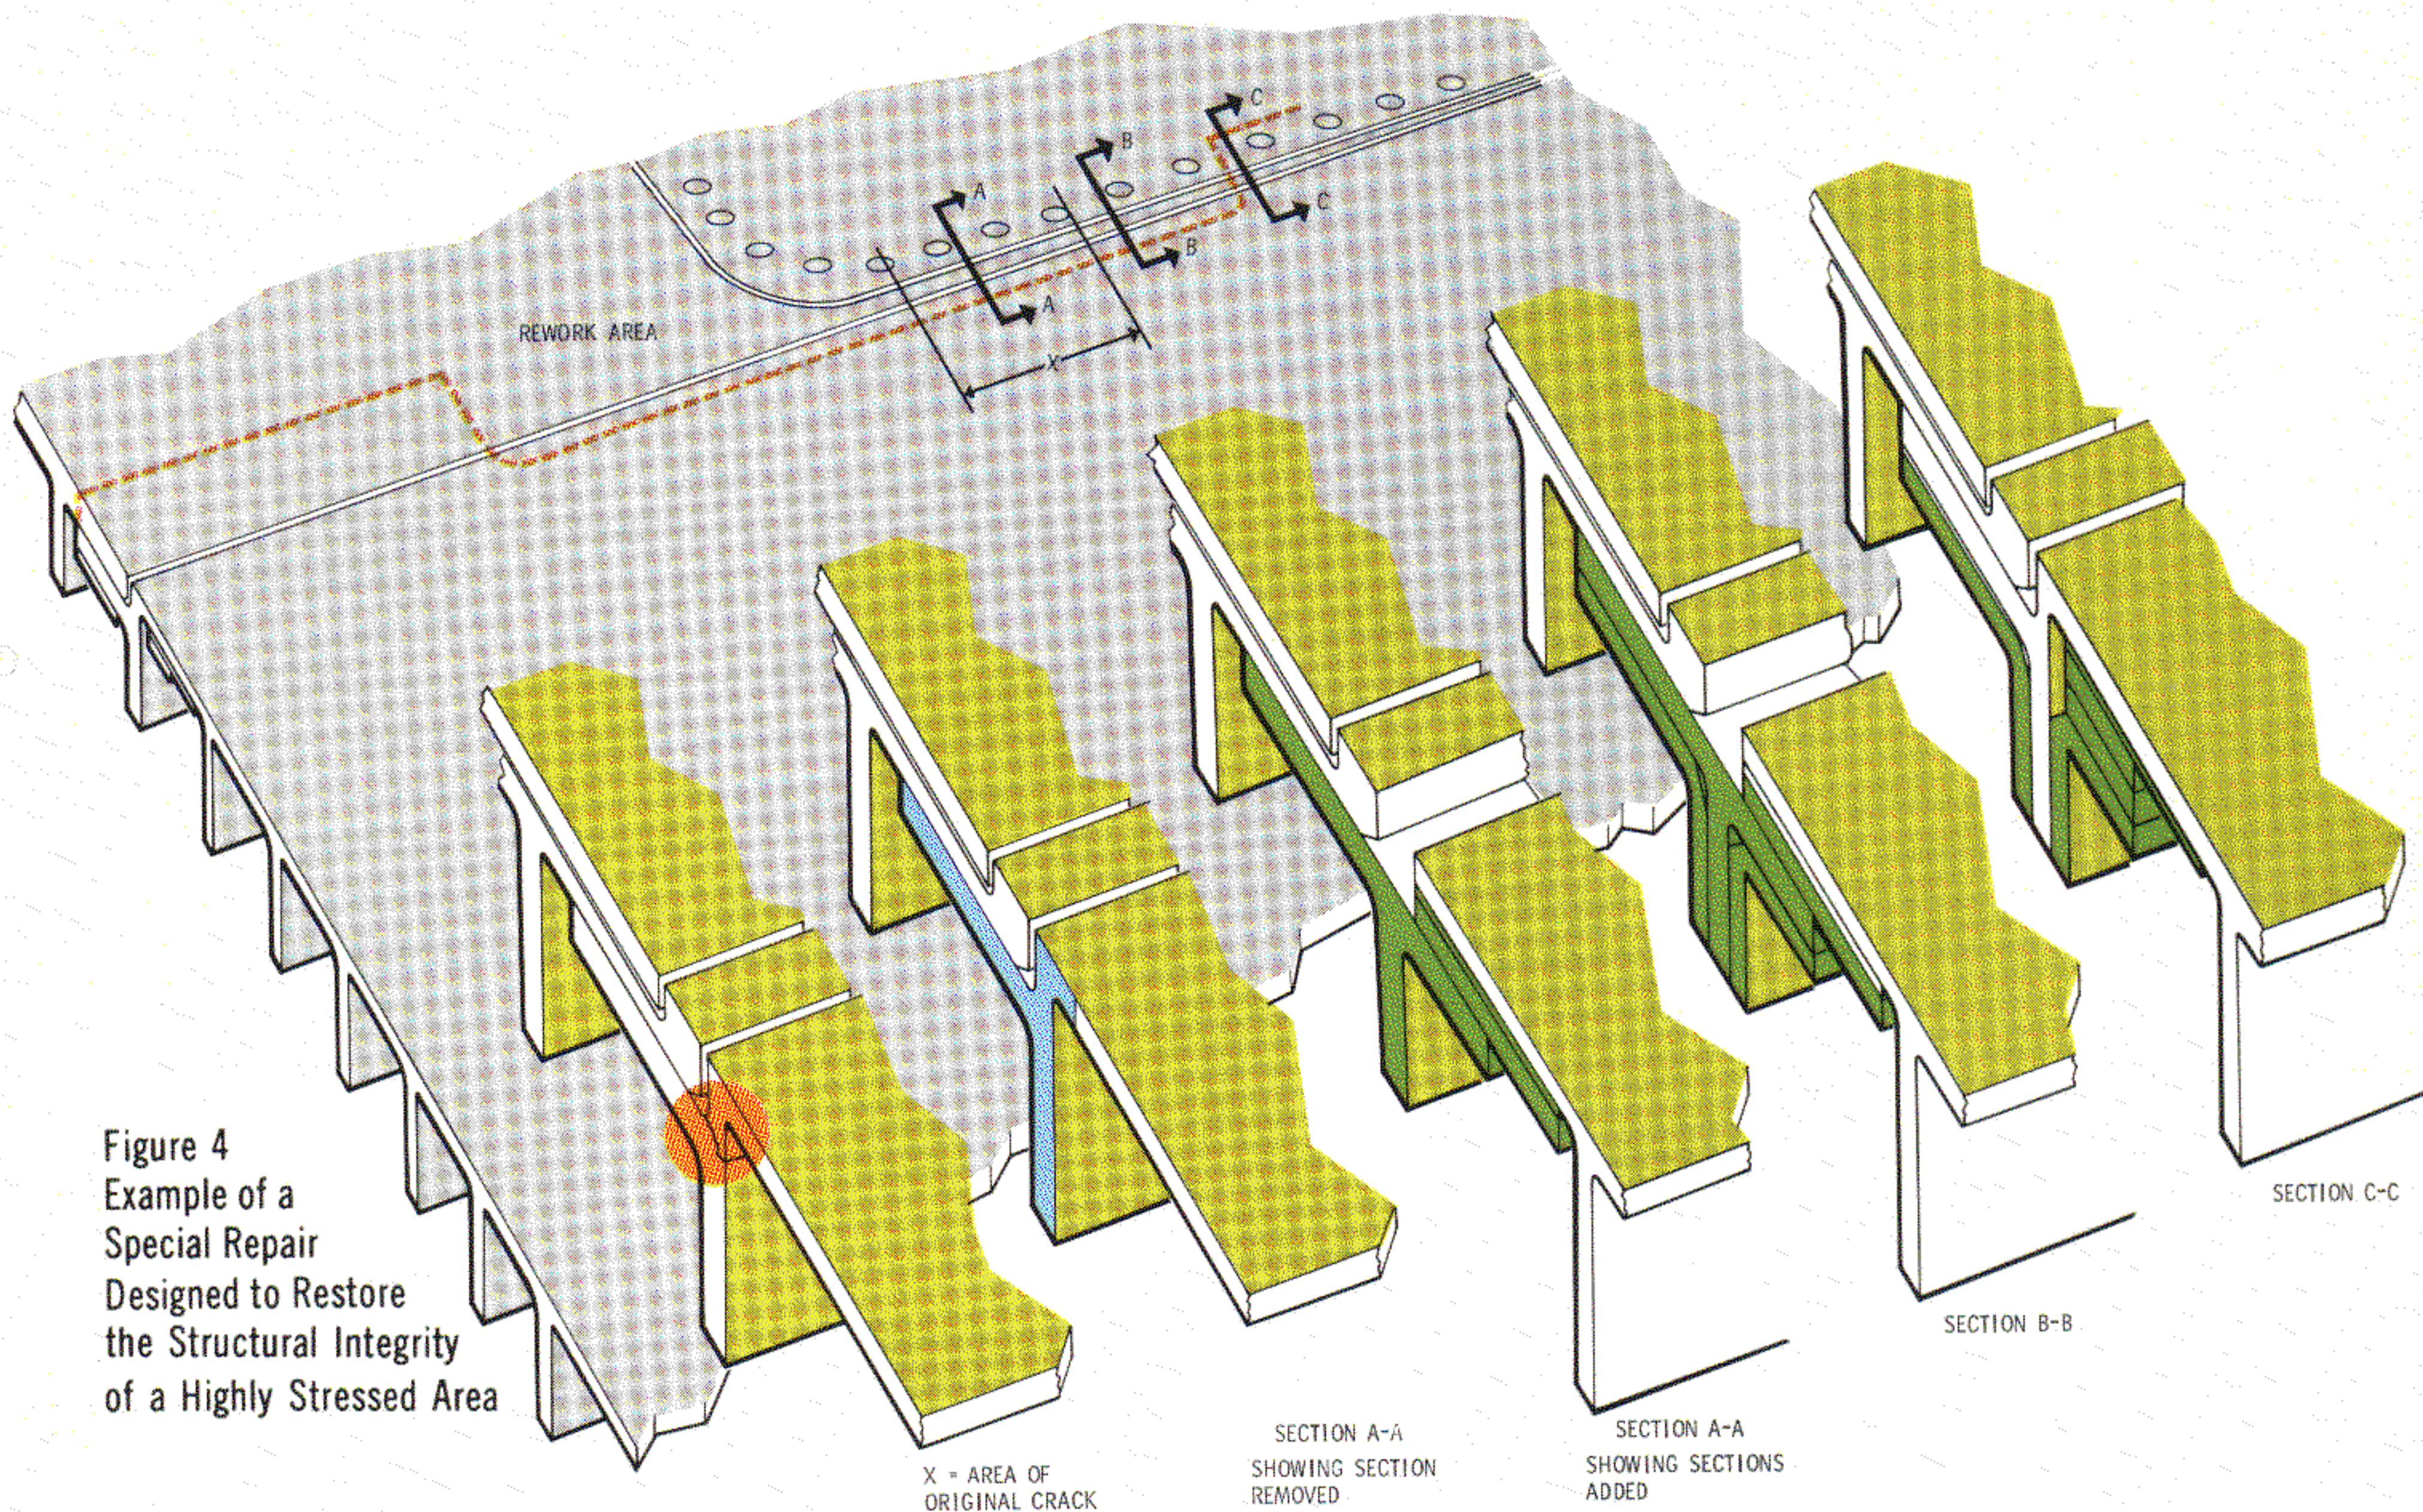
Figure 4
Example of a
Special Repair
Designed to Restore
the Structural Integrity
of a Highly Stressed Area

To date, the corrosion reported on the wing plank skin has been superficial in nature, with the exception of the one stress corrosion* crack. Removal of the corrosion deposits, cleaning of the surfaces, and restoration of protective finishes has been accomplished by standard procedures outlined in the official corrosion control publications.

Repair In the case of the crack, which was located in an area of relatively high stress, a special repair was designed by Lockheed to restore the structural integrity of the area (see Figure 4). Any repair of this nature must be designed by a qualified structures engineer, and he must give thorough consideration to P-3 stress distribution when making the design.

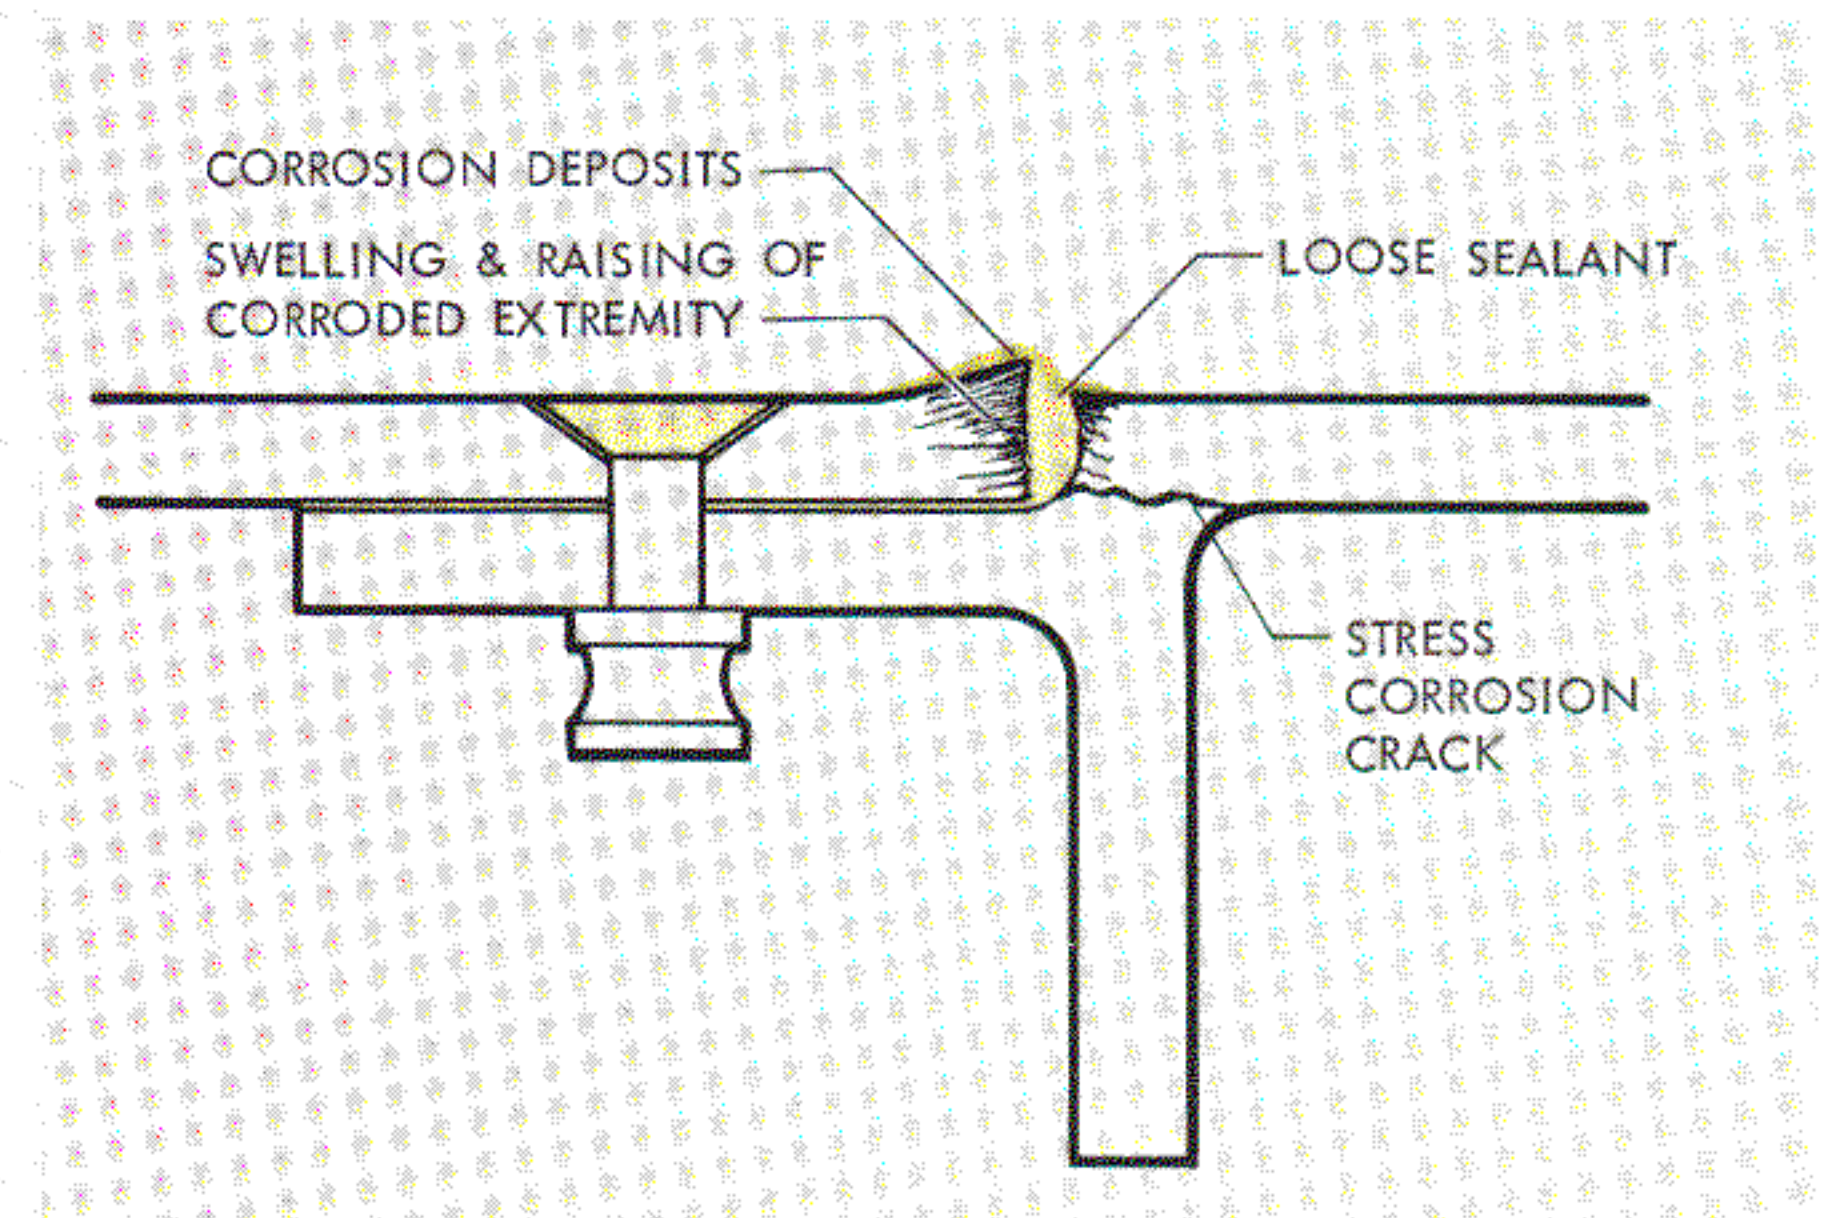
Figure 8 Exfoliation Causes Swelling of the Gap Edge Material

Repair If the corrosion removal operation exceeds allowable structural limits, repairs must be made before the application of protective coatings. Refer to the introductory section on repairs for precautionary measures and to the Structural Repair Manual NAVWEPS 01-75PAA-3-1 or -2 for allowable limits.

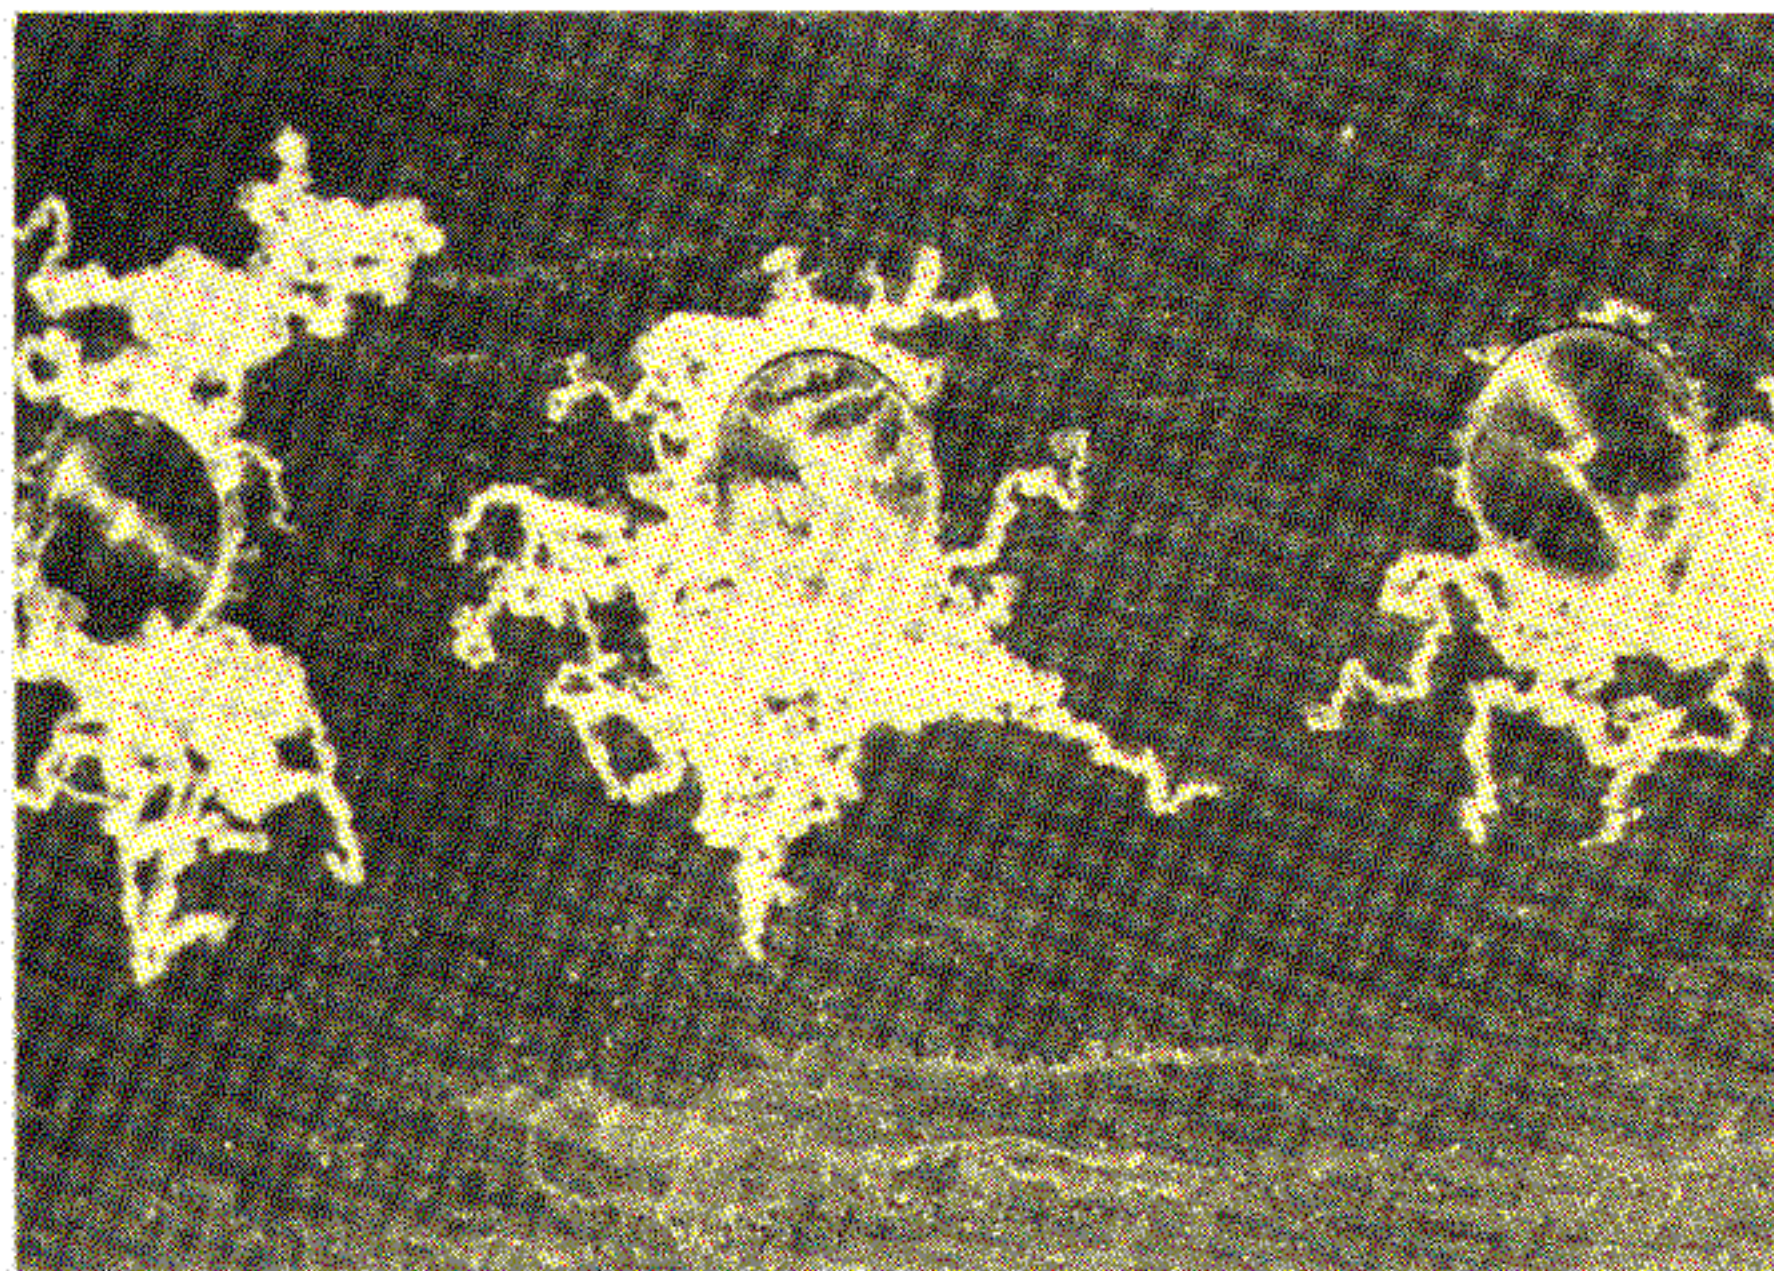
Figure 11 Example of Filiform Corrosion

FASTENERS Filiform* corrosion has been detected around steel and aluminum fasteners on the fuselage and empennage surfaces. It appears at random and usually shows evidence of microscopic working between the fastener and attaching surface. Manufacturing tolerances between the fastener head and the countersink may prevent accomplishment of a perfect seal during assembly and create small entrapment areas. These minute gaps are effectively masked from the environment by the protective paint coatings, but working of the fasteners may cause the paint to crack and permit entry of moisture and contaminants.

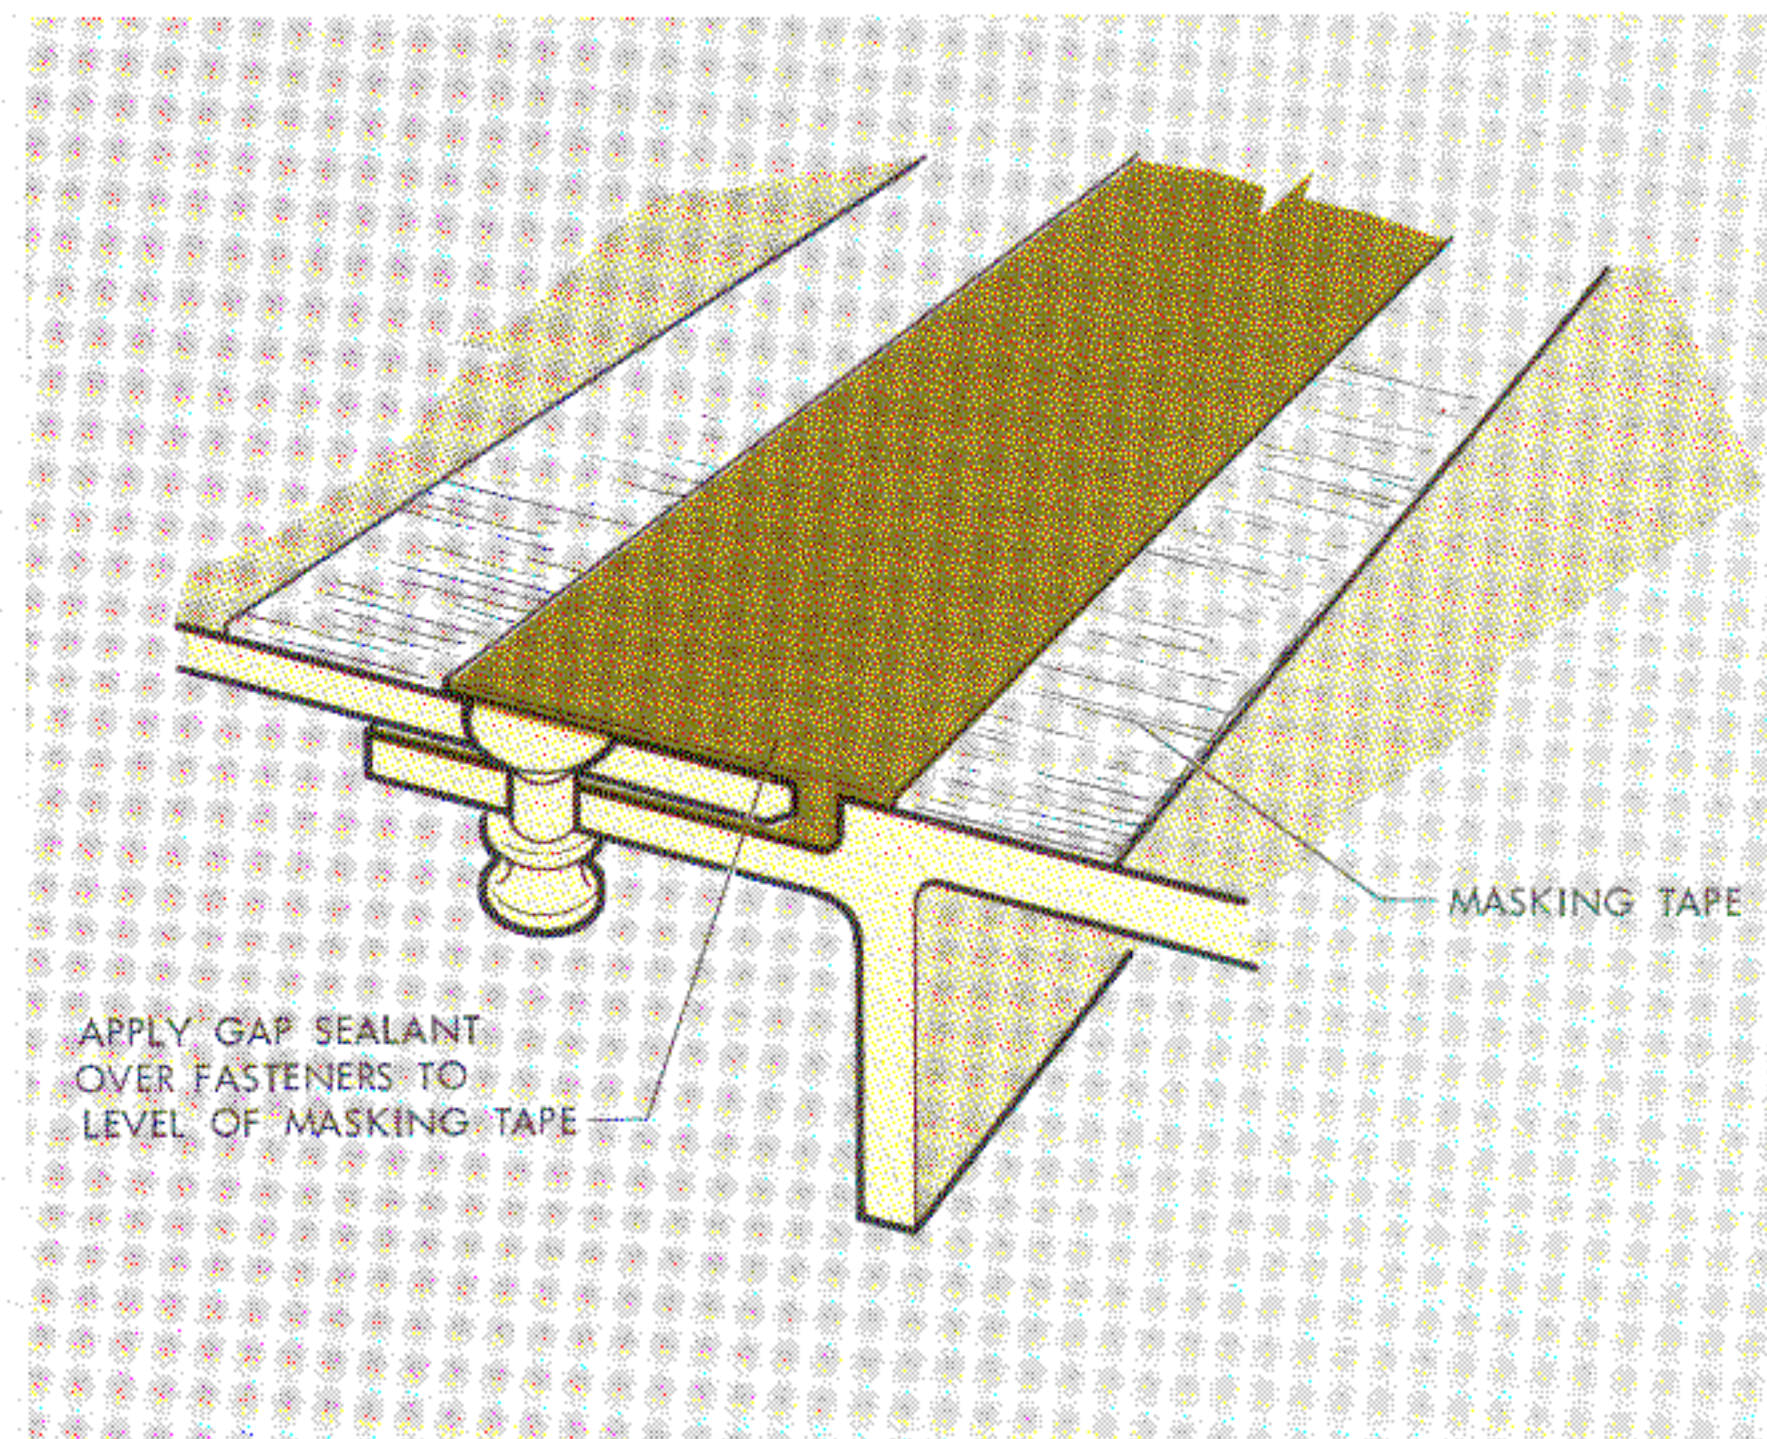
Figure 12 Method of Applying Sealant Over Steel Fasteners Installed in Wing Planks

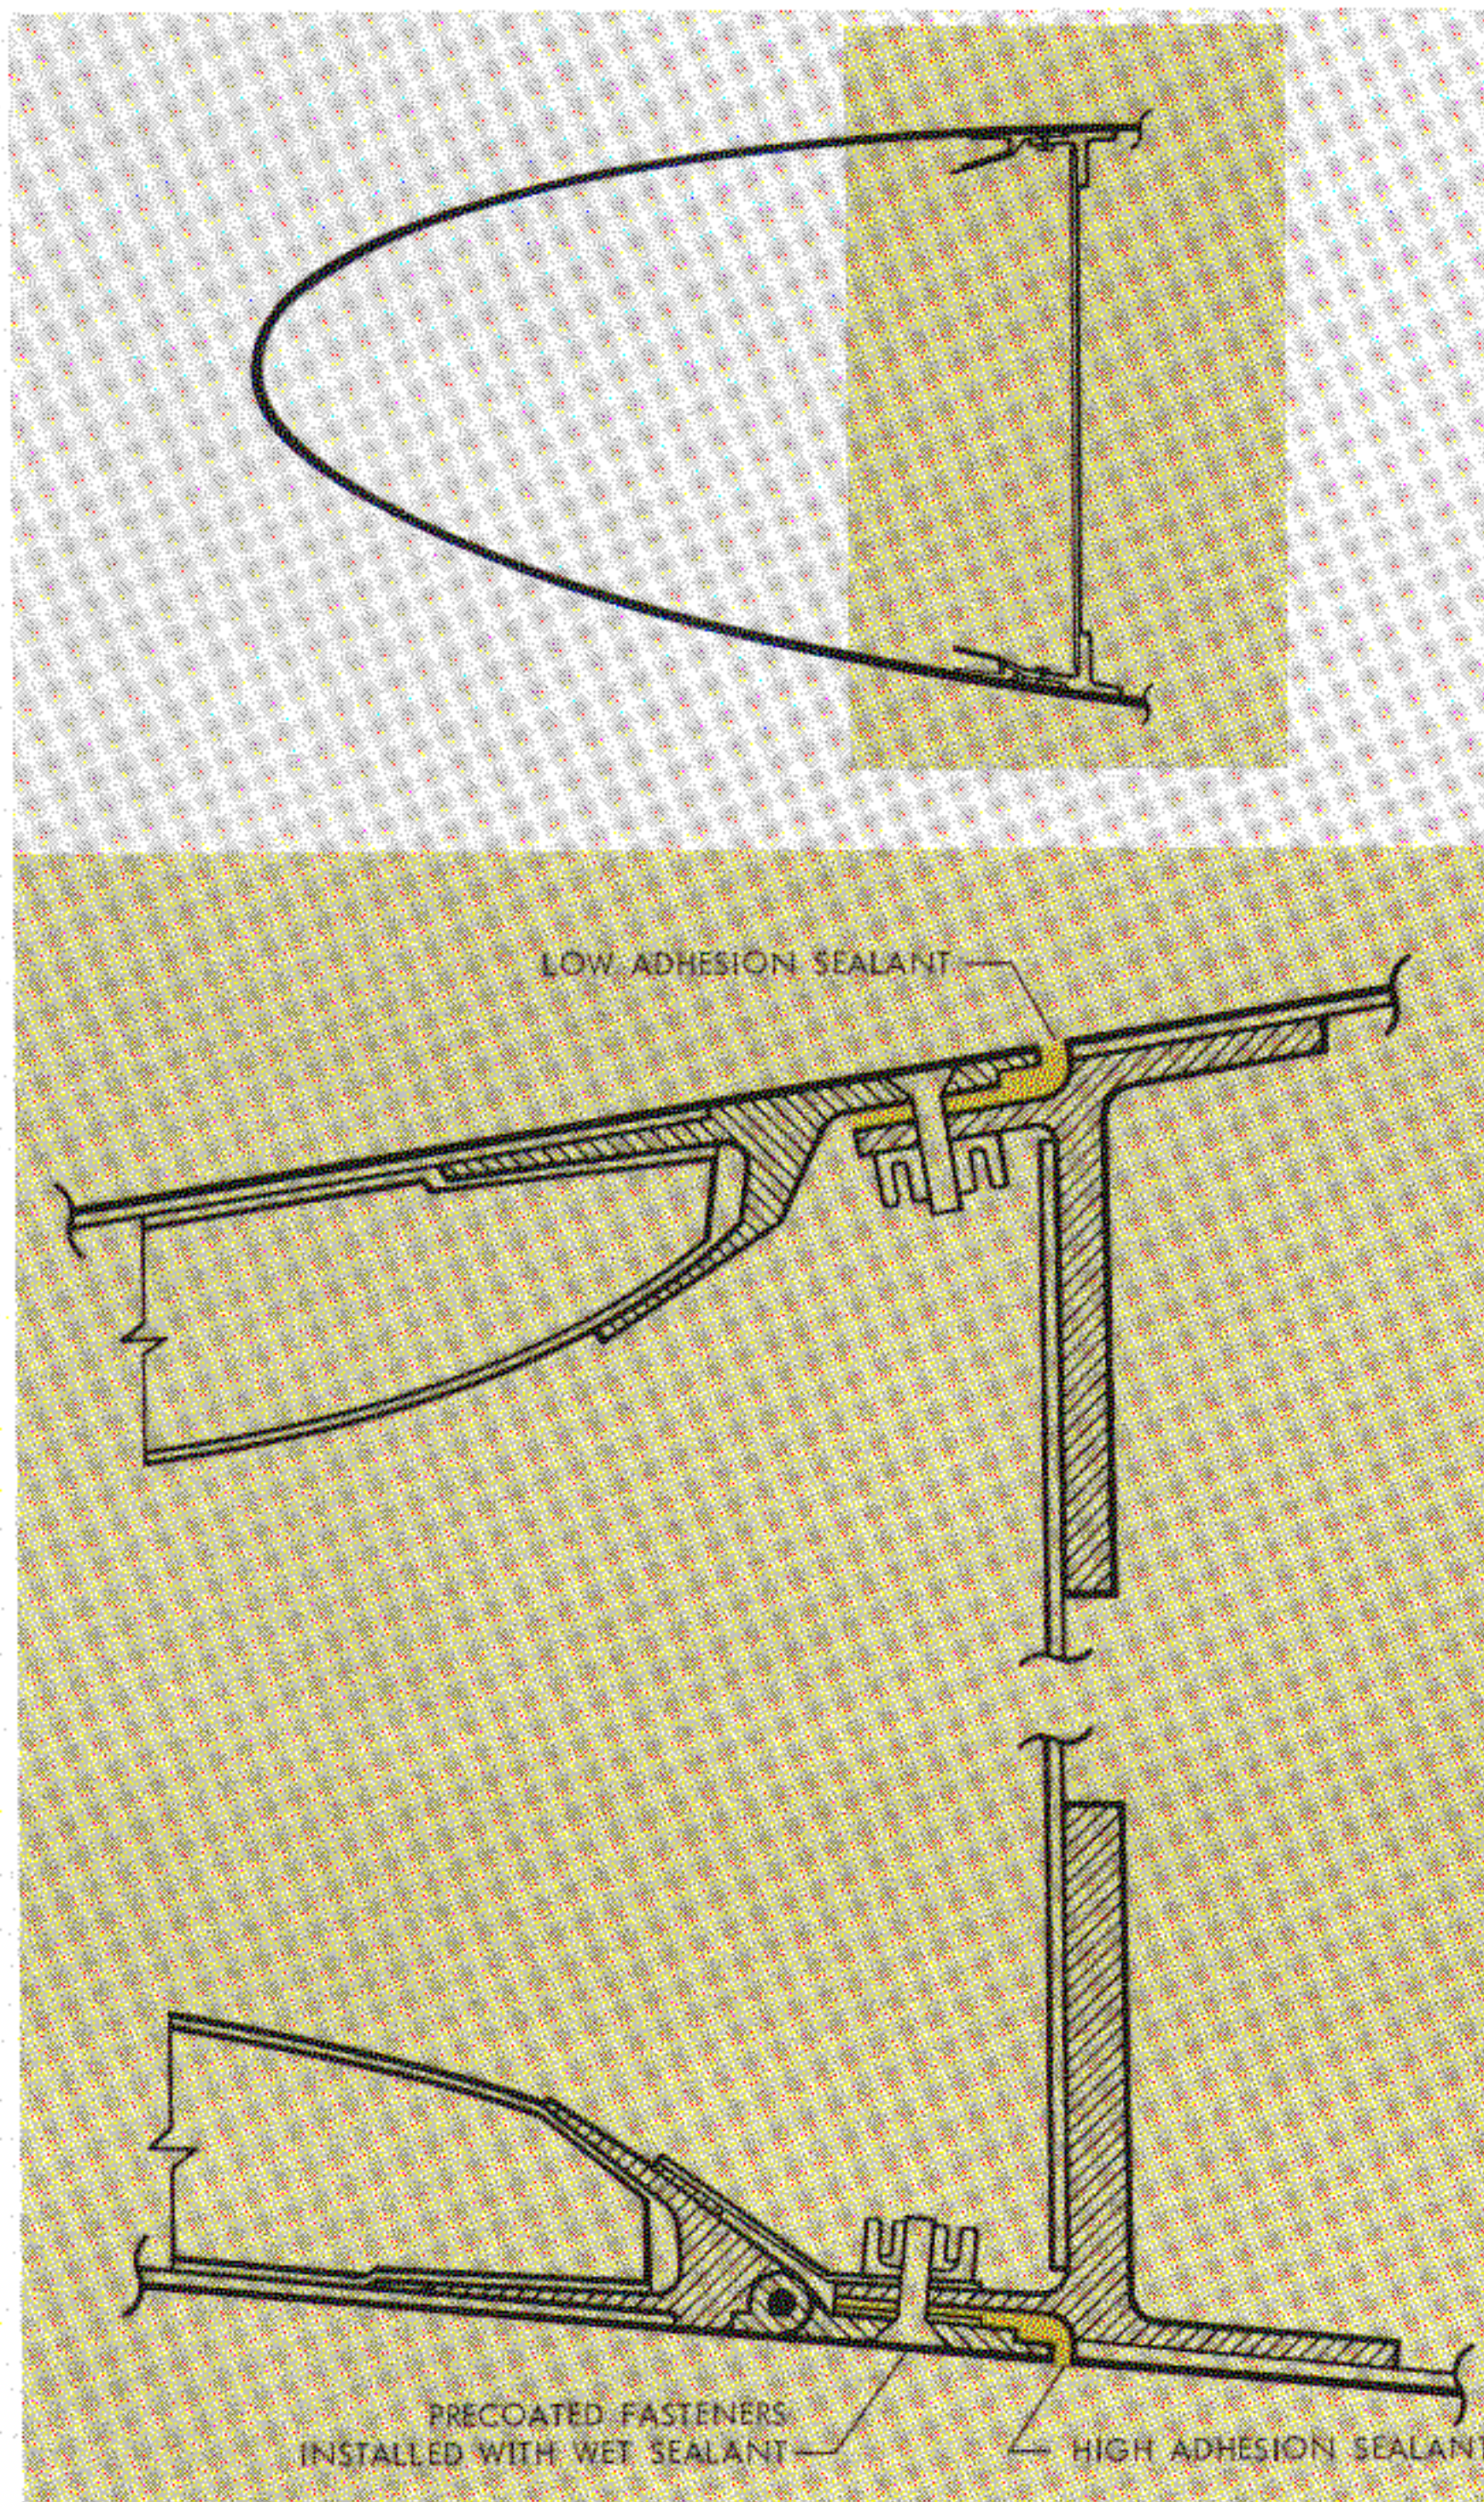
Figure 13 Location of Sealant on Wing Leading Edge-to-Spar Cap Faying Surfaces. High adhesion sealant is permanently installed.

construction. The leading edge skin forms the outer layer of a hot air duct system which provides anti-icing protection. Some reports of corrosion at the spar cap-to-leading edge faying surfaces and around the fasteners have been received on early aircraft. When removing or installing fasteners, proper screwdrivers must be used to avoid damage to the protective cadmium coatings on the fasteners.
