SERVICE DIGEST

issue **14** August 1966

CORROSION AND THE P-3 ORION

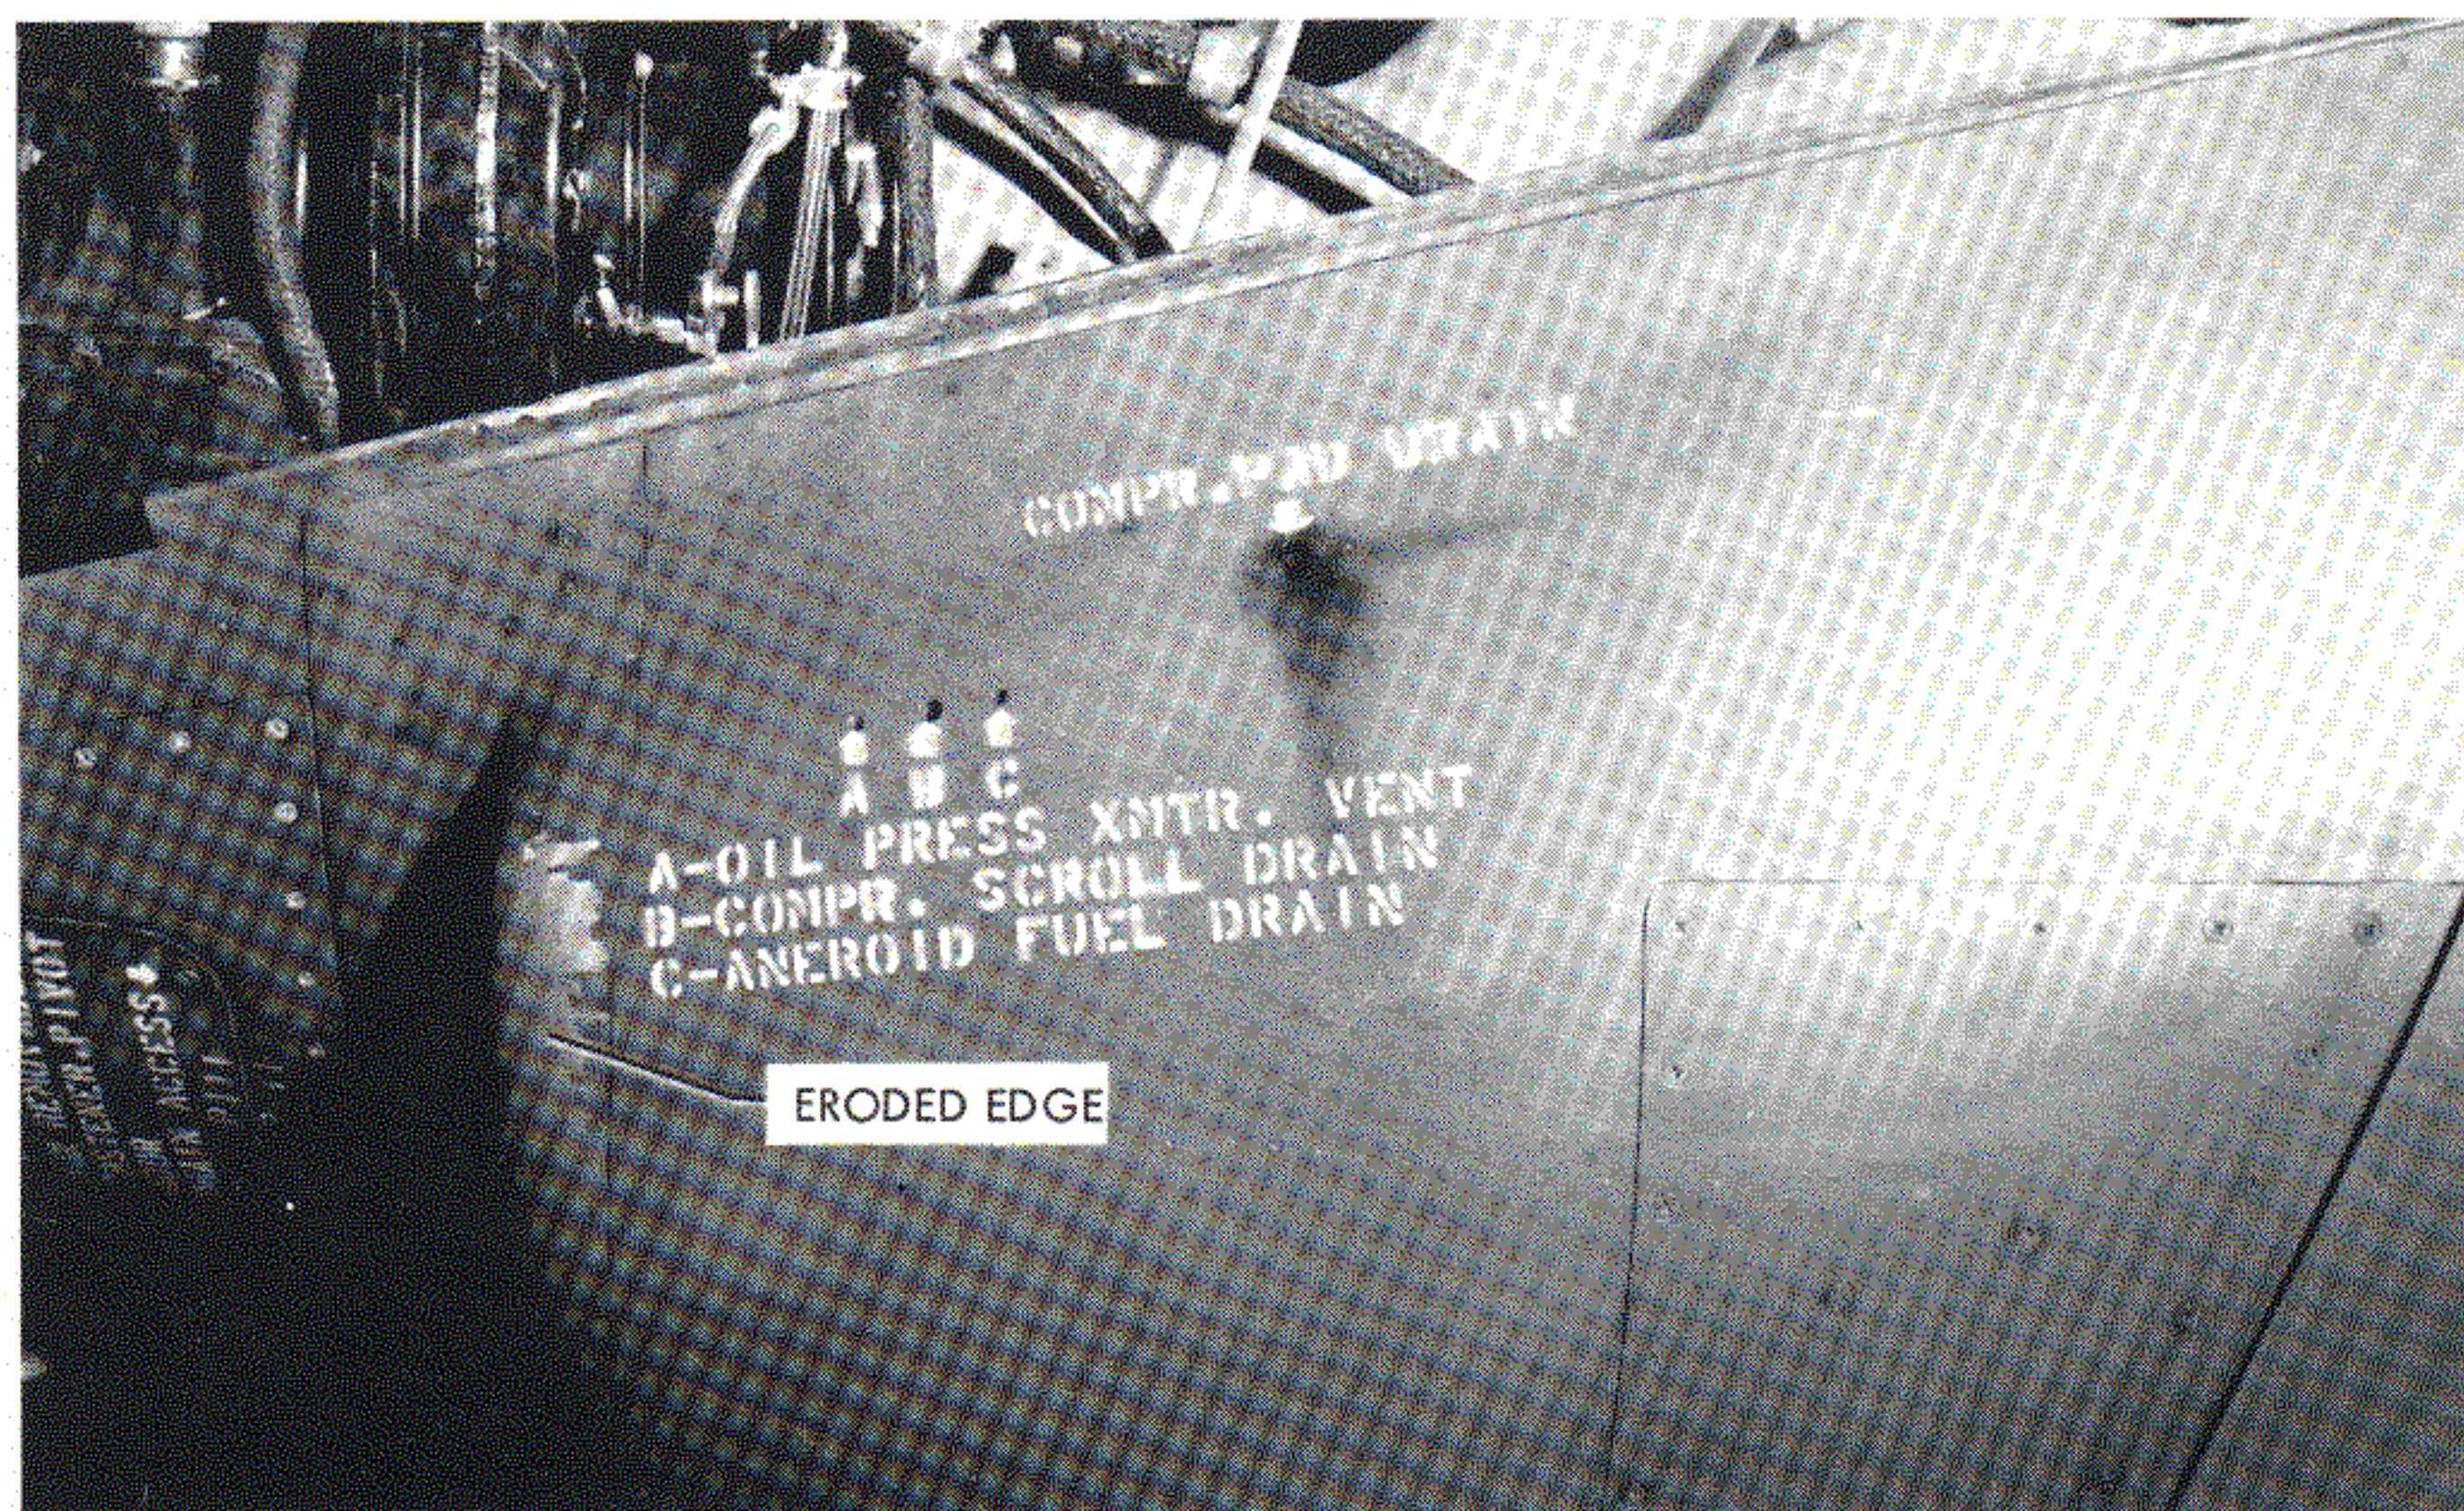
Figure 23
Erosion of Paint on the
Oil Cooler Air Scoop Leading Edge

Cleaning and Inhibiting Immediately after removal of corrosion products, wash the reworked area with fresh water and allow to dry. Inhibit the area by using chromic acid solution, MIL Spec. FED-0-C-303, FSN G6810-264-3939. Apply one coat of solution and allow to stand for fifteen minutes. Wash the area with fresh water and allow to dry.
