# ORION

# digest

issue **29**

## TURBINE INLET TEMPERATURE AND TURBINE LONGEVITY

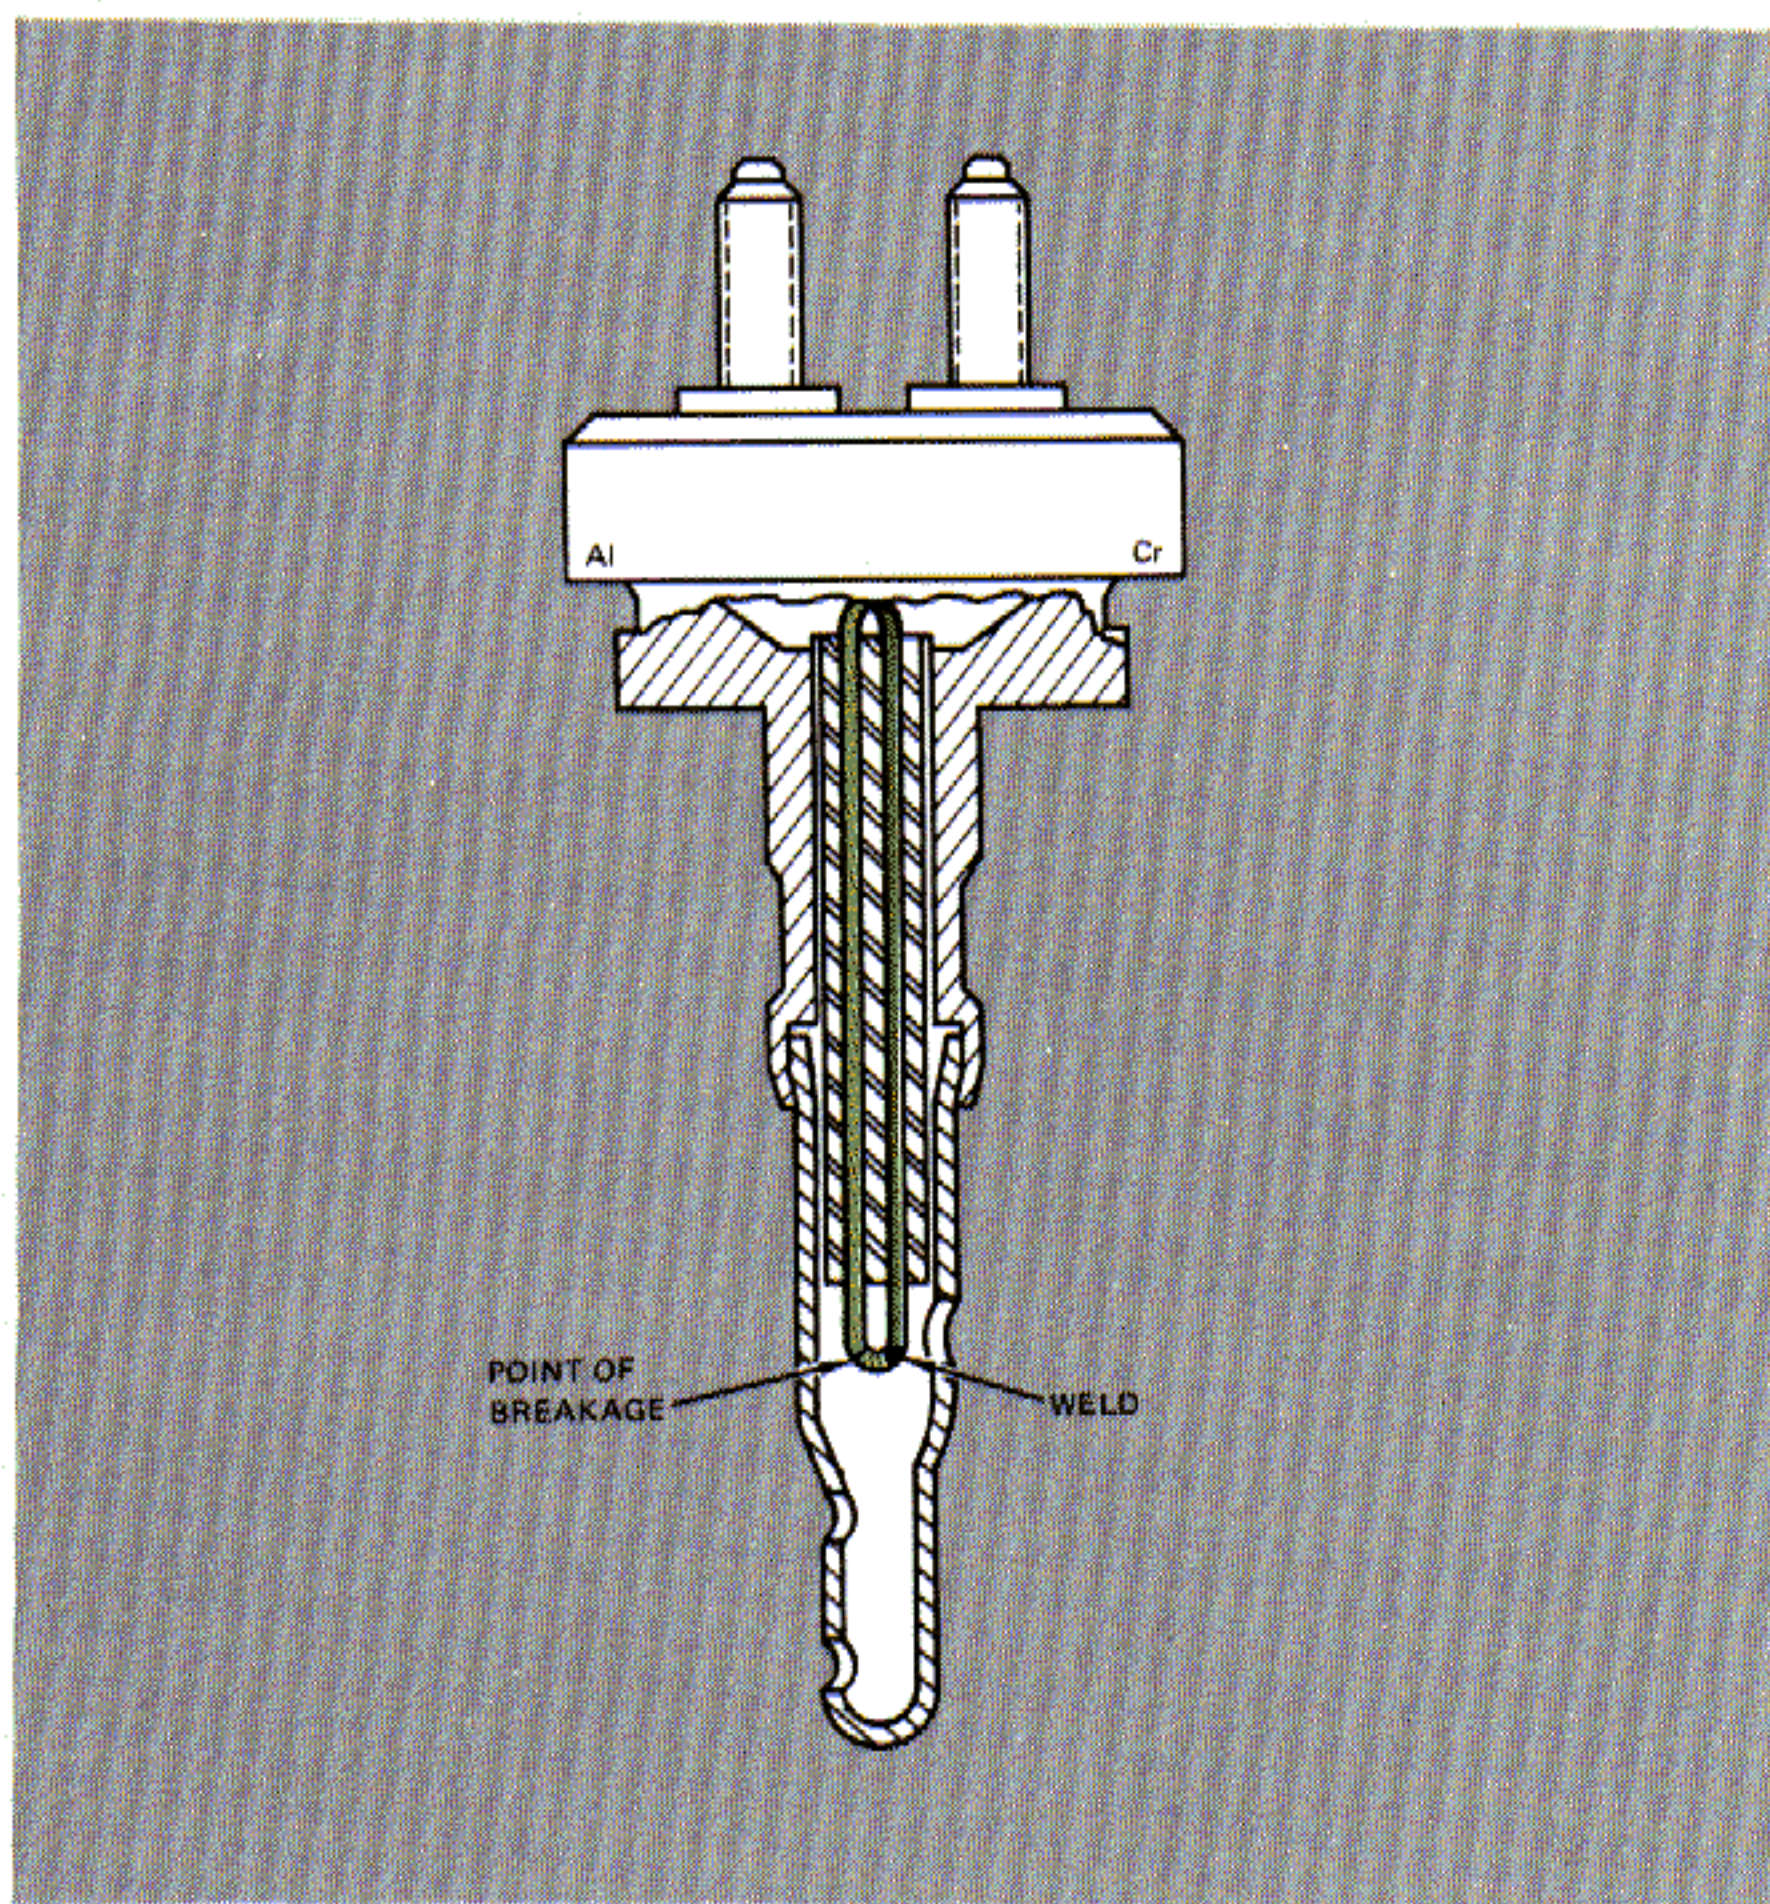
Figure 3 Thermocouple with Open Junction due to Breakage in Sensing Element. Point of Breakage is Shown near Weld of Sensing Element's Dissimilar Metals.

**Thermocouples With Open Junctions** Let us draw the reasonable assumption that the first thermocouple to fail will be the one at the hottest spot of the turbine inlet. (There are numerous possible failure sequences, but we shall comment on the simplest condition.) We shall further assume that both sensing element junctions of this thermocouple develop open circuits. Usually such open circuits are due to breakage of the sensing element, adjacent to the weld of the dissimilar metals (see Figure 3).

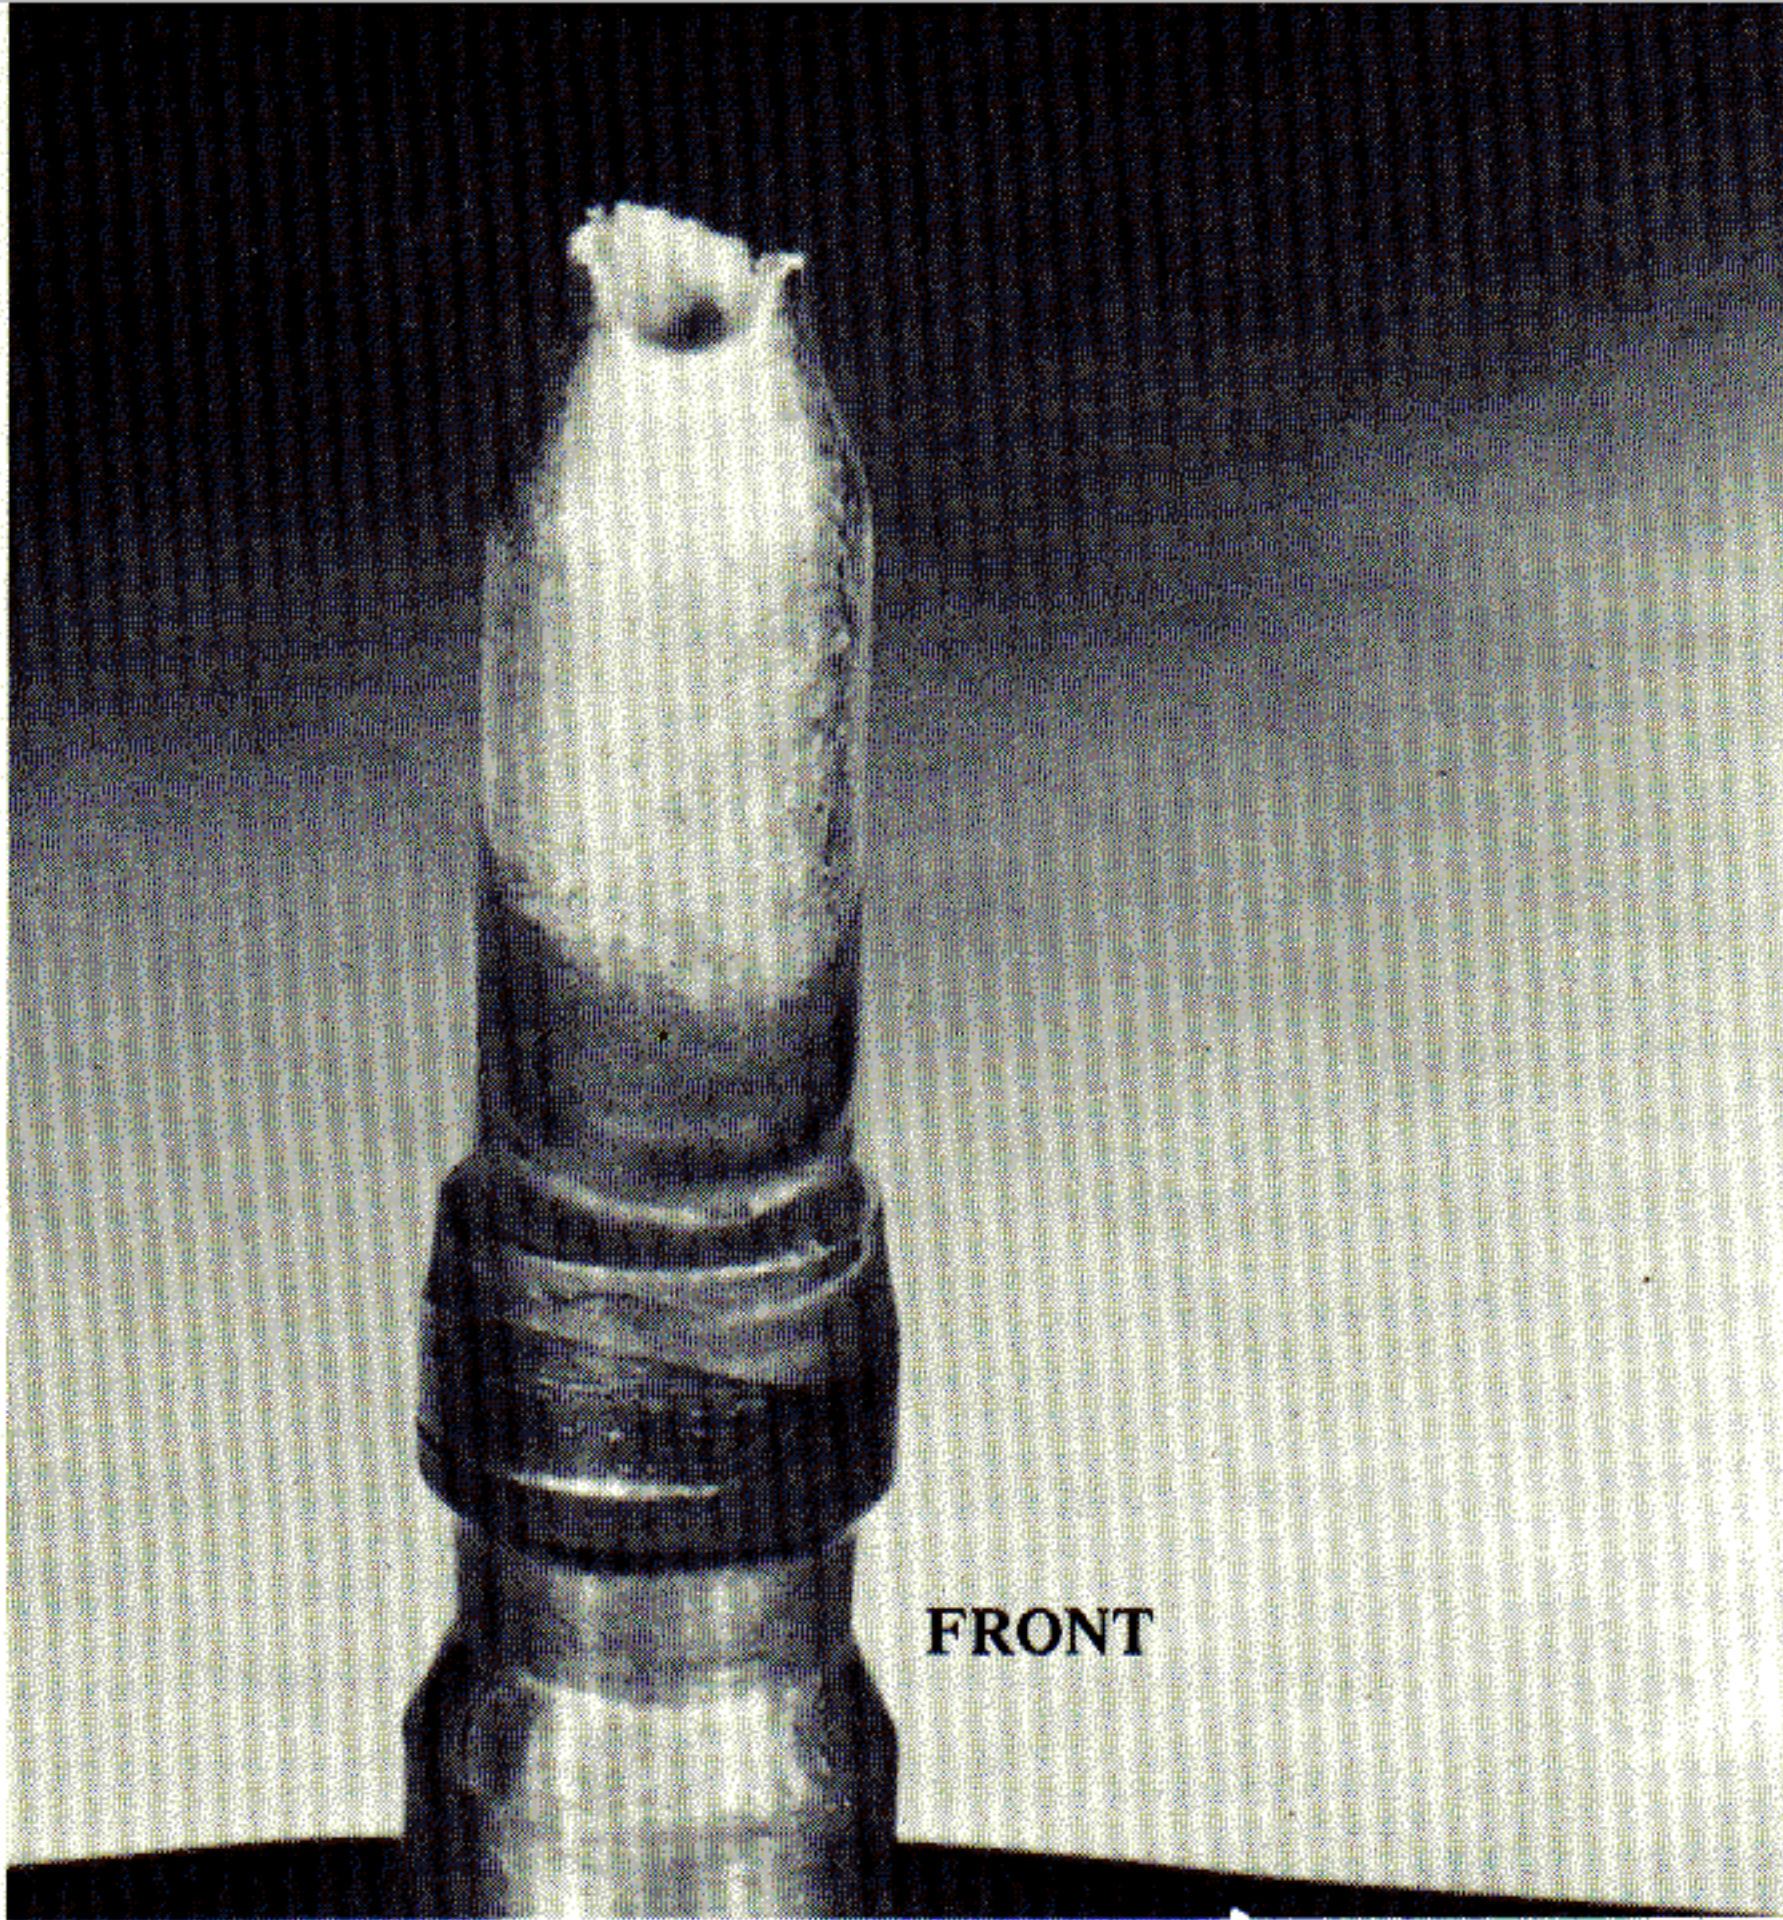
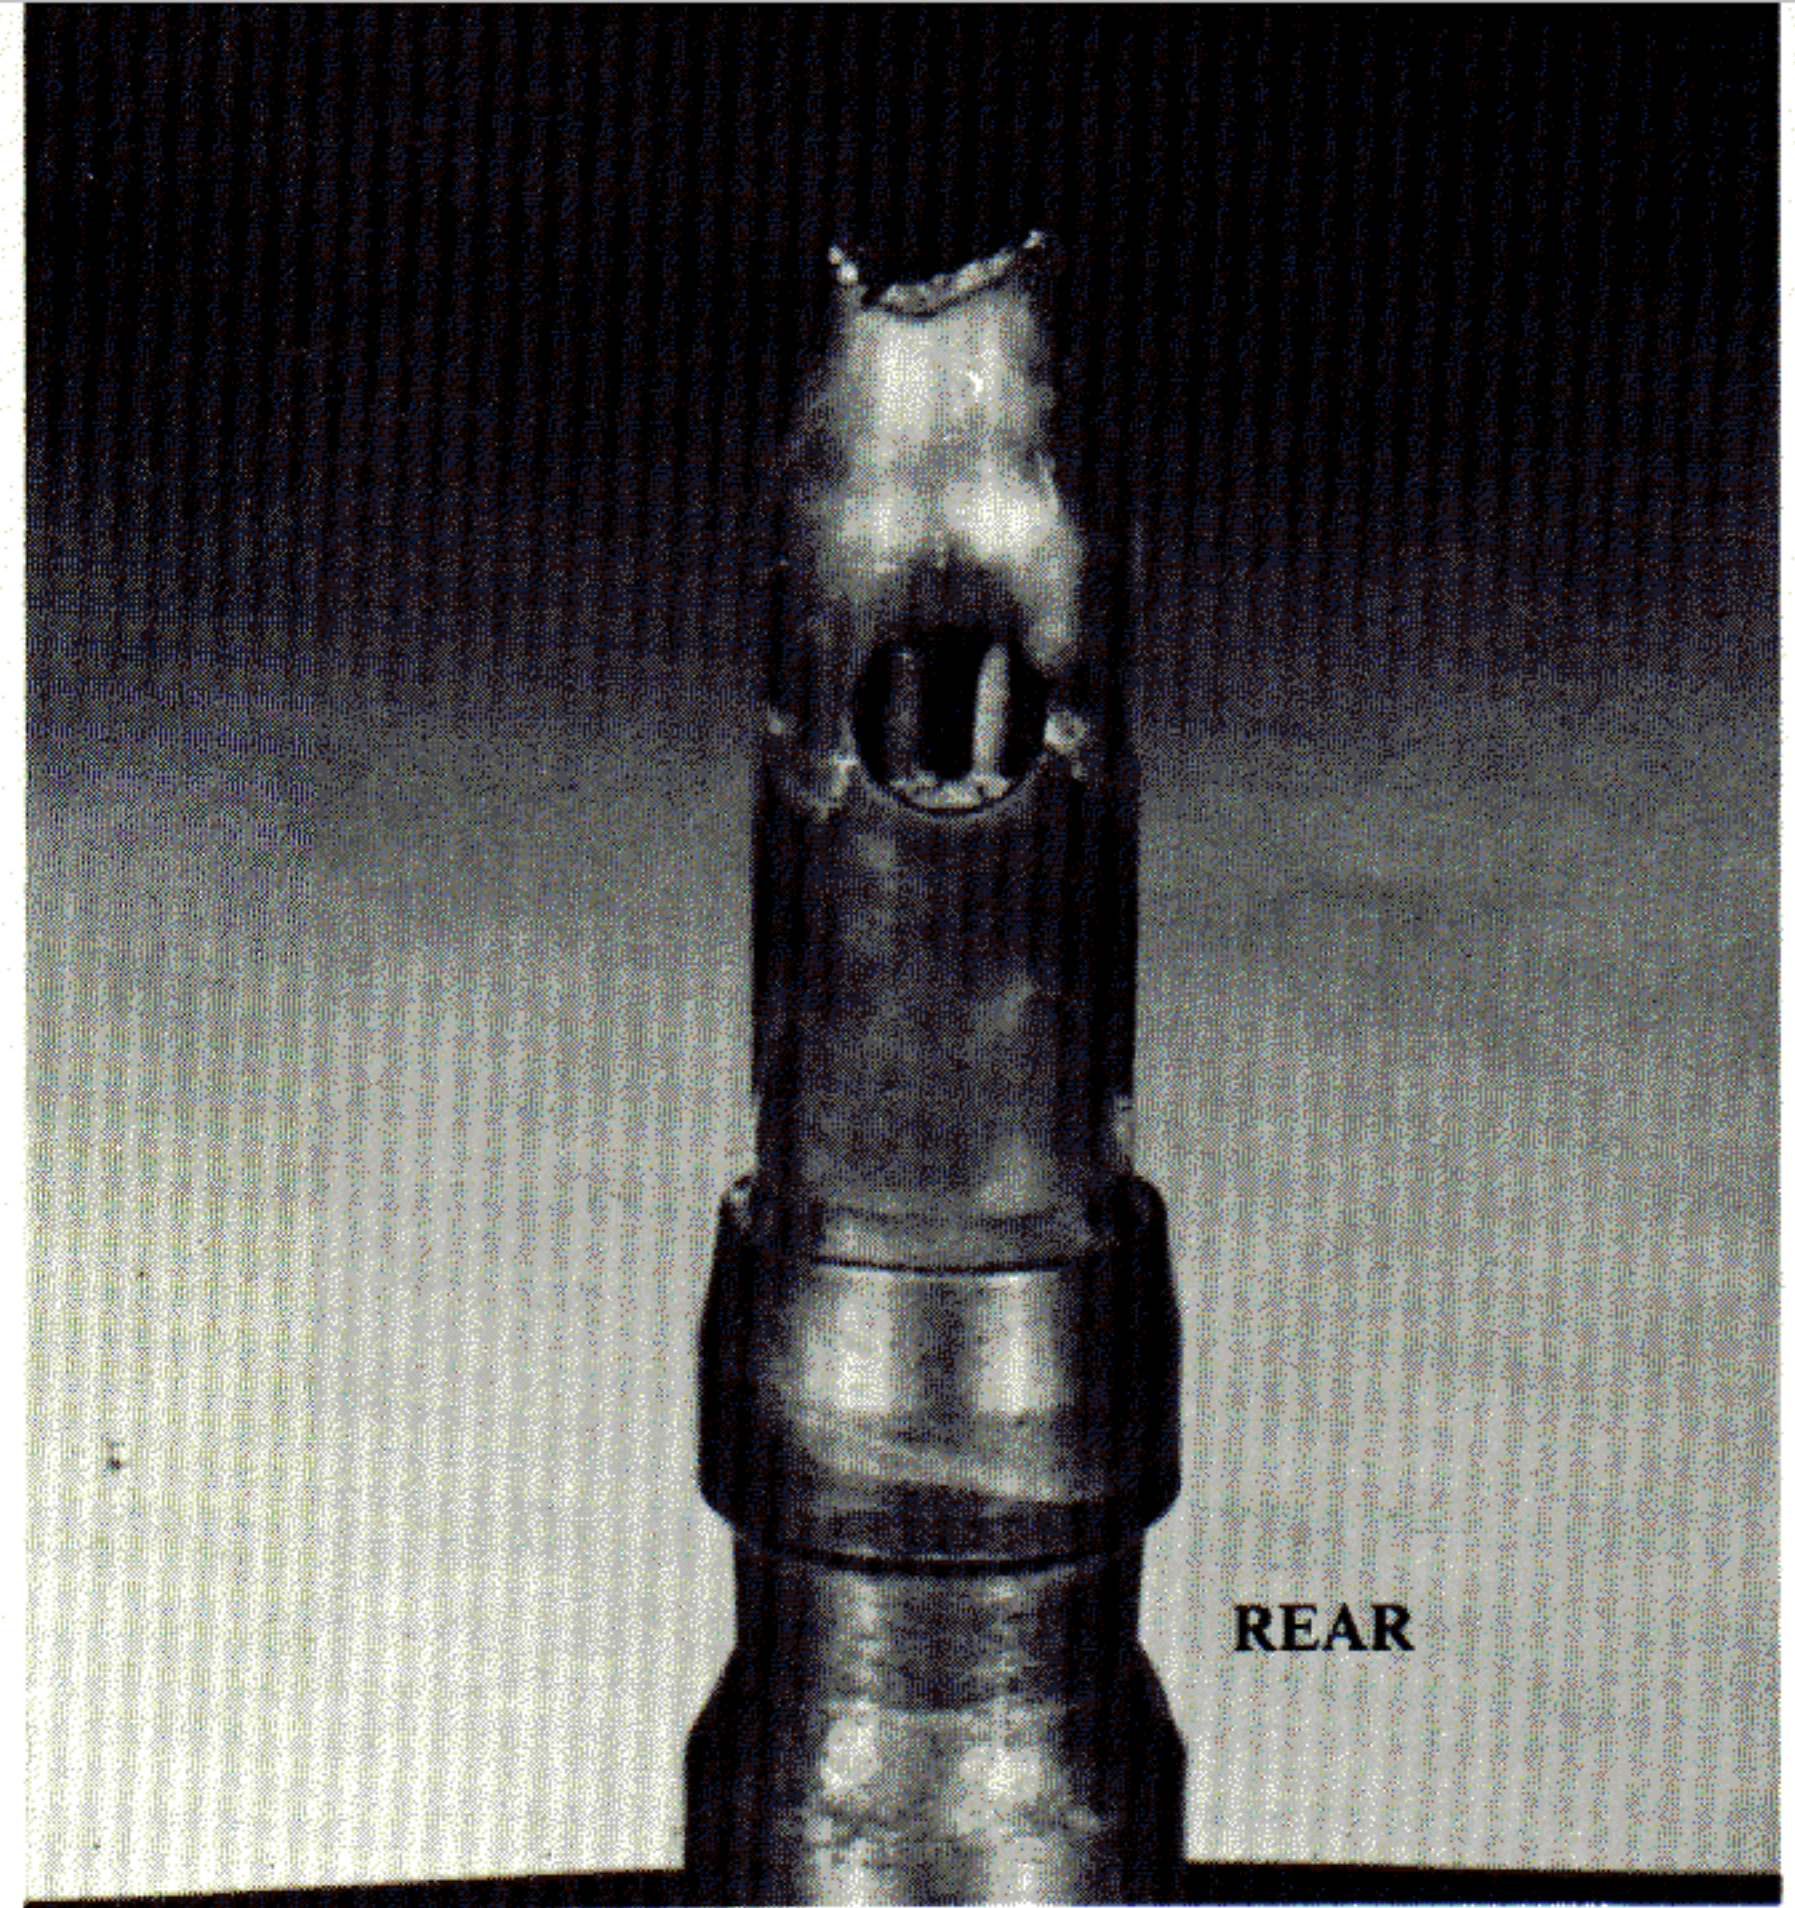
Figure 5 Front (l.) and Rear (r.) Views of Thermocouple with Broken Probe Tip

If a thermocouple probe tip breaks off (generally the break is through one of the sampling holes as shown in Figure 5), the gas sample is not obtained from deep within the hot gas path where the temperature is greatest. Instead, the sensor junctions experience the relatively cool environment at the periphery of the combustion gas path. This causes the sensing elements to introduce an excessively low gas temperature signal to the parallel thermocouple circuits.

Thermocouple probe tip failure is usually due to erosion and is accelerated by exposing the probe to excessive temperatures. Eventually the probe tip can no longer withstand the forces in the high-velocity gas stream, and it breaks off. Since the probe is most vulnerable to erosion at the gas sampling inlet holes, these holes should be checked to determine the condition of the probe. Detailed inspection instructions are presented in NAVAIR 02B-5DD-6.

**THERMOCOUPLE INSPECTIONS** In practice, thermocouples are not the easiest things to inspect. Consequently, there is the temptation to defer this task even though engine instrument indications may demand it. From the preceding discussions, the detrimental effect of damaged thermocouples on an engine is apparent, thus the need for timely thermocouple inspections and maintenance cannot be overemphasized. Detailed maintenance and inspection instructions are presented in NAVAIR 01-75PAA-2-4, NAVAIR 01-75PXX-6-X4 (Activities transitioned to P-3 Improved Maintenance Program) or NAVAIR 01-75PAA-6-3 (Activities not employing the Improved Maintenance Program), NAVAIR 02B-5DD-6-1, and NAVAIR 02B-5DD-6-2.

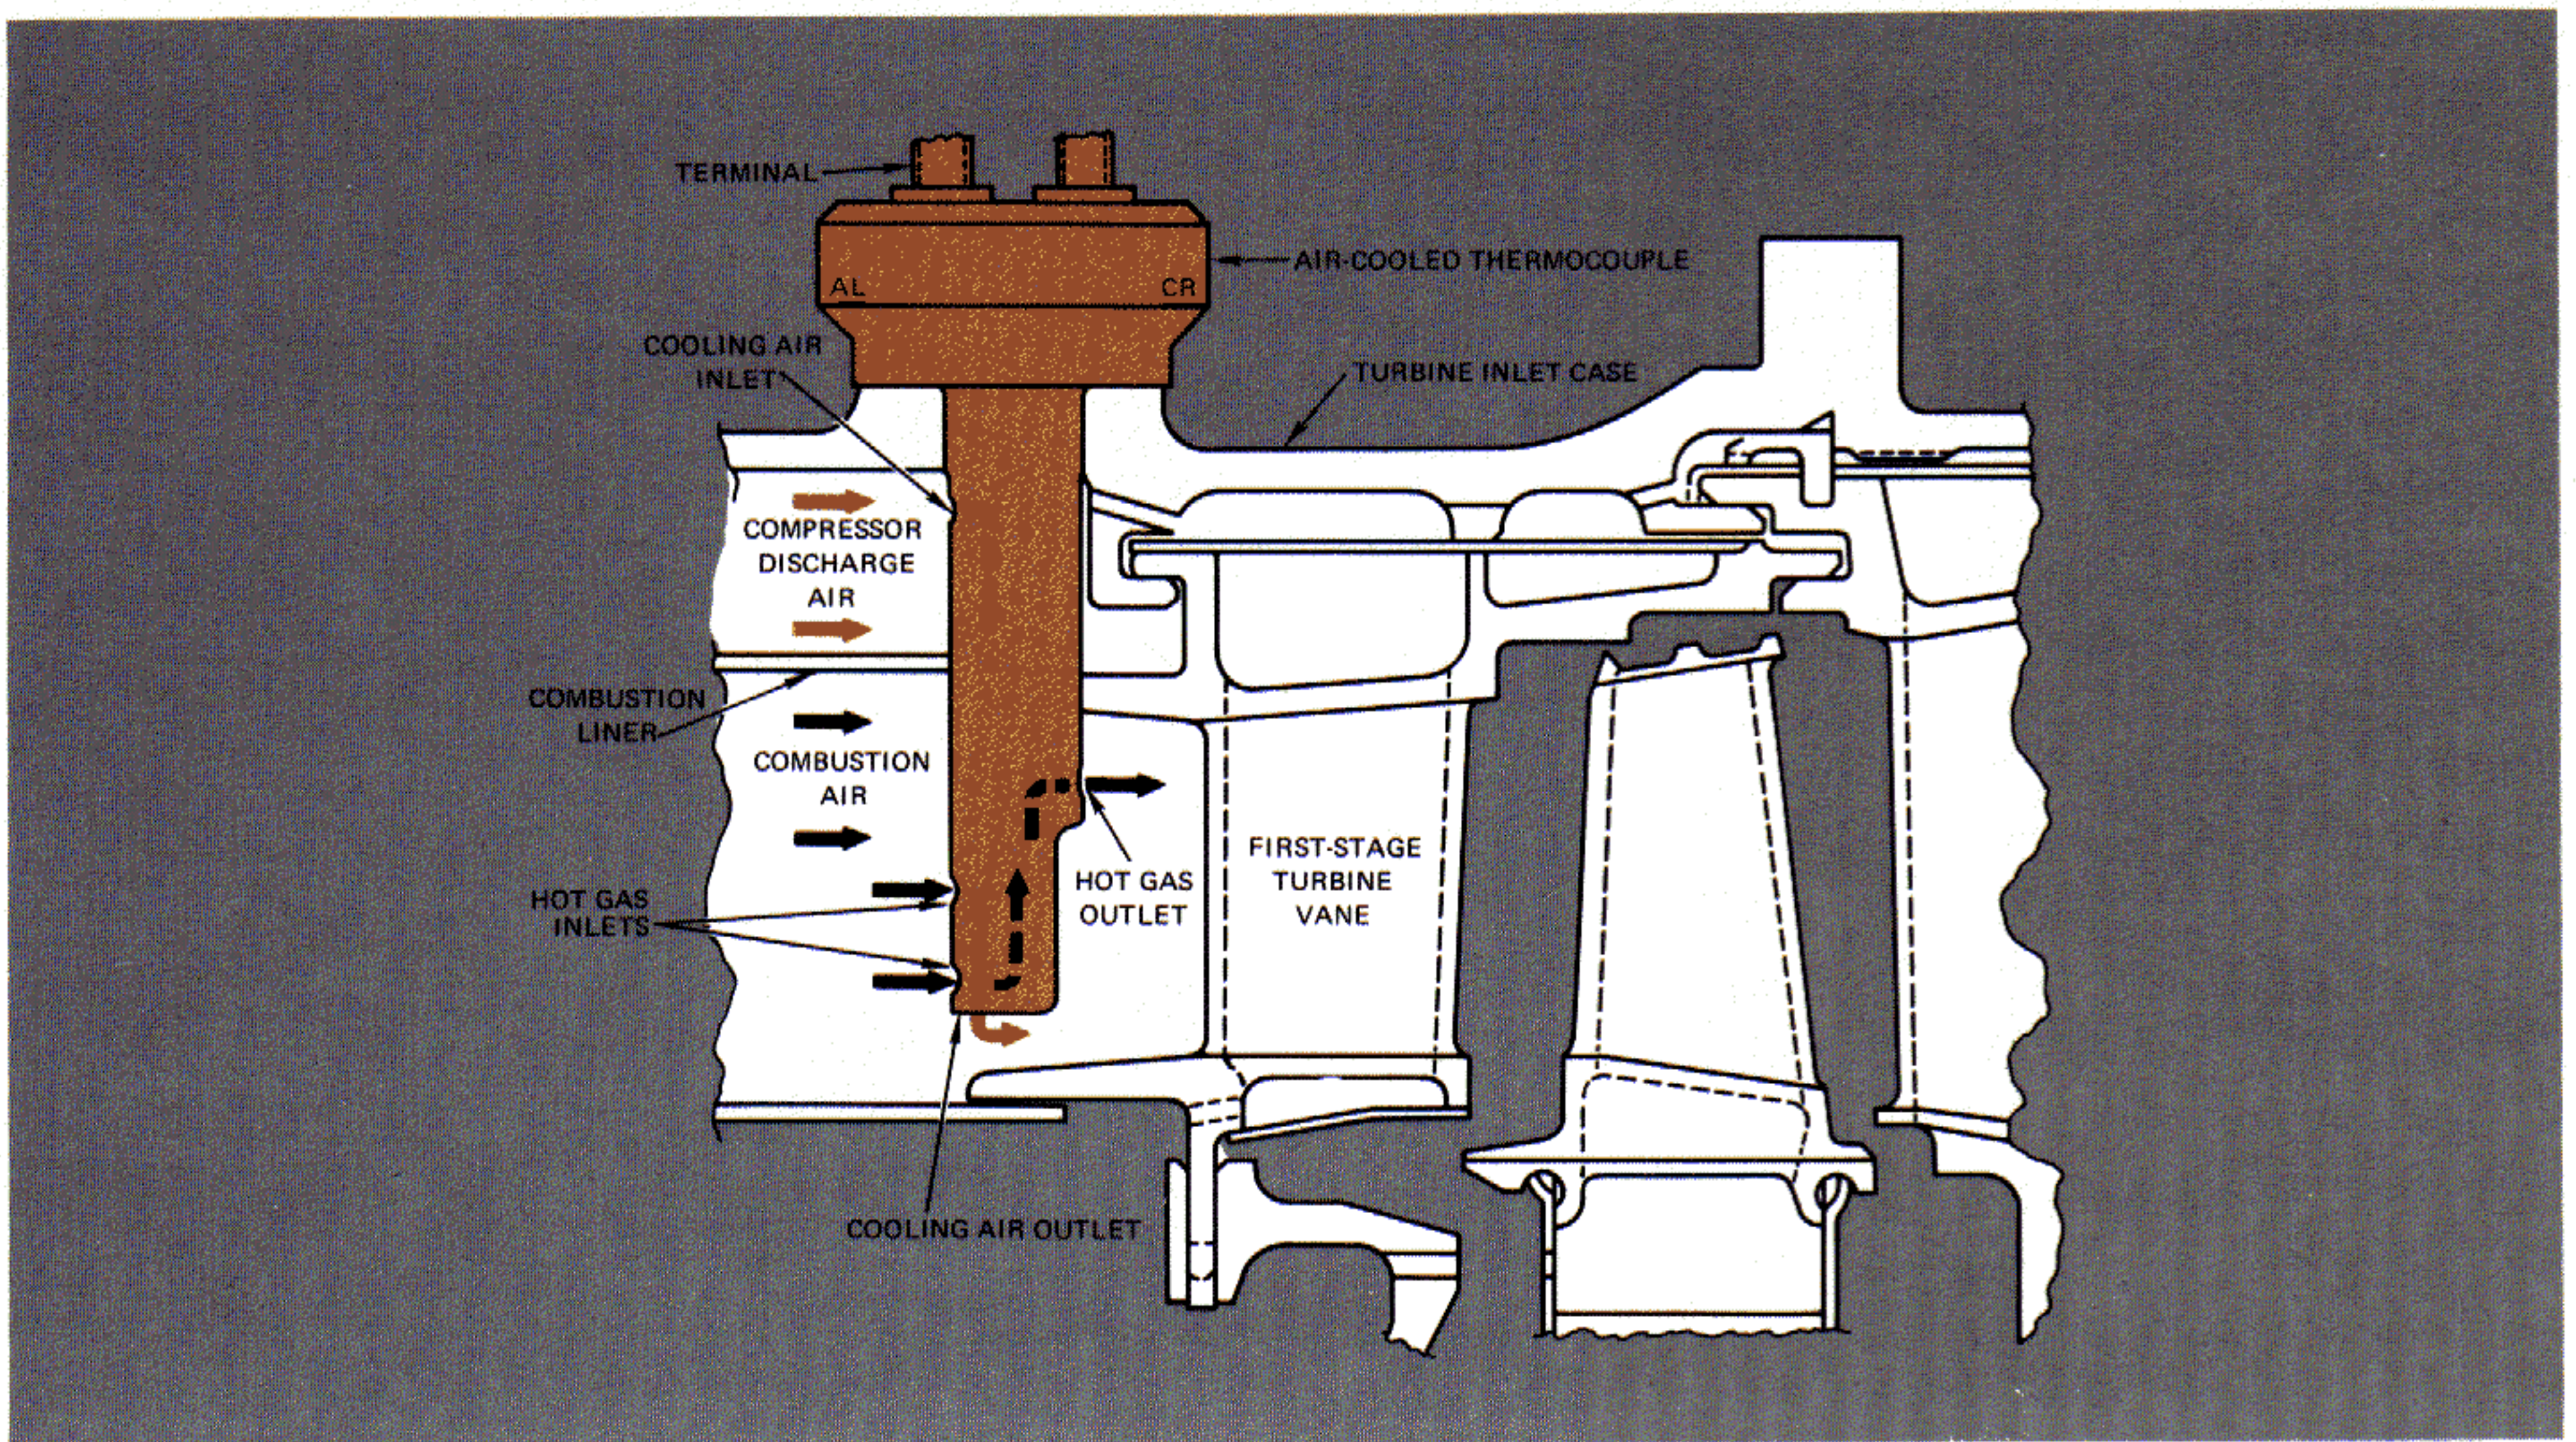
Figure 4 Location of Typical Thermocouple in T56-A-14 Engine Turbine Inlet. Location of Thermocouples in T56-A-10WA Engine Turbine Inlet is Similar.

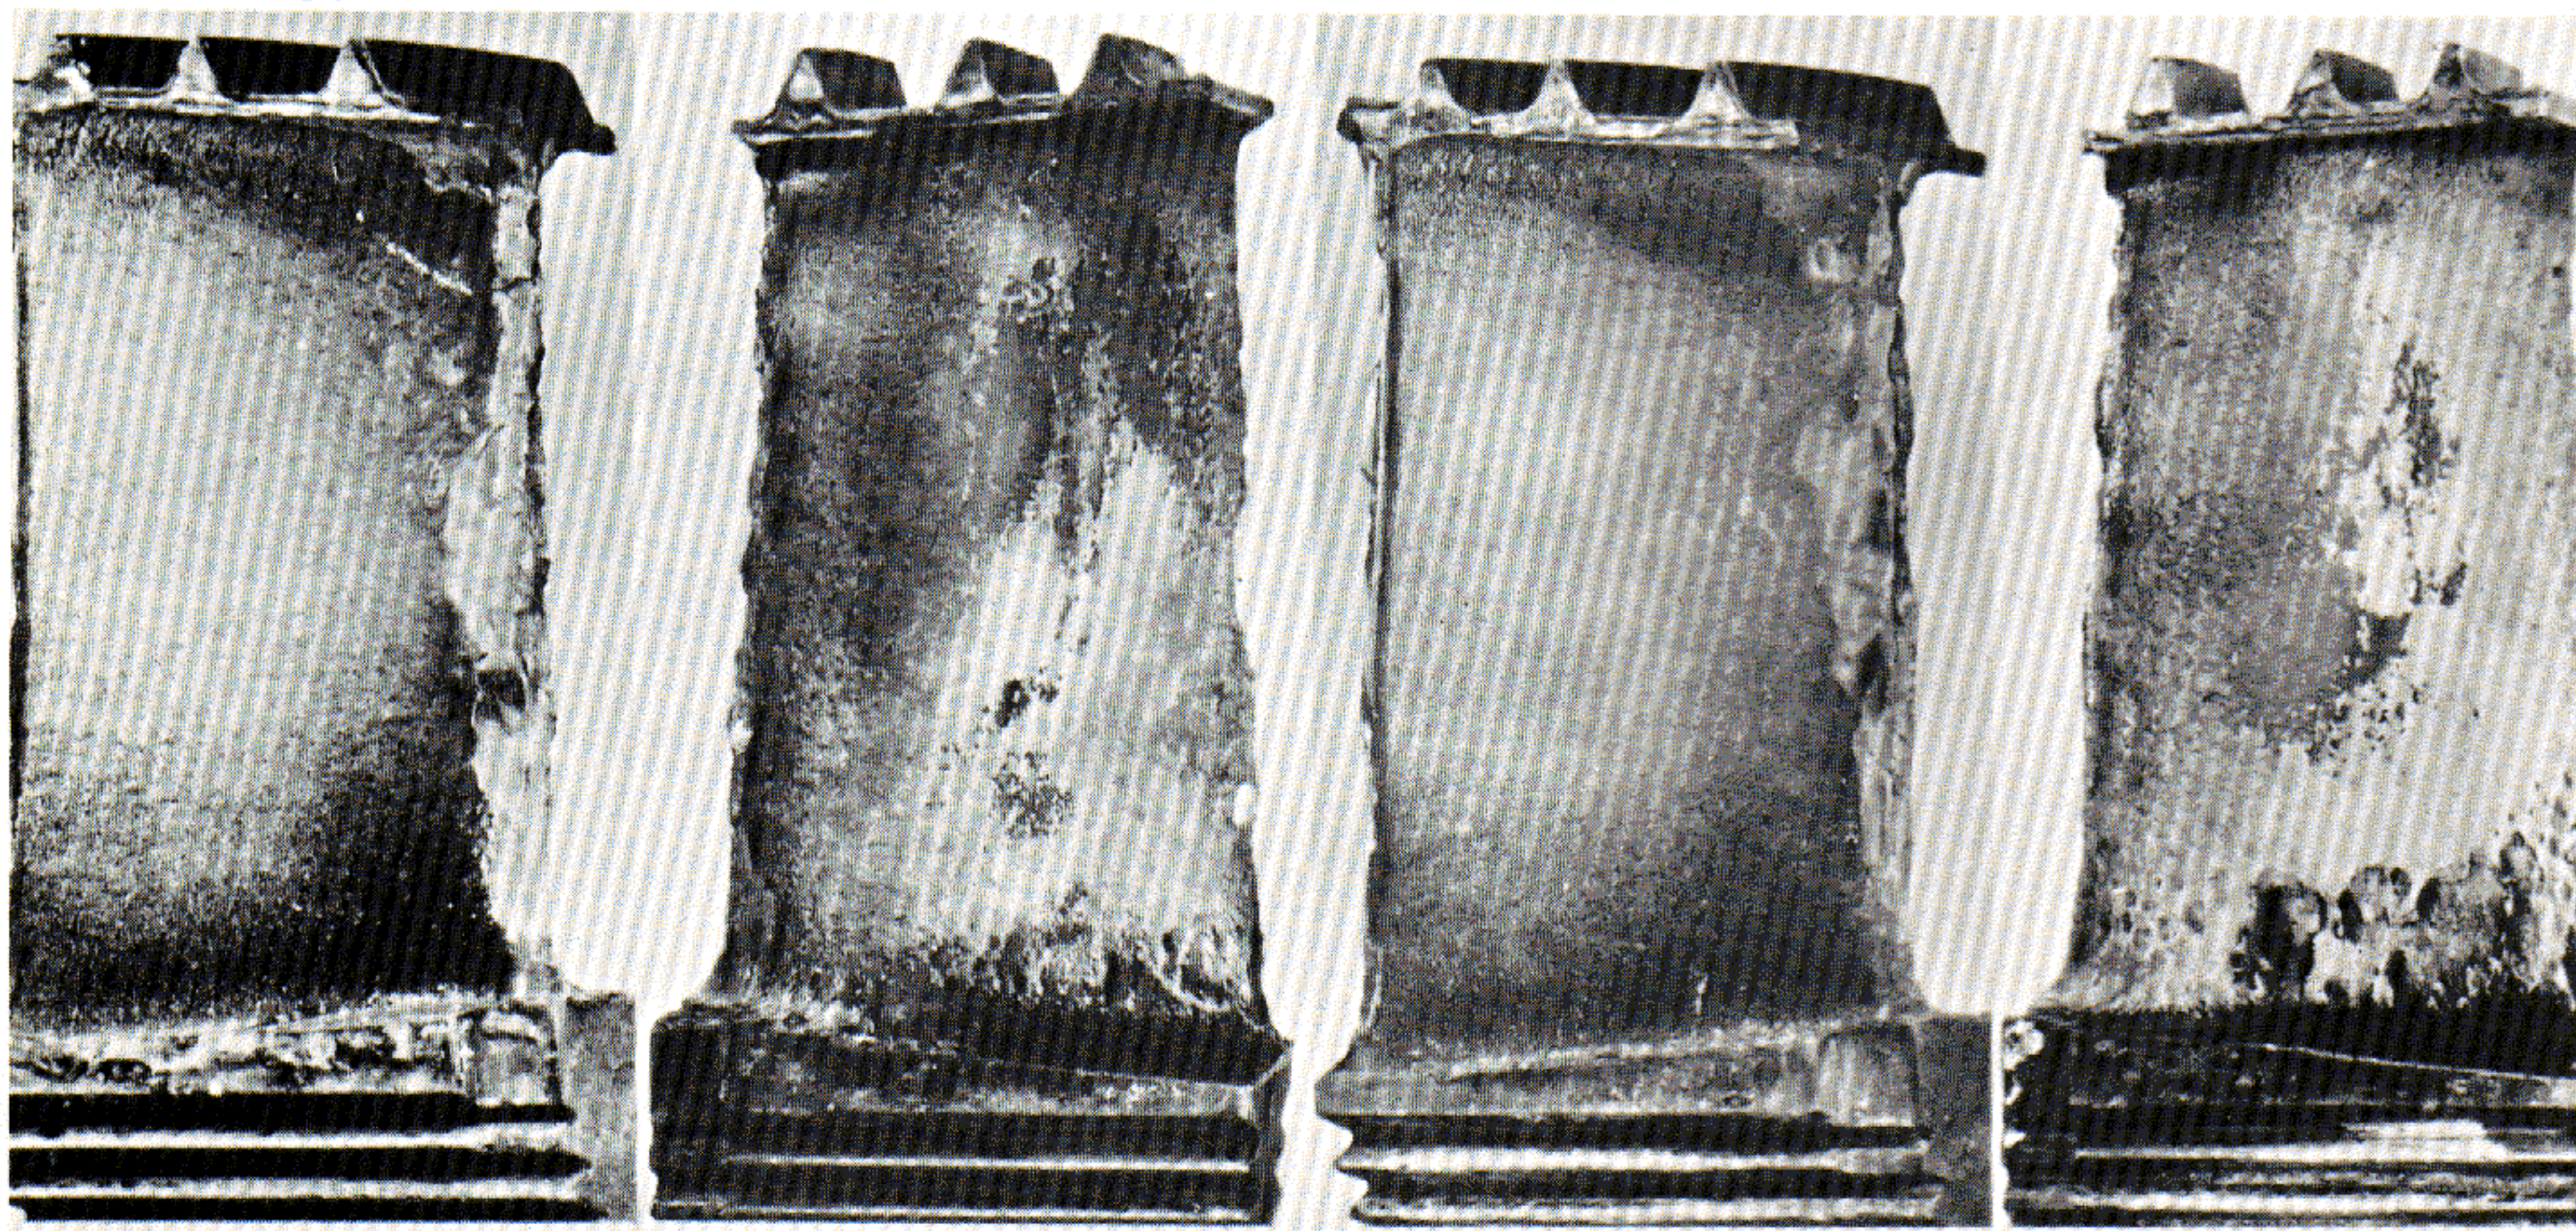
Today we know that sulfidation is the corrosive attack of certain base elements in some superalloys by sodium and sulfate ions when these alloys are subjected to high temperature. It is most pronounced at the first stage of a turbine where the environment is most harsh. Figure 7 shows examples of advanced sulfidation of first stage turbine blades from a T56-A-10W engine. The blades appear to be blistering, scaling, or delaminating, and the material loss from the blade coincides with the combustion gas path.

*Figure 7 First Stage Turbine Blades from T56-A-10W Engine that have Experienced Advanced Sulfidation*
