# ORION

# digest

issue **29**

## TURBINE INLET TEMPERATURE AND TURBINE LONGEVITY

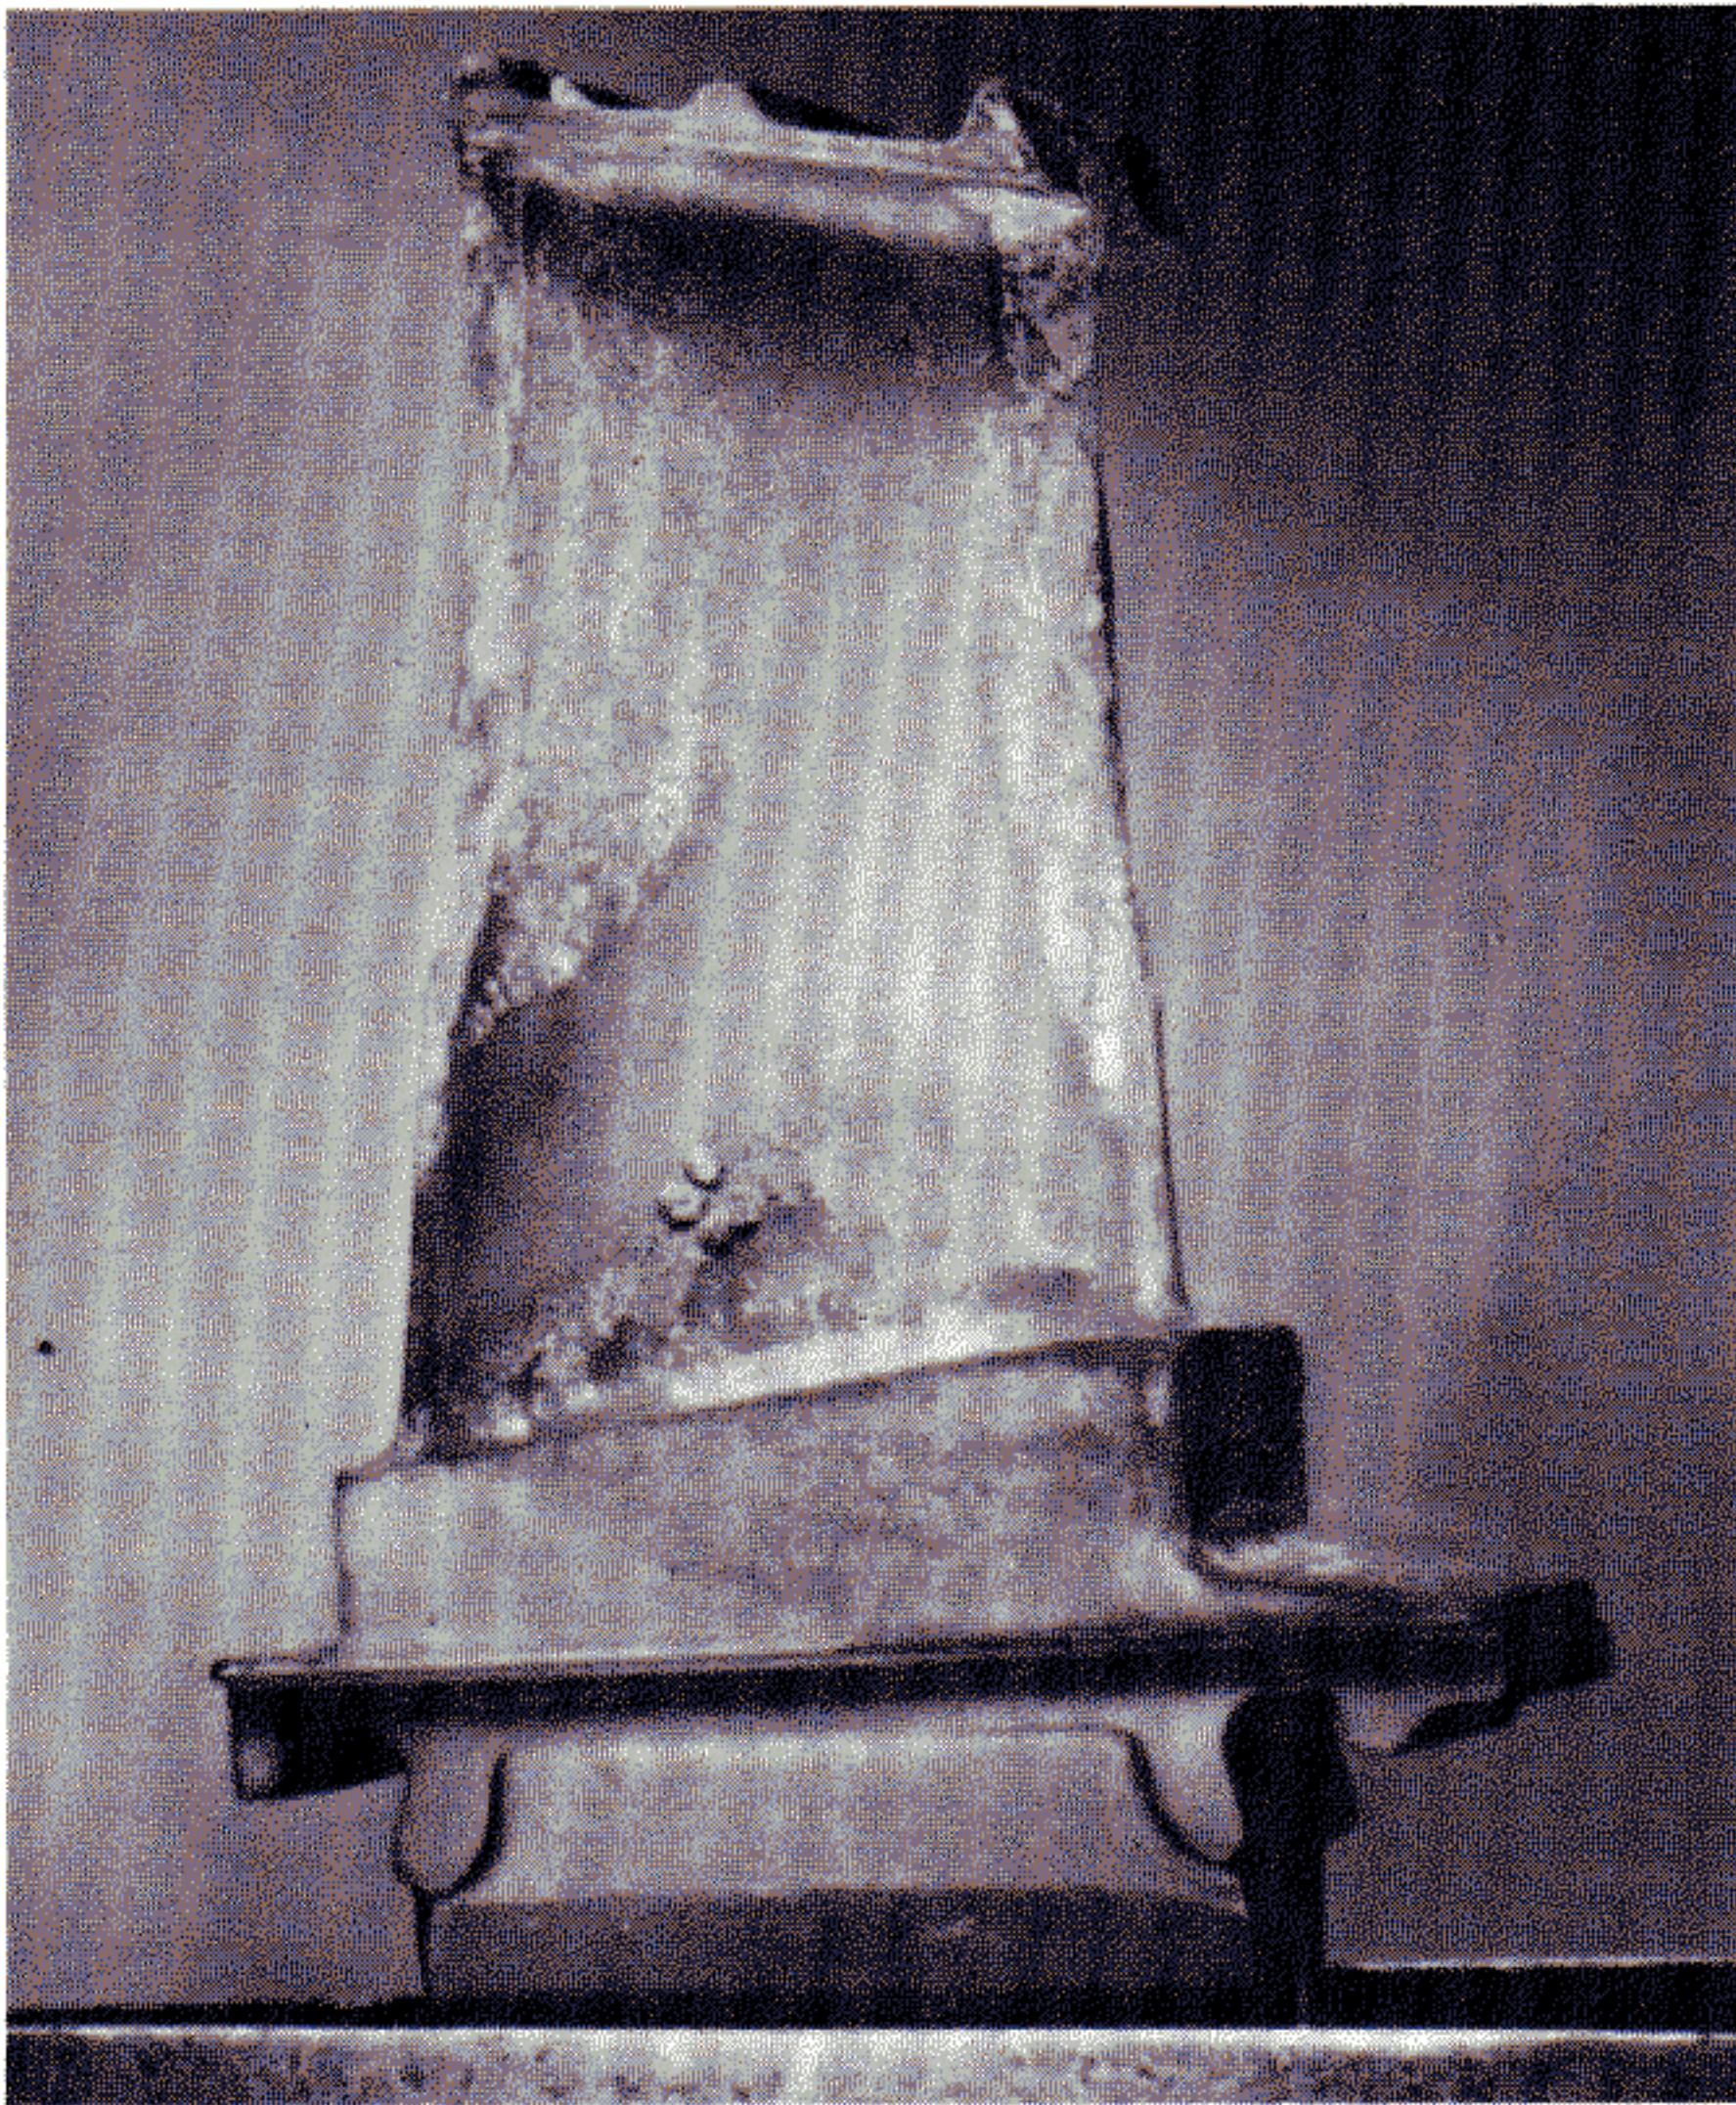
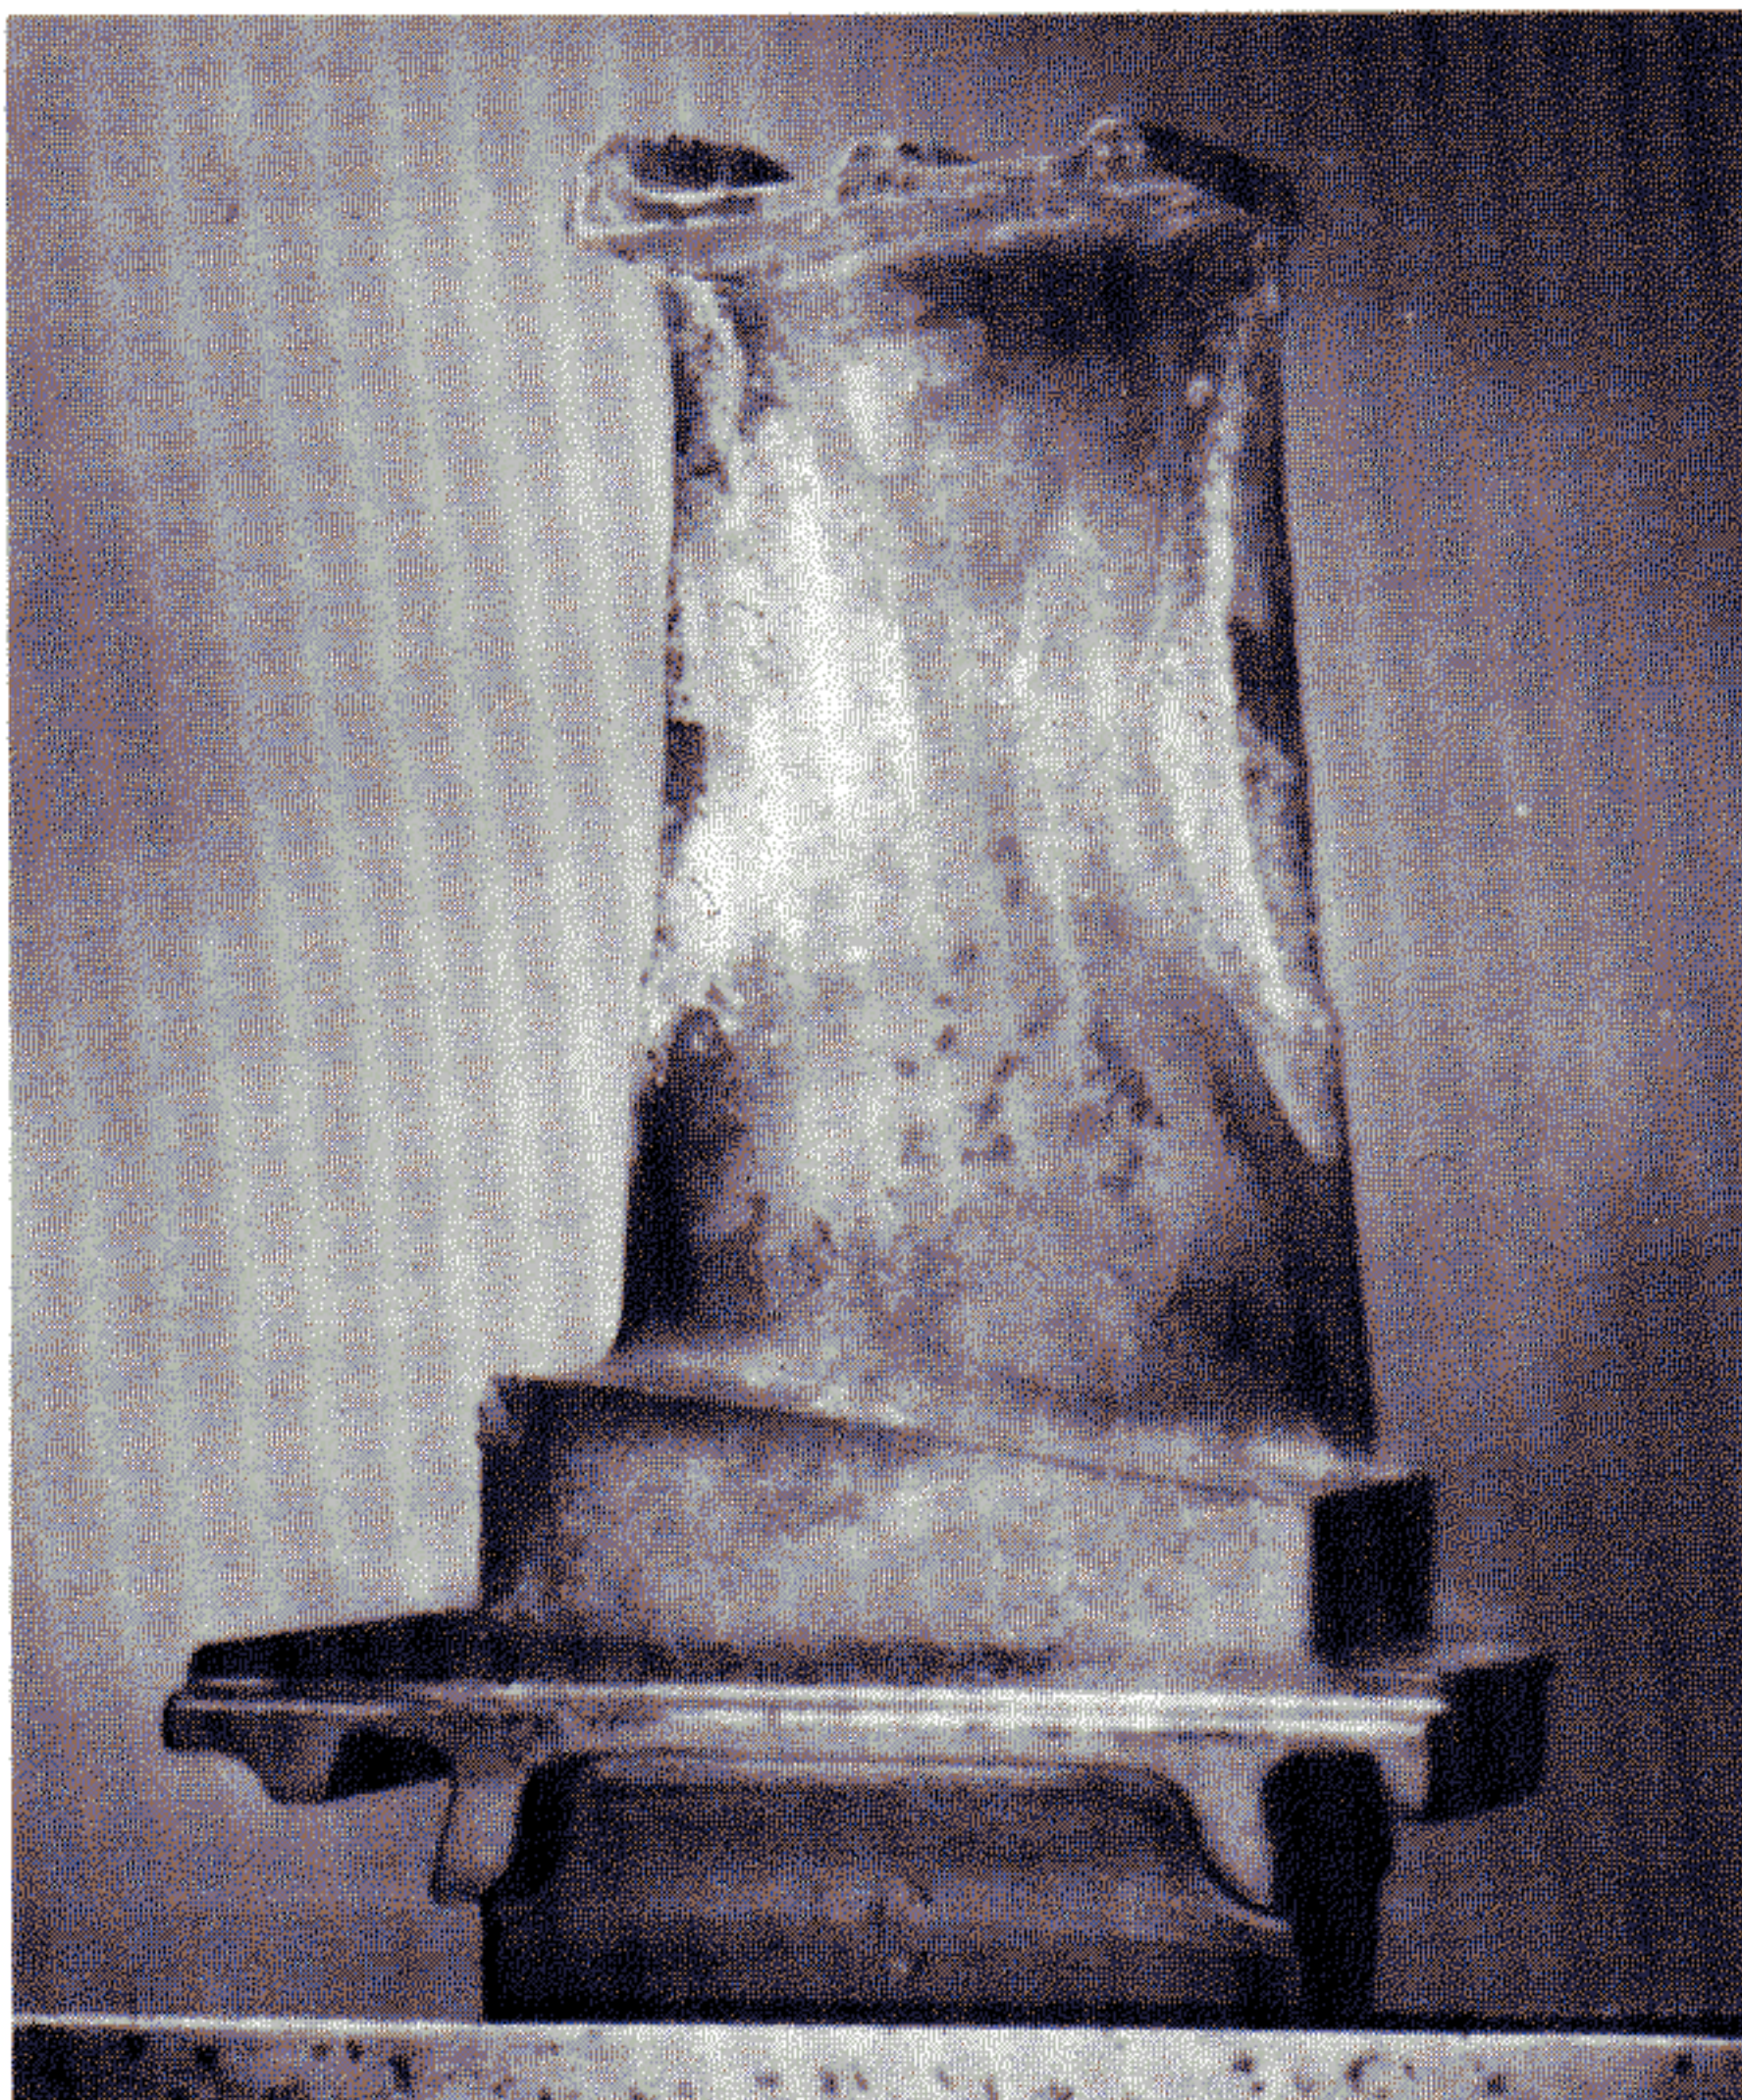
*Figure 8 Views of Alpak-Coated Turbine Blade with Sulfidation Damage. Blade was Removed from the First Stage Turbine of a T56-A-14 Engine.*

Naturally, if the eroded Alpak coating is not renewed, the bare portion of the part will be exposed to sulfidation. Figure 8 shows views of a first stage turbine blade made of Alpak-coated Alloy 713C that is from a T56-A-14 engine. Both the concave and convex sides of the blade are shown, and material loss due to sulfidation is readily apparent. Note that sulfidation generally attacks the airfoil edges first, since the Alpak coating on these surfaces is subjected to the greatest erosion. After the protective Alpak coating has been removed by erosion, sulfidation of the base material can commence.

**Alpak Protective Coating** Alpak is a diffused coating of aluminum that is applied to Alloy 713C turbine parts to provide a protective barrier between the component and sodium/sulphate ions. This coating has demonstrated that it is an effective means of protection, extending the service life of Alloy 713C turbine parts by a factor of 4 or 5. Although the Alpak coating will eventually erode, it can be reapplied to a blade or vane wherever approved facilities exist. NARF Alameda has established an in-house capability to reapply Alpak protective coatings. Any T56 turbine processed by NARF Alameda after 1 April 1974 should have Alpak applied, as required, to the appropriate hardware.

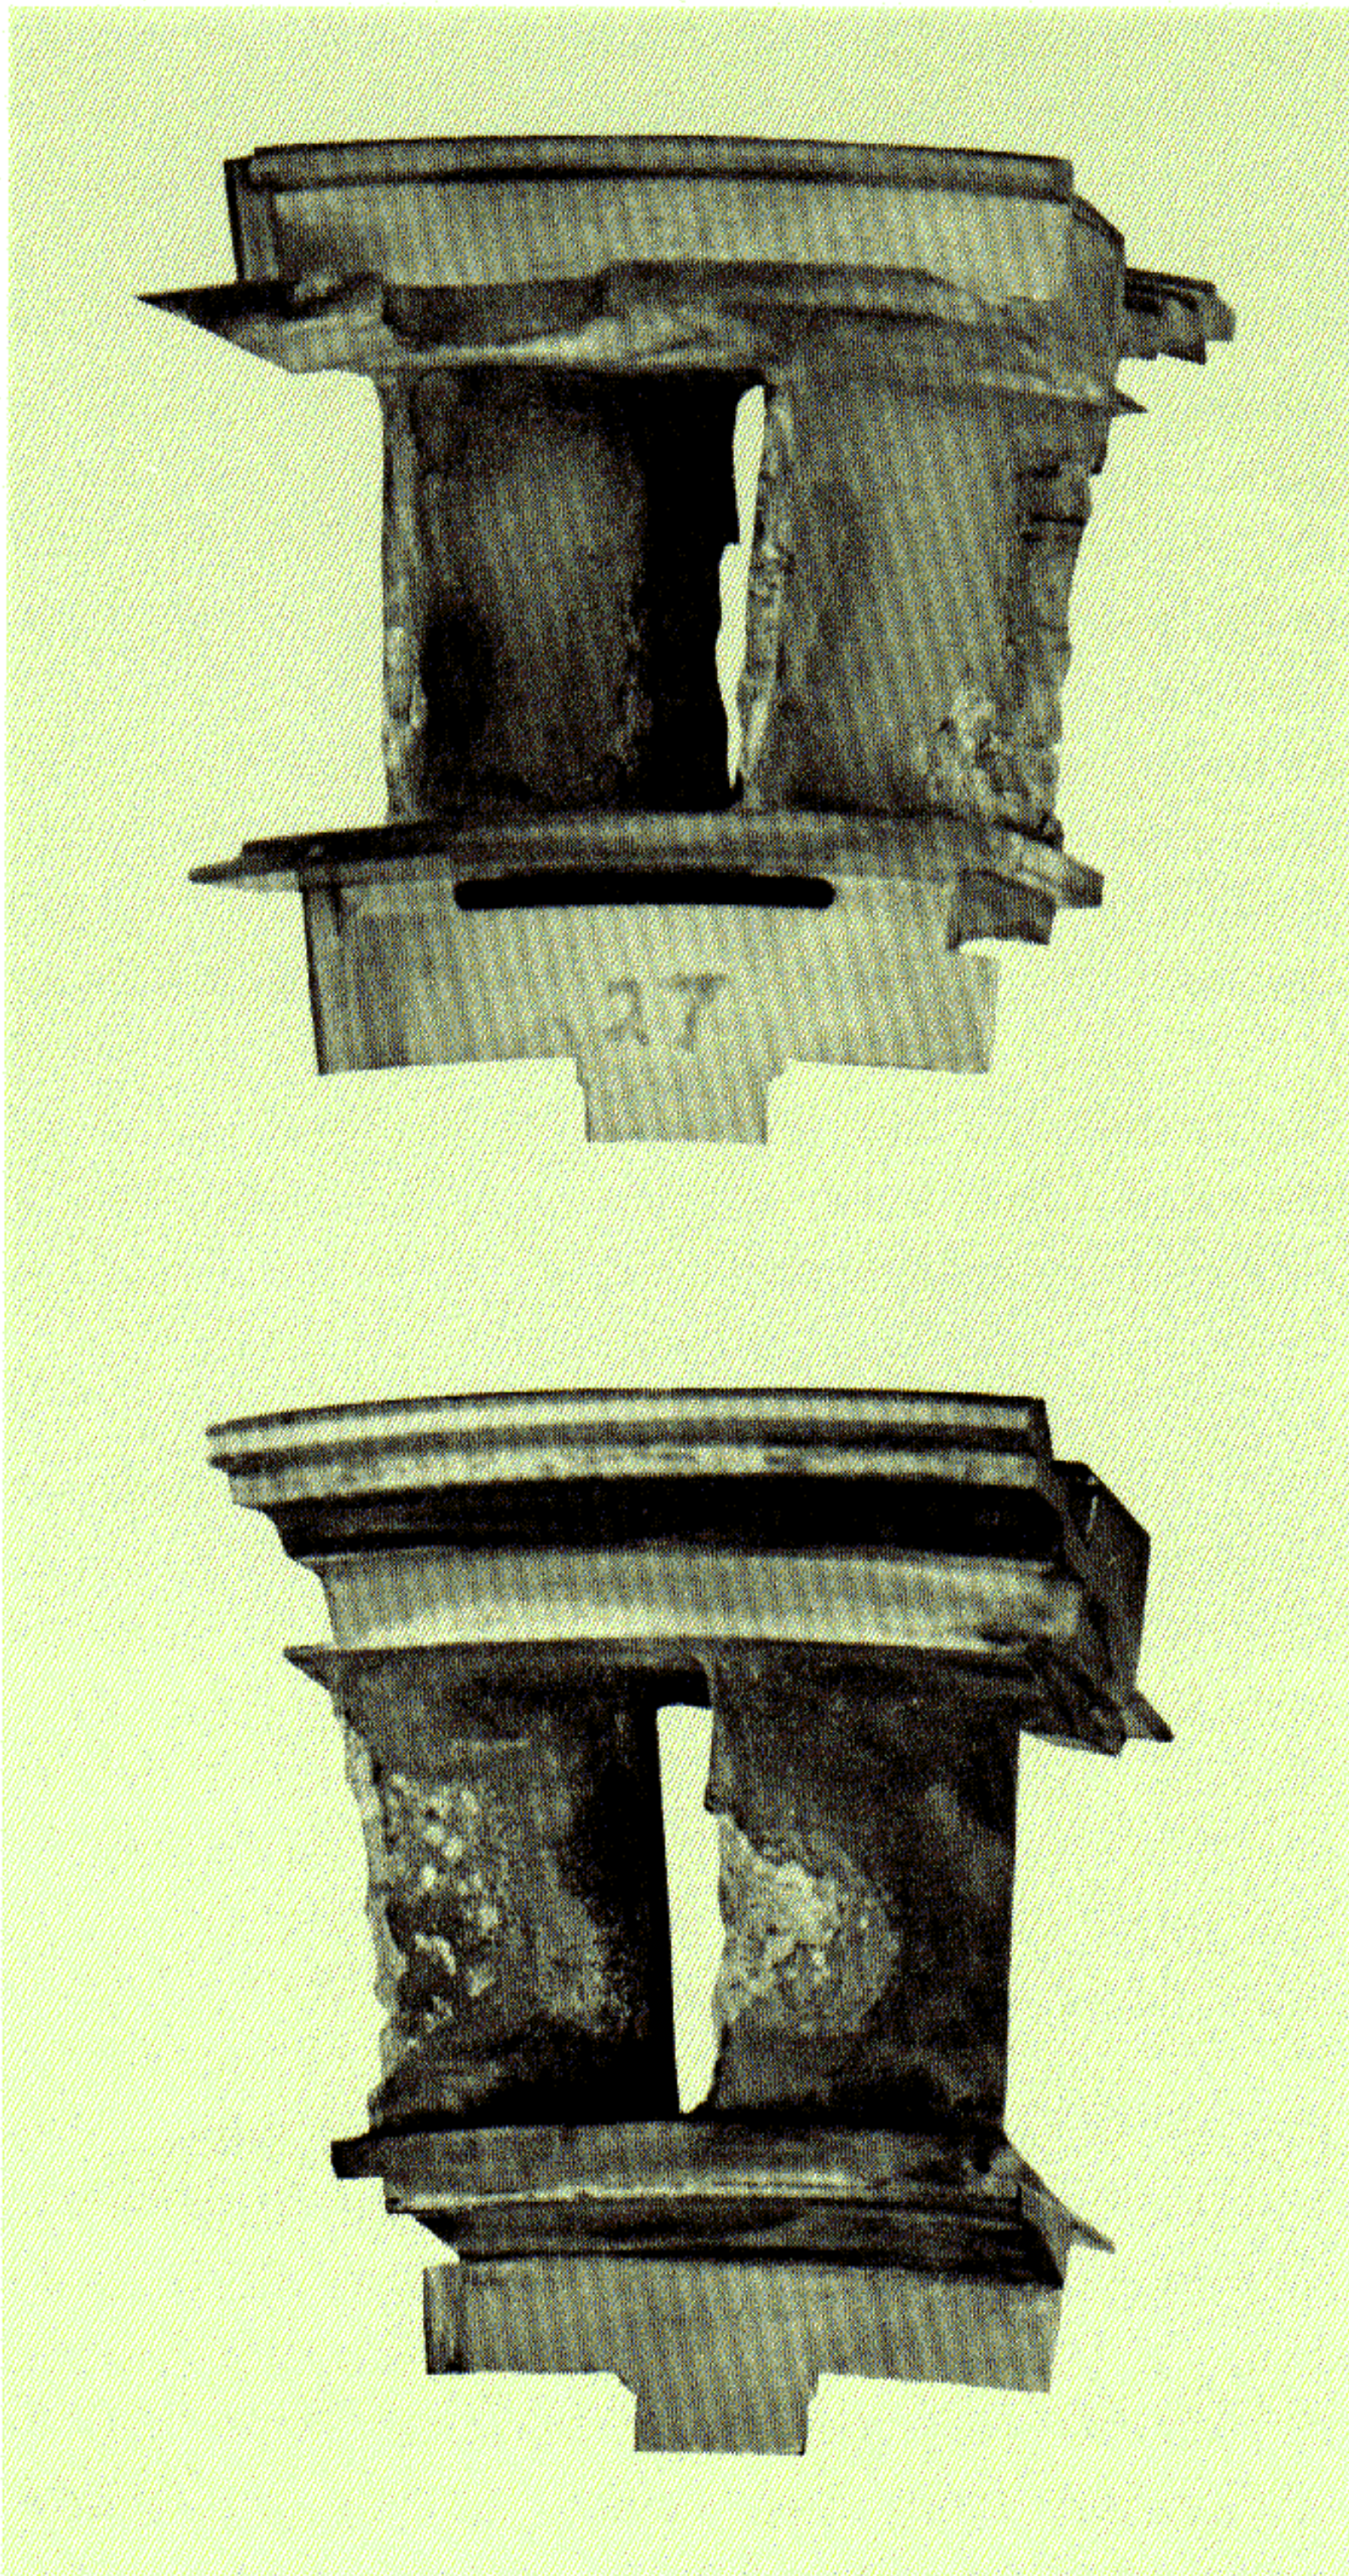
Figure 9 shows the front and rear view of an Alpak-coated Alloy 713C first stage turbine vane segment with sulfidation damage that was removed from a T56-A-14 engine. A borescope inspection revealed the obvious material loss due to sulfidation from the vane's leading and trailing edges, where the Alpak coating had eroded. Further examination of the leading edge also revealed a crack that leads to the internal cavity of the air cooled vane. Metallurgical analysis of this vane also established that it had been subjected to excessive temperature for an unknown period during the engine's service life.

*Figure 9 Views of Alpak-Coated Alloy 713C Turbine Vane Segment with Sulfidation Damage. Vane Segment was Removed from the First Stage Turbine of a T56-A-14 Engine.*
