SERVICE DIGEST

22

September 1970

P-3 WINDSHIELDS

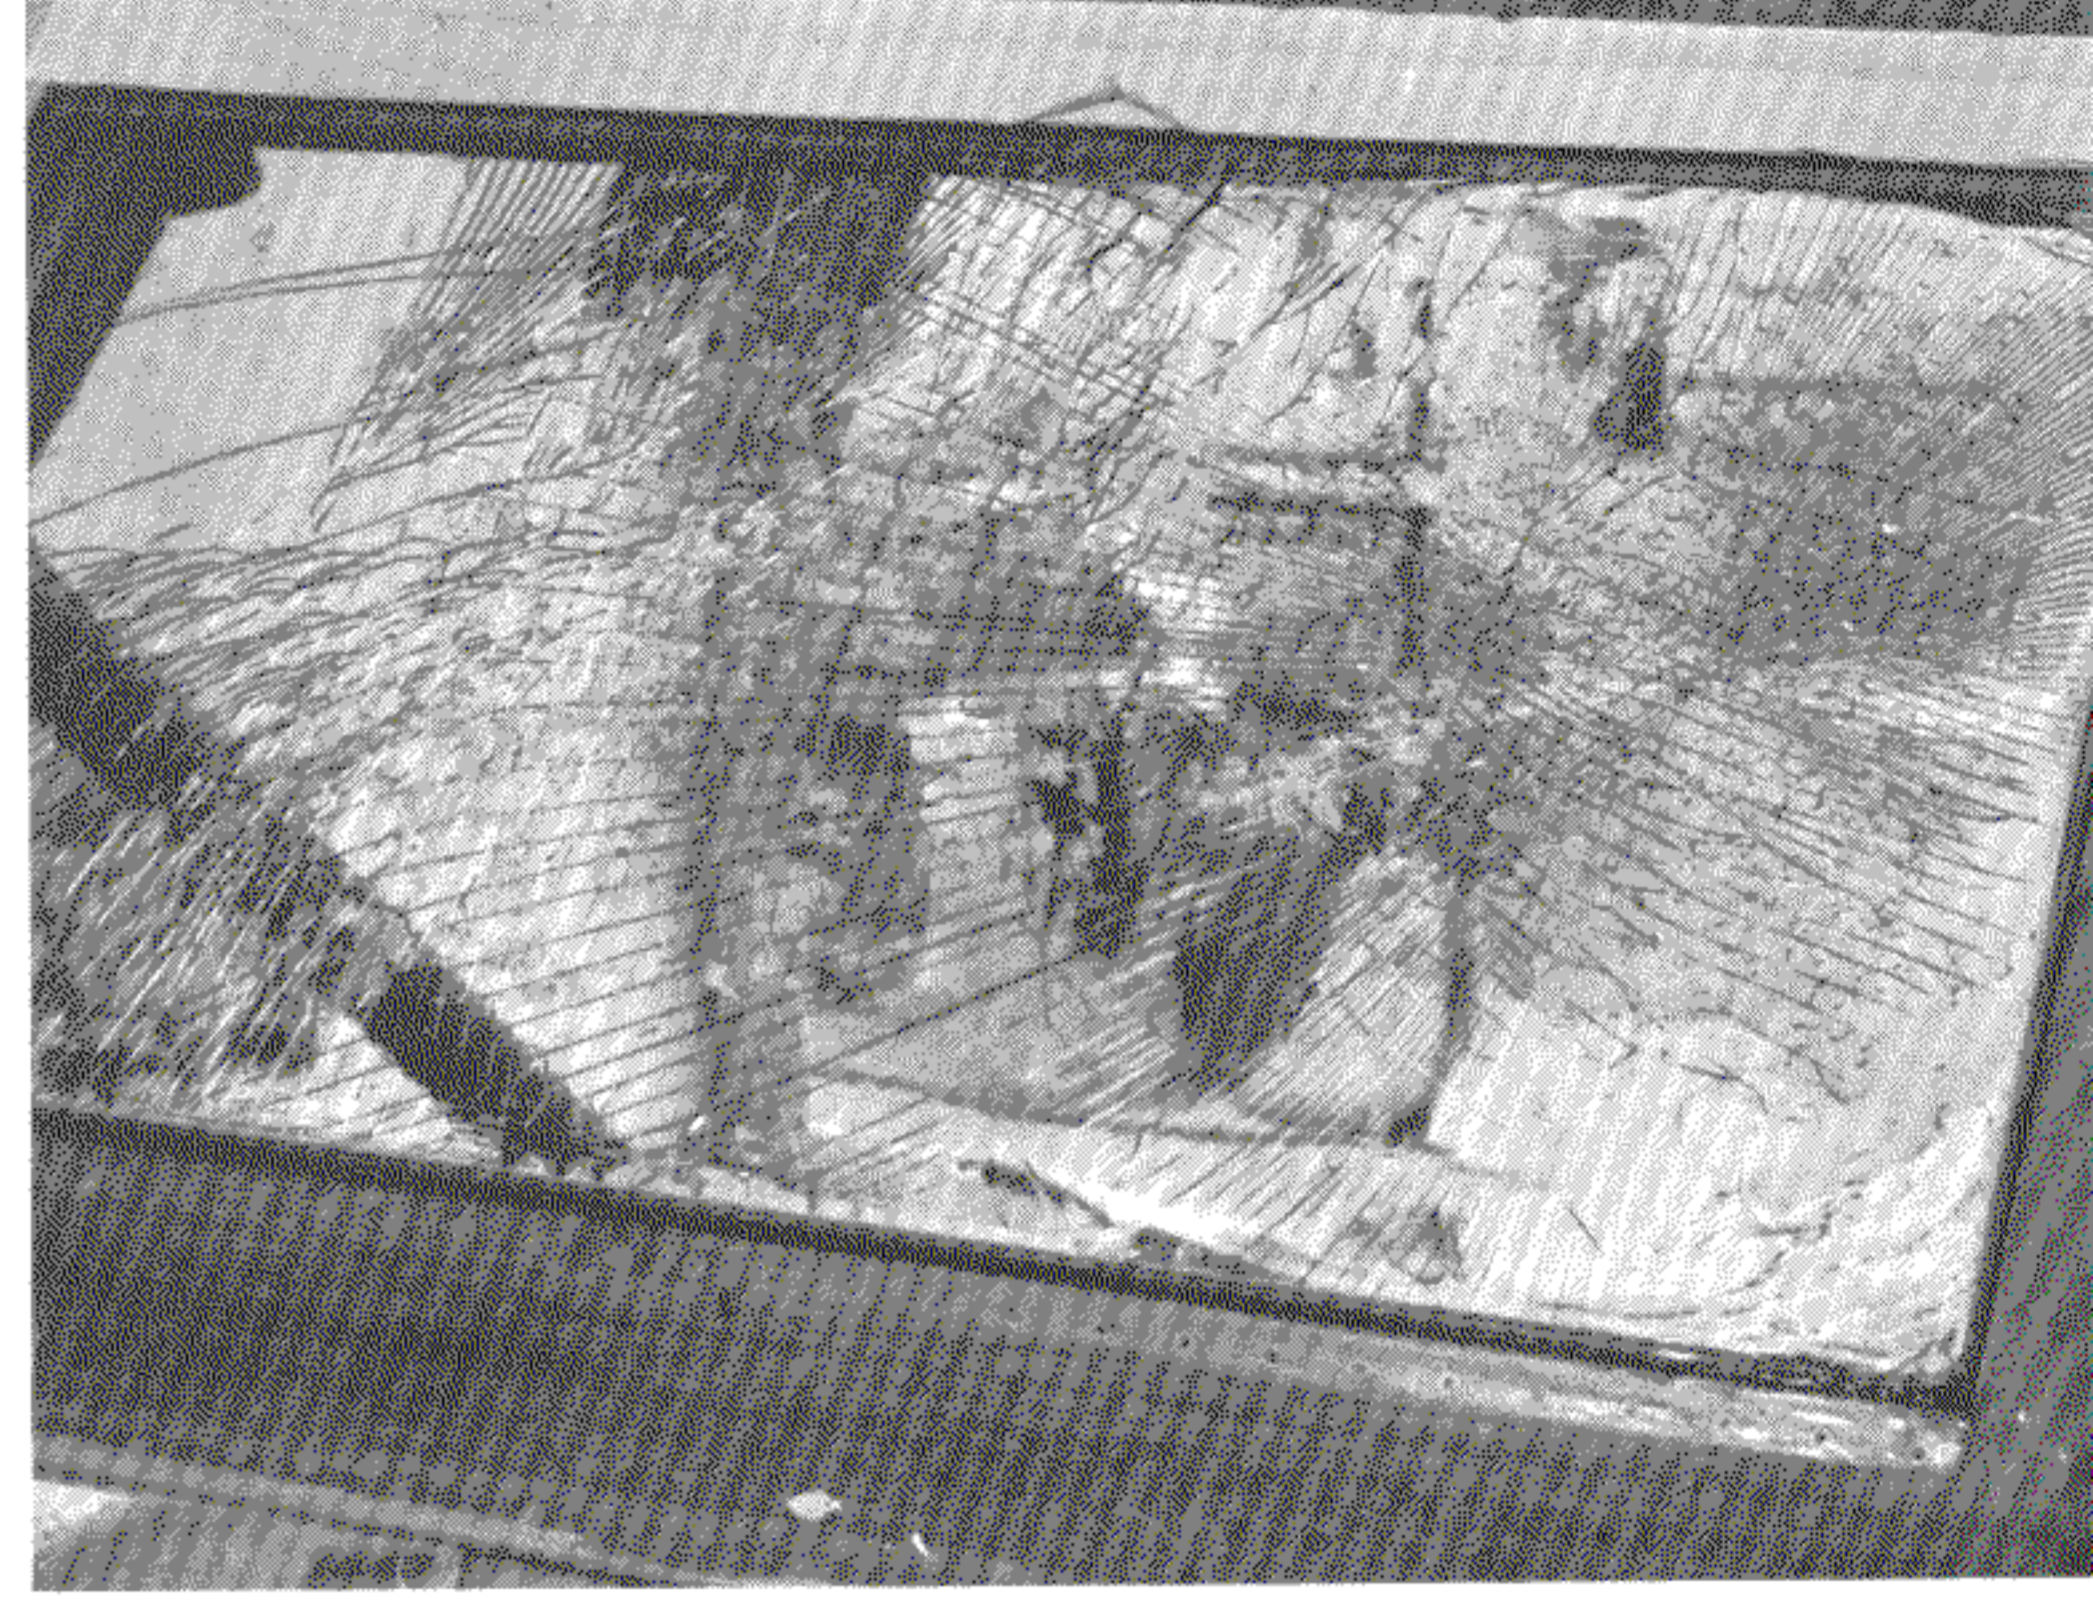
Figure 19. Cold Windshield Tests. Front view of production-type Electra 5-ply windshield panel after impact of a 4-pound bird at 256 knots (vinyl temperature 22°F). Note how cracks radiate from point of impact at top right-hand corner.

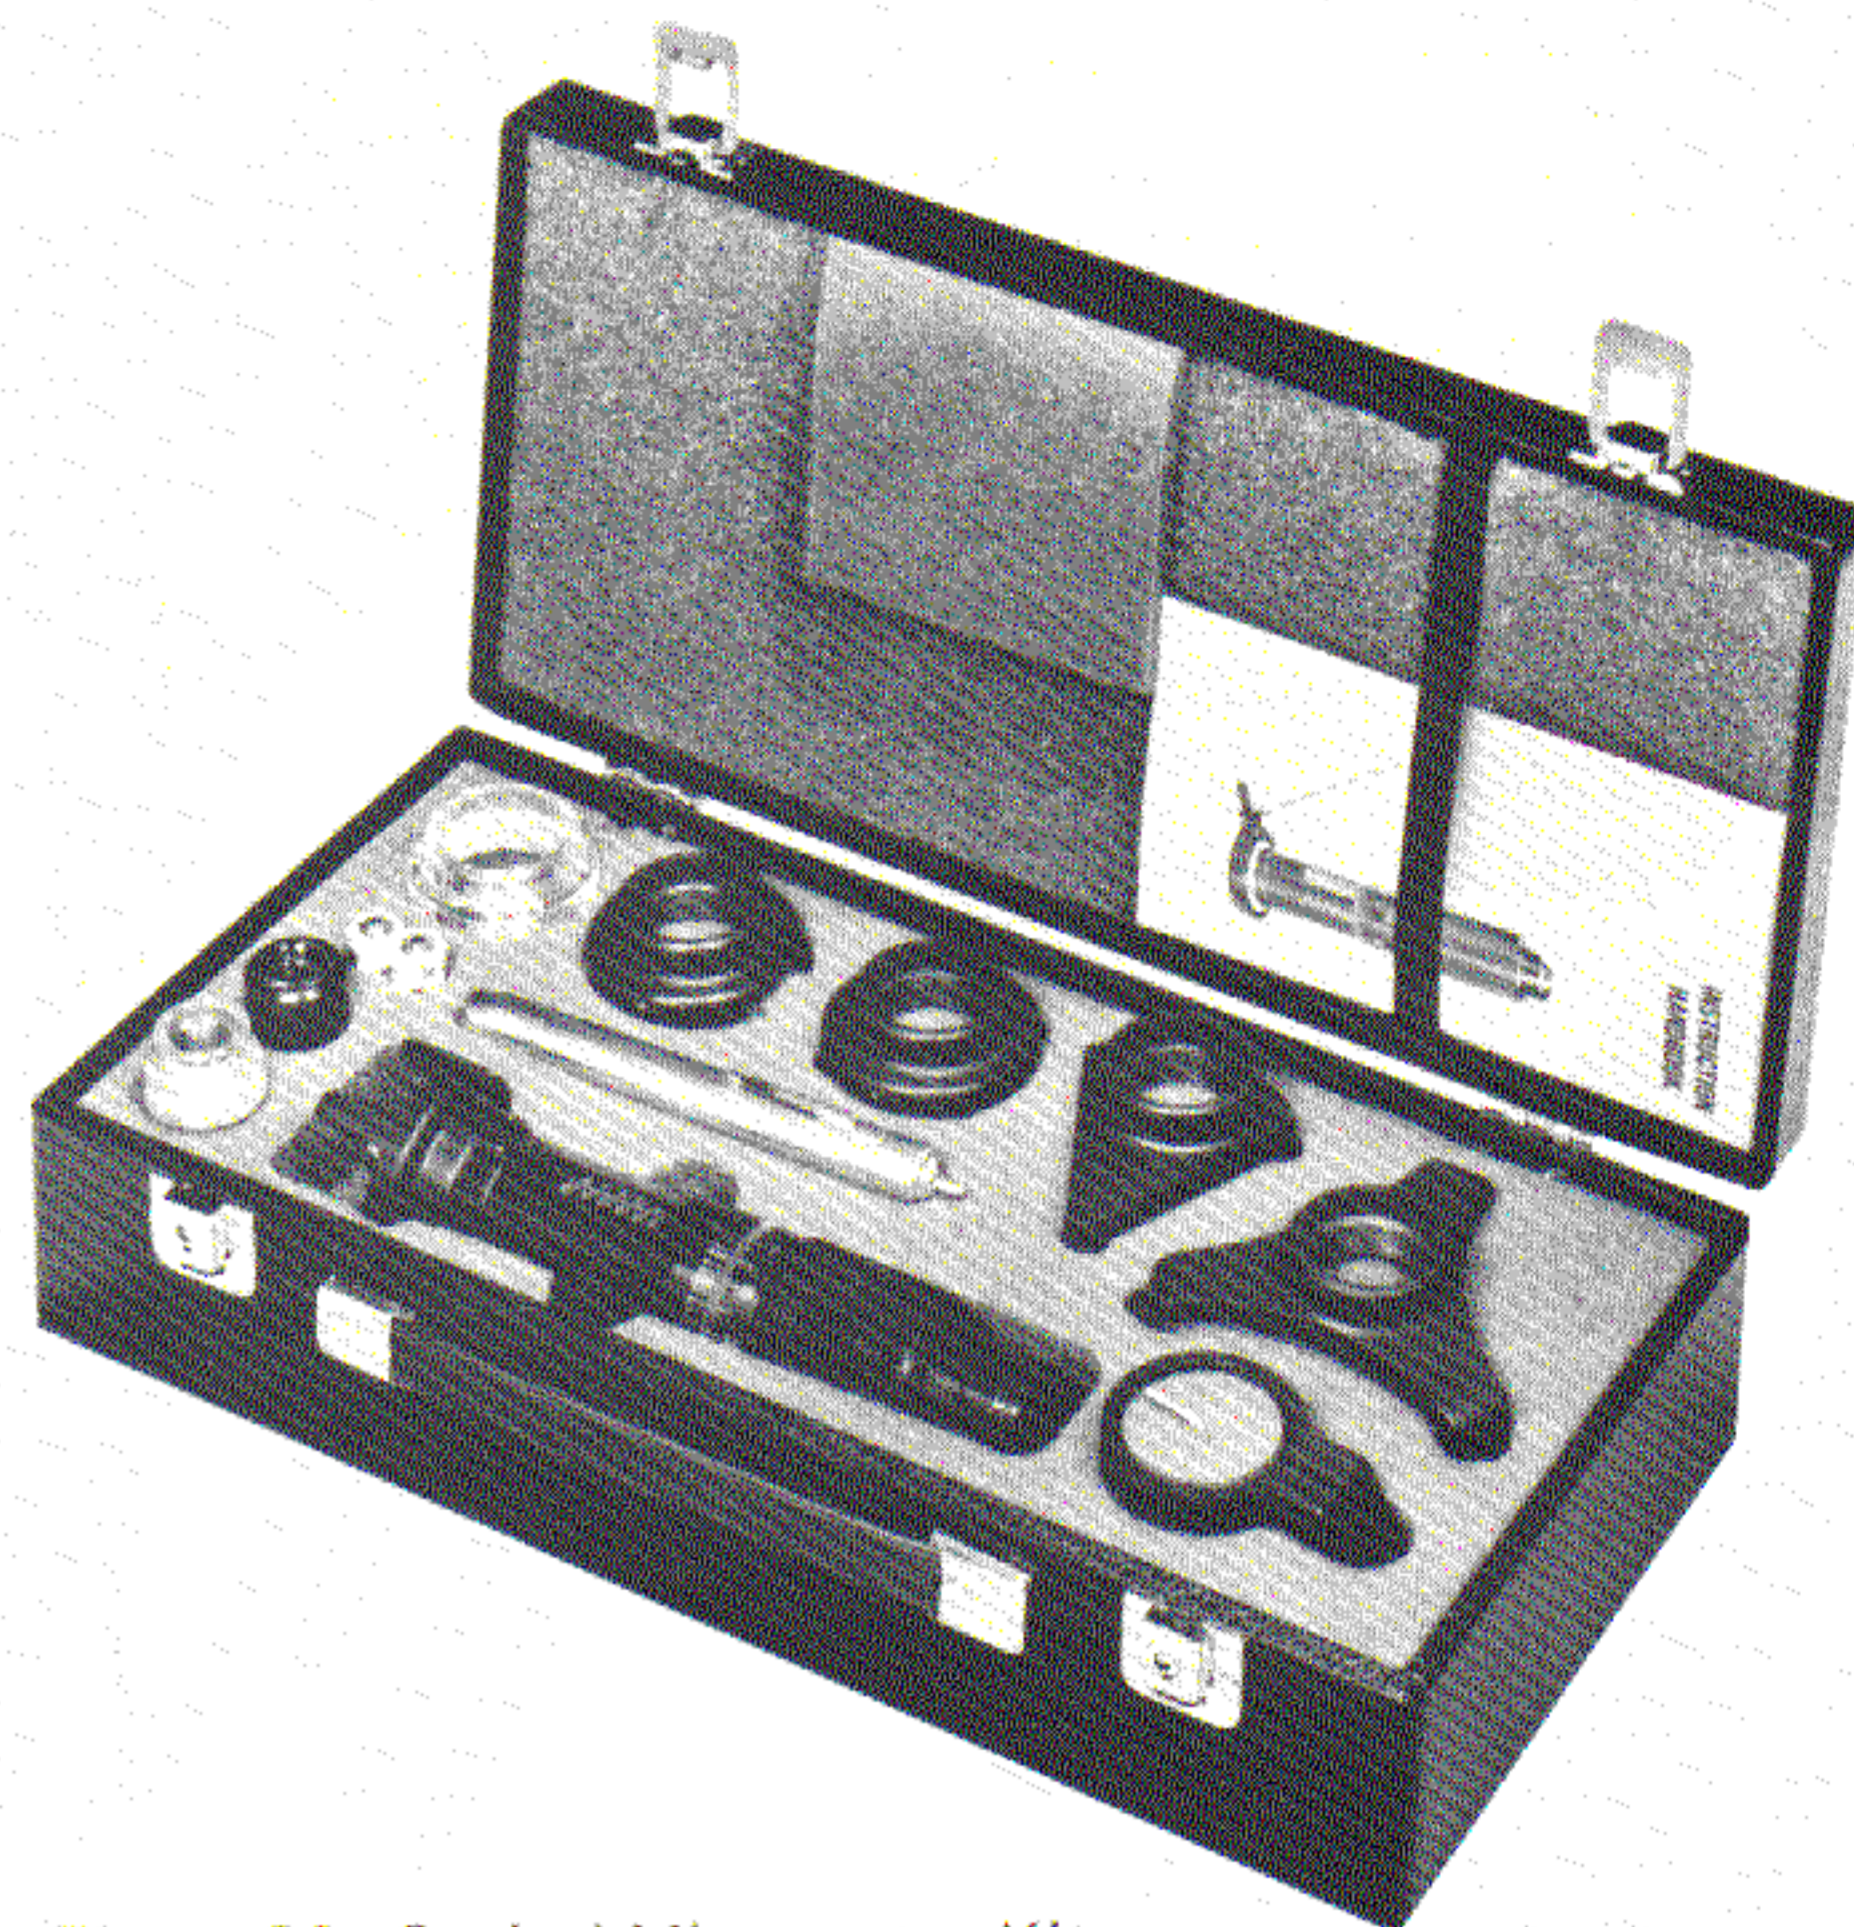
Figure 26. Optical Micrometer Kit

When reading *into* or *through* a transparent material with an optical micrometer, an error is induced into the measurement by the refraction of light as

it passes through the material. This error is corrected by multiplying the micrometer reading by the refraction index of that particular material. For example, 1.5 is the refraction index of the stretched acrylic plastic plies of the side windshield panels. Thus, if the depth of a flaw within an acrylic ply is measured as 0.204 inch, the reading is multiplied by 1.5 which gives the actual depth of the flaw as 0.306 inch.
