SERVICE DIGEST

issue **14** August 1966

CORROSION AND THE P-3 ORION

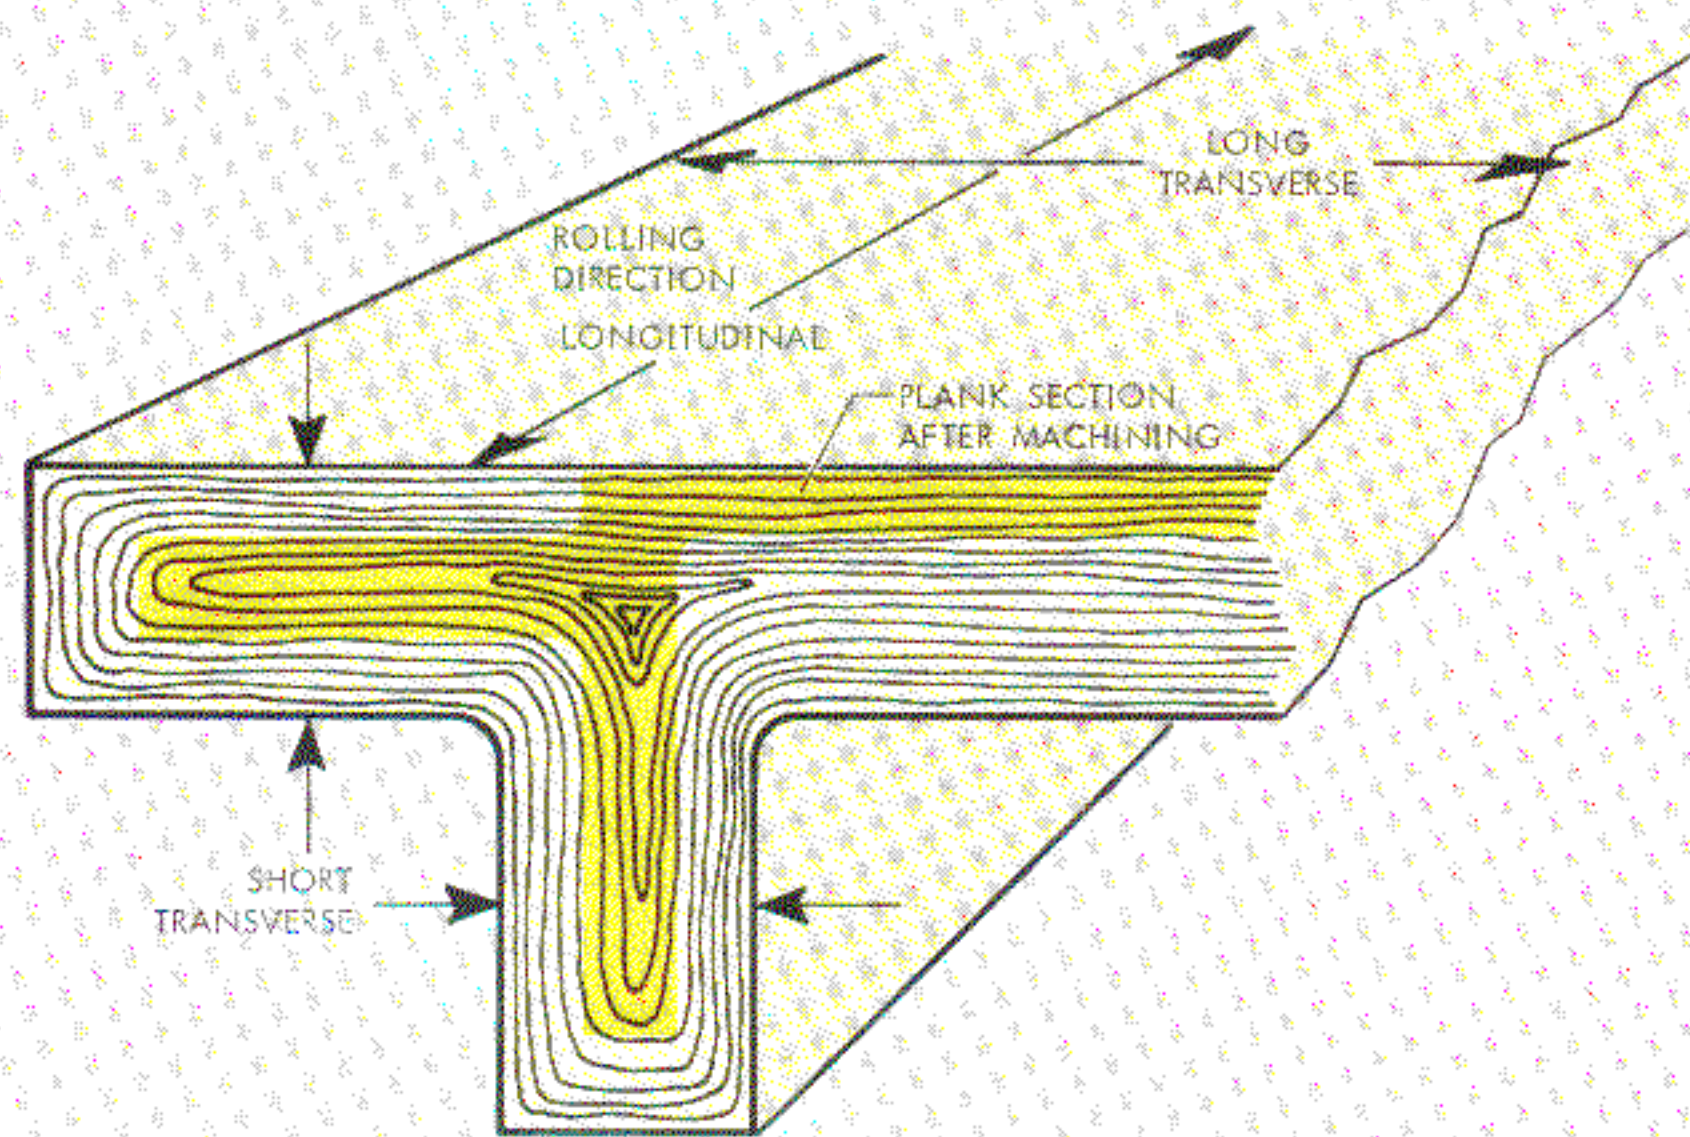
Figure 5 Cross Section of a Typical Lap Joint in the Wing Structure

tion. Fig. 5 shows a cross section of a typical splice joint looking spanwise. This basic joint configuration exists in the center section and throughout the outer wing. Fig. 6 shows the basic plank composition from raw extrusion to machined finish, with a macrograph portrayal of the granular flow in the finished radii. It was in the outer radius of the underlying tang that the crack previously reported had developed.

The steady-state stresses imposed in this area create the possibility of stress corrosion cracks if this area is also exposed to corrosive attack. Sealant placed in the gap area prevents the entry of materials which might cause corrosive attack. By shotpeening the radii, the material can be rendered resistant to stress corrosion cracking up to 75% of its yield strength. Application of surface coatings (see Figure 7) to exclude the corrosive environment will provide the radii additional protection.

Listed below is a summary of numerous corrosion preventive measures associated with the wing plank splice area:

1. Wet sealant has been applied between tang faying surfaces from the beginning of P-3 production.
2. From the beginning of production the interior wing surfaces (fuel tank area) have been sealed with BUNA "N" compound, and the lower tank surfaces have been overcoated with polyurethane.
3. Wet sealant installation of removable fasteners at Serial No. 5087 (BuNo 151374).
4. Sealing wing plank gaps and access doors in the outer wing during production at Serial No. 5087 (BuNo 151374).
5. Sealing wing plank gaps on aircraft in service by retrofit through P-3 Airframe Change No. 79.

6. Wet sealant installation of permanent fasteners during production at Serial No. 5126 (BuNo 152156).
7. Center section plank gaps will be sealed during production at Serial No. 5208 (BuNo 152890).
8. Shotpeening machined radii during production to begin with Serial No. 5226 (BuNo 153429).
9. Application of polyurethane coating over shotpeened underlying tang faying surface during production to begin with Serial No. 5226 (BuNo 153429).
10. Center section permanent fasteners will be installed with wet sealant at Serial No. 5226 (BuNo 153429).
11. Wing plank gap seams will be opened to .060 in. minimum during production at Serial No. 5239 (BuNo 153442) to facilitate application and maintenance of gap sealant.

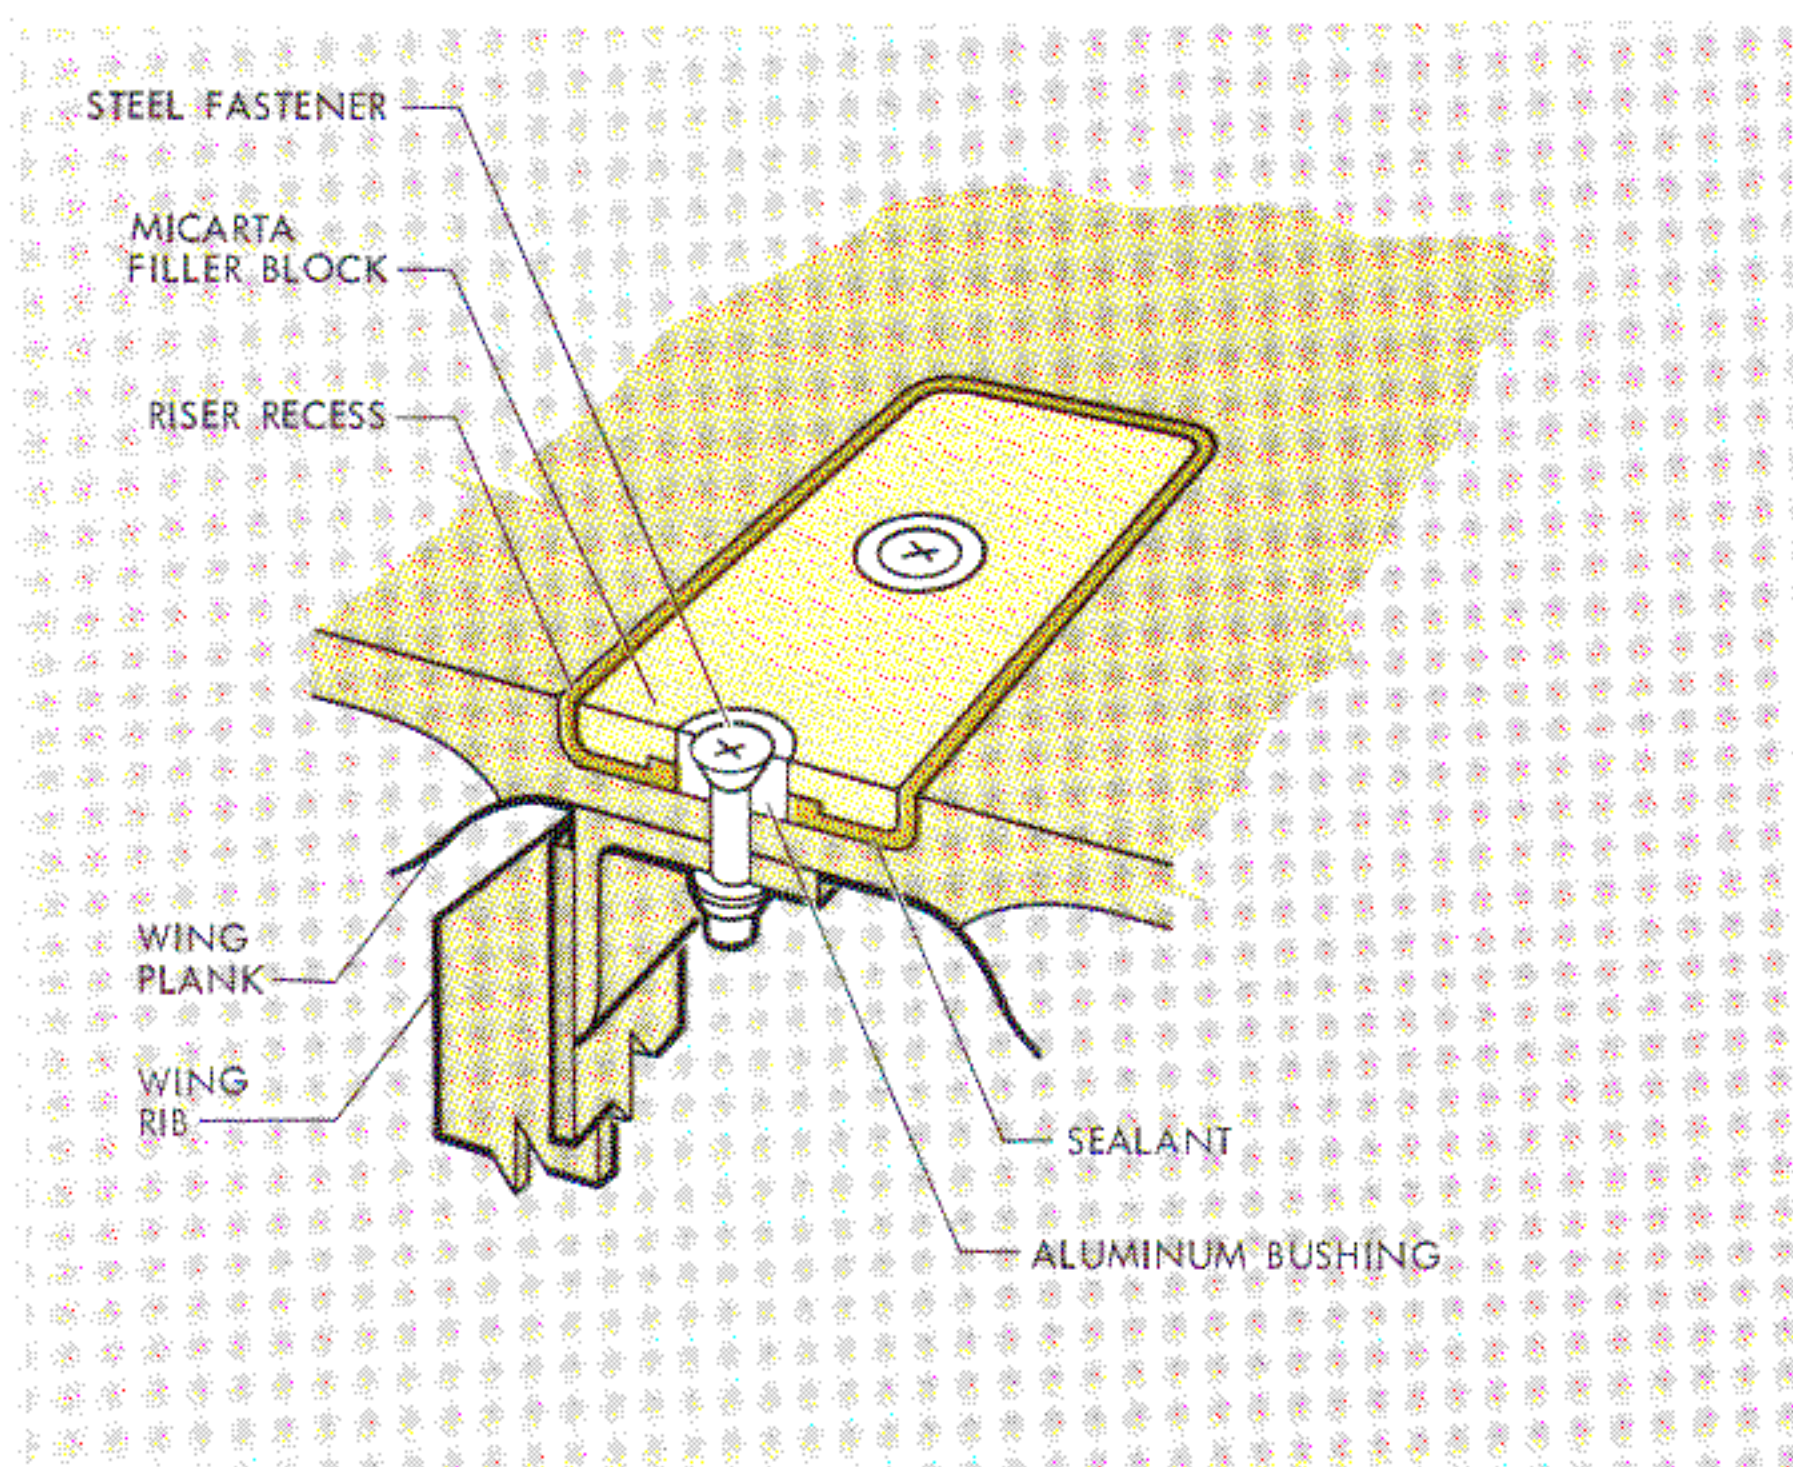
Figure 9 Older Style Centroid Riser Recess Micarta Filler Block

the filler with the plank recess surface. The filler block was installed with wet sealant as shown in Figure 9, to provide an insulation barrier and to prevent the accumulation of moisture in the recess. Galvanic corrosion was detected where the plank surface contacted the aluminum bushing. **Protection** The micarta filler block was redesigned to eliminate the recess in the block and the aluminum bushings. An O-ring was installed around the fastener to act as a standoff to prevent contact of the filler block with the plank surface (Figure 10). Otherwise the corrosion protection provisions remain the same. A program is presently underway to replace the phenolic filler blocks with blocks made of aluminum alloy because of the hygroscopic qualities of the phenolic material.

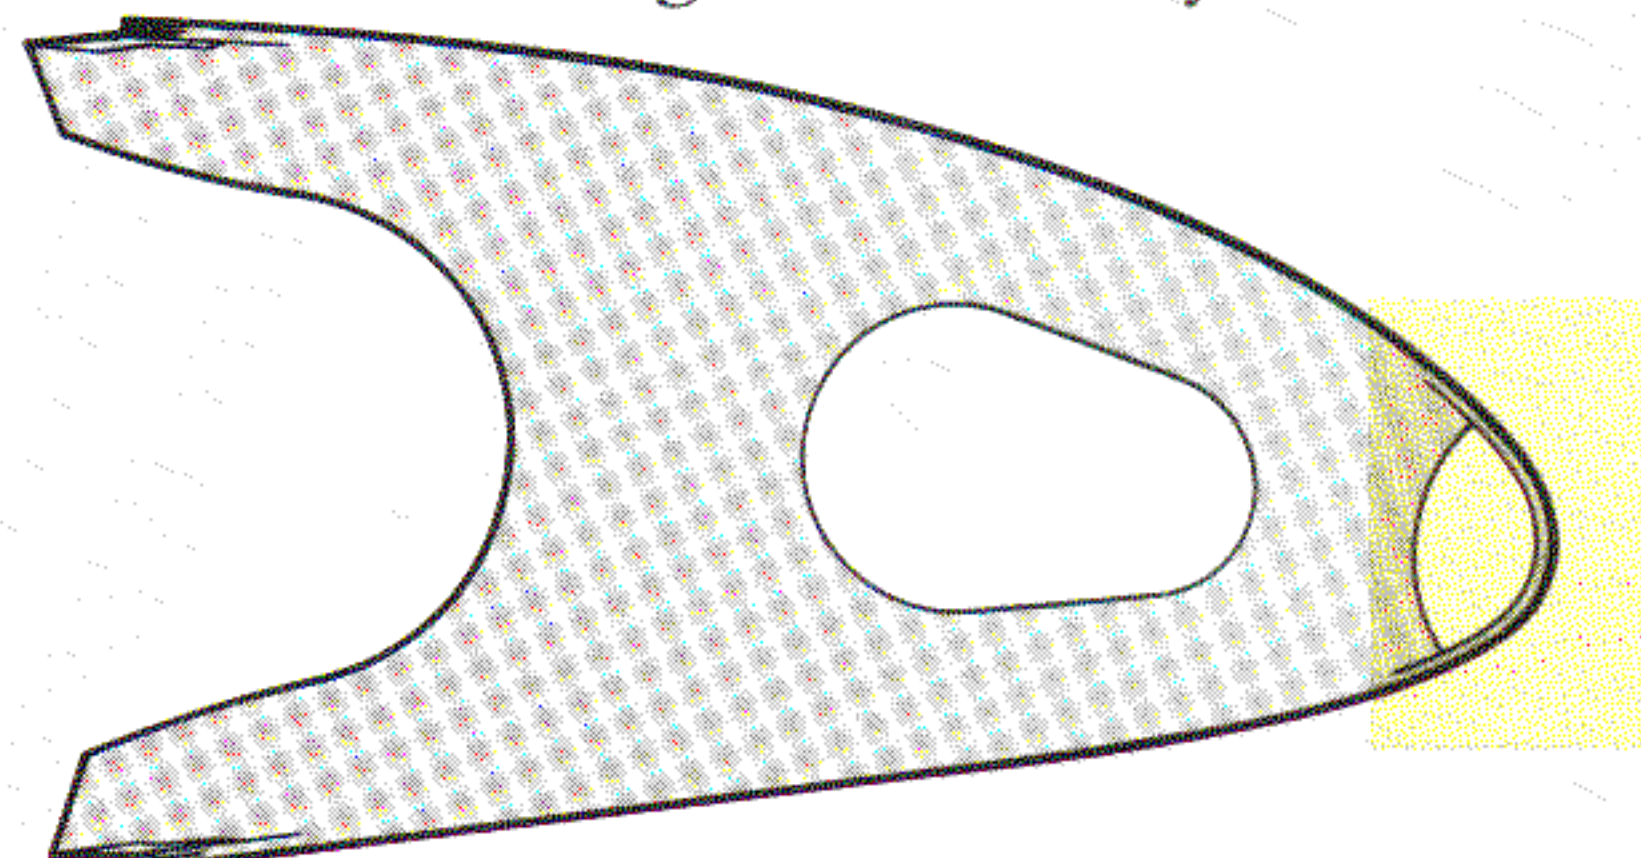
Figure 15 Detail of Empennage Leading Edge Construction

HORIZONTAL AND VERTICAL STABILIZER LEADING EDGES The construction of the empennage leading edges differs from the wing leading edge in that electrical thermal anti-icing is provided in lieu of compressor bleed hot air. General erosion of the empennage leading edges has occurred, with associated pitting corrosion progressing to extended surface attack of the skin. Figure 15 depicts the construction of the leading edges which consists of the outer aluminum alloy skin, various laminated layers of fabric, glass cloth, heating elements, adhesives and the supporting structure.

On early aircraft, fabrication techniques permitted voids in the laminate which contributed to corrosive attack of the skin. Special tooling was developed for this assembly to assure good lamination adhesion and minimize voids. Effective on production Serial No. 5141 (BuNo 152172) the leading edge skin was changed from .012 inch 2024 aluminum alloy to .016 inch 6061 aluminum alloy to further improve the corrosion resistance.

Protection In addition to the above fabrication improvements, the following changes were incorporated in production to improve the corrosion protection:

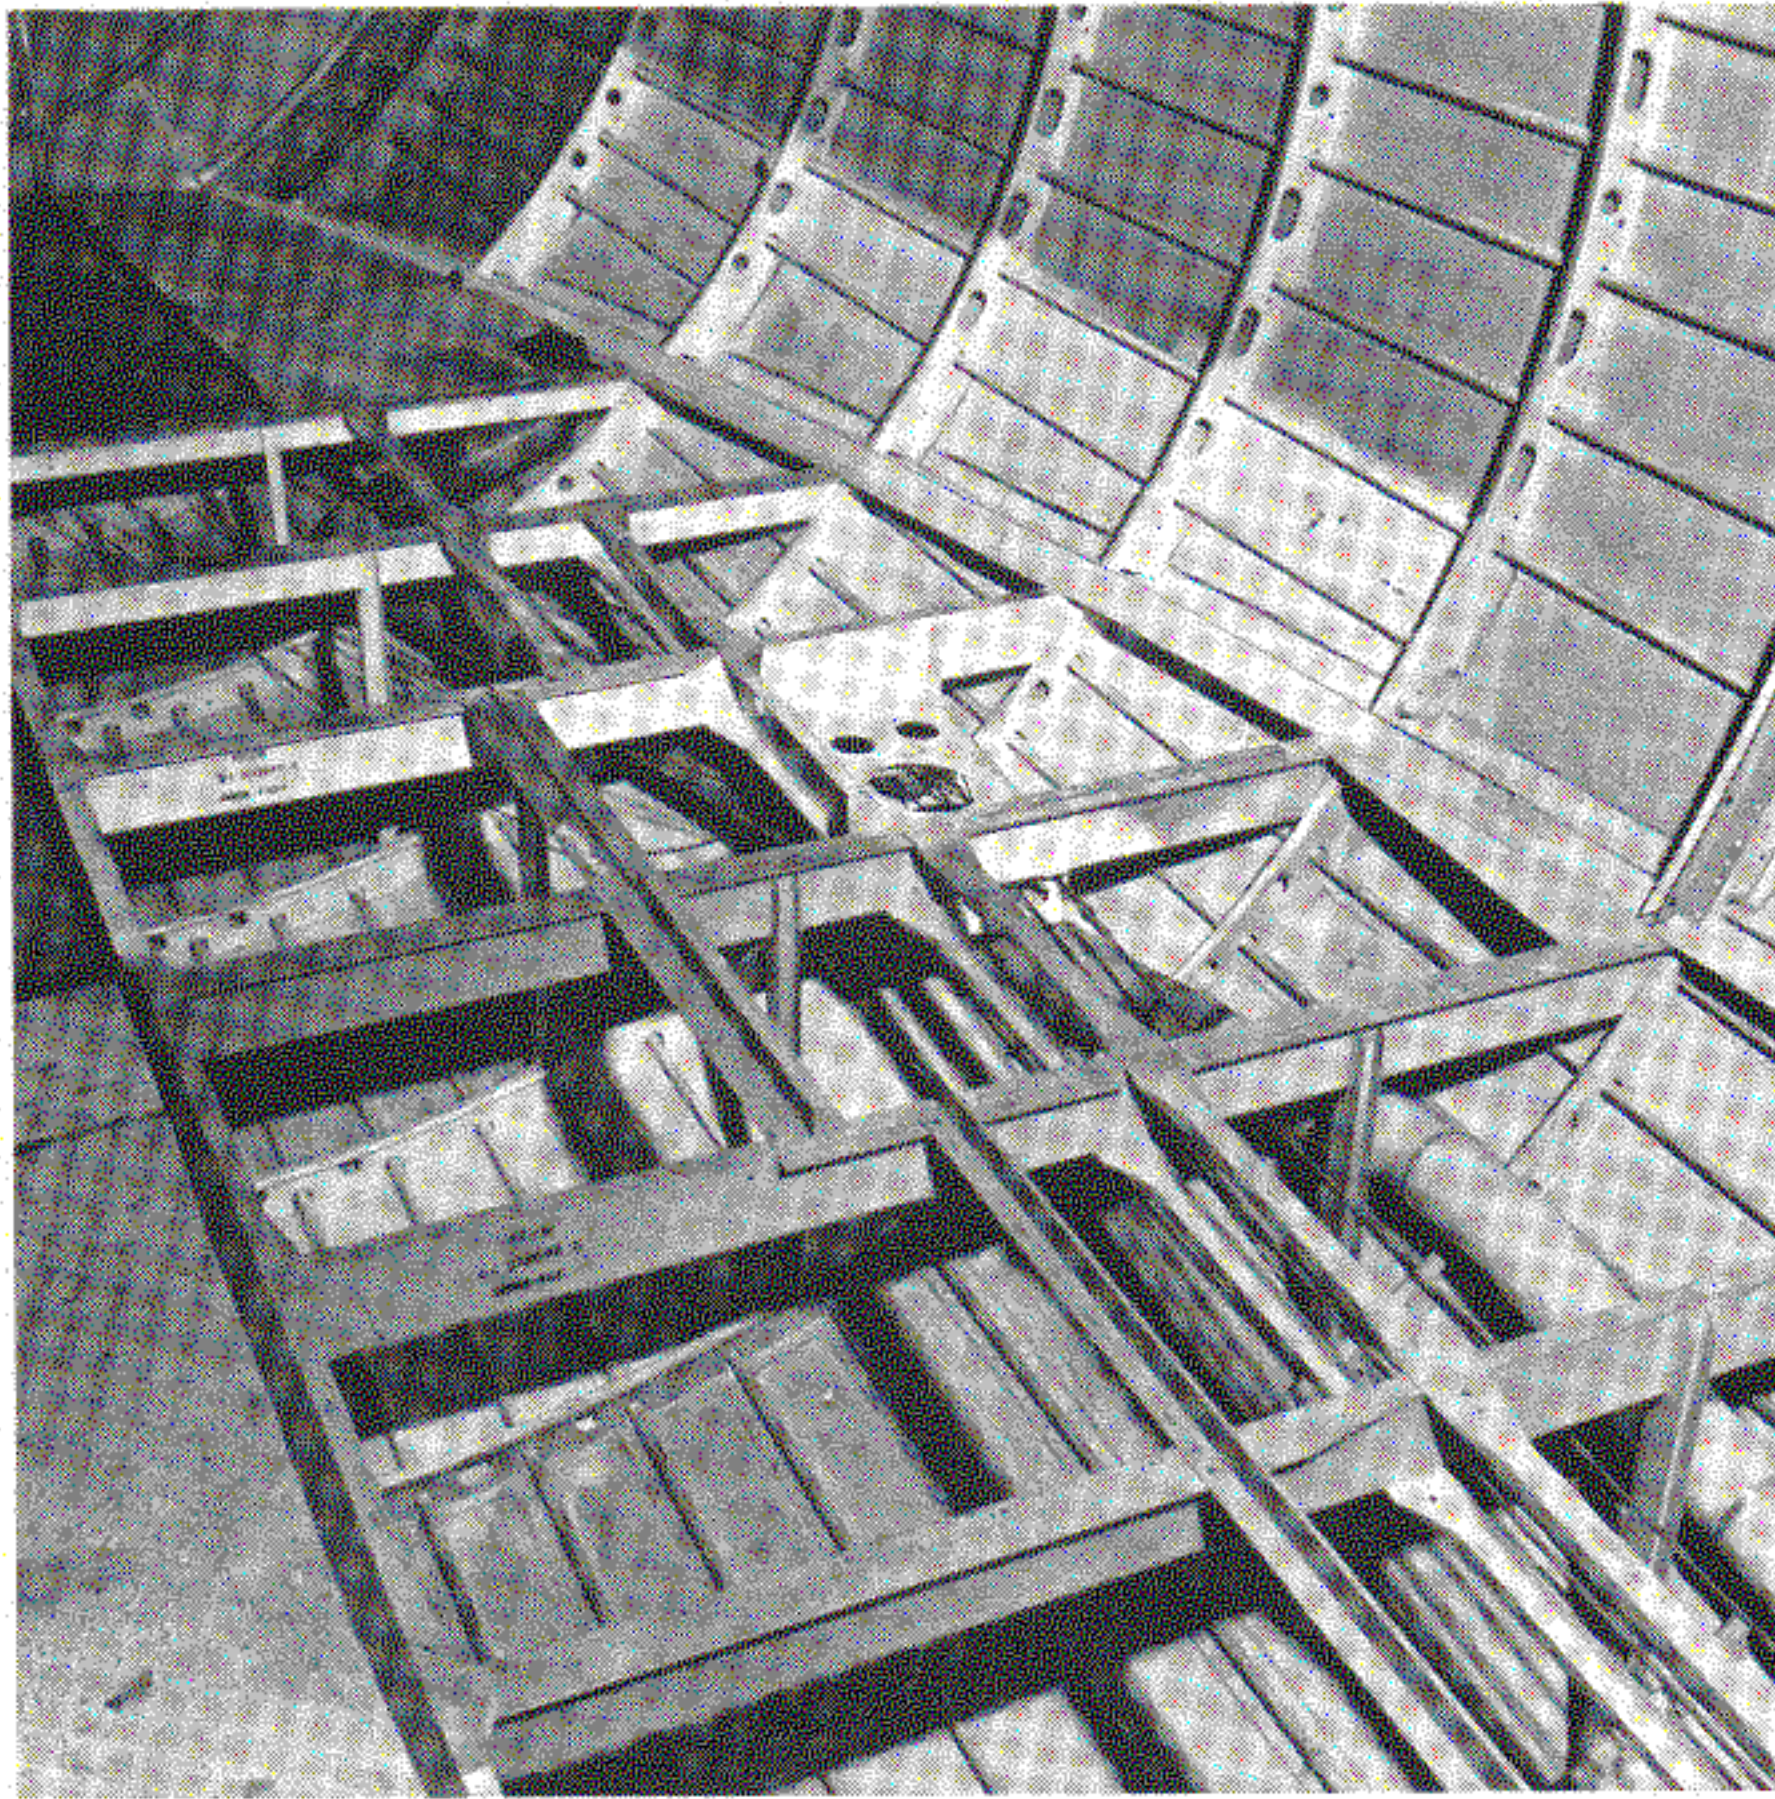
Figure 16a Structure in Galley Area Protected by Acid-resistant Lacquer

Protection The structures in the galley and lavatory areas (Figures 16 and 17) are protected with an acid-resistant white lacquer applied over zinc chromate primer.

Restoration of Protective Finish Apply zinc chromate primer and acid-resistant lacquer to the refurbished surfaces in accordance with NAVWEPS 01-75PAA-2-2.1, Section VIII.

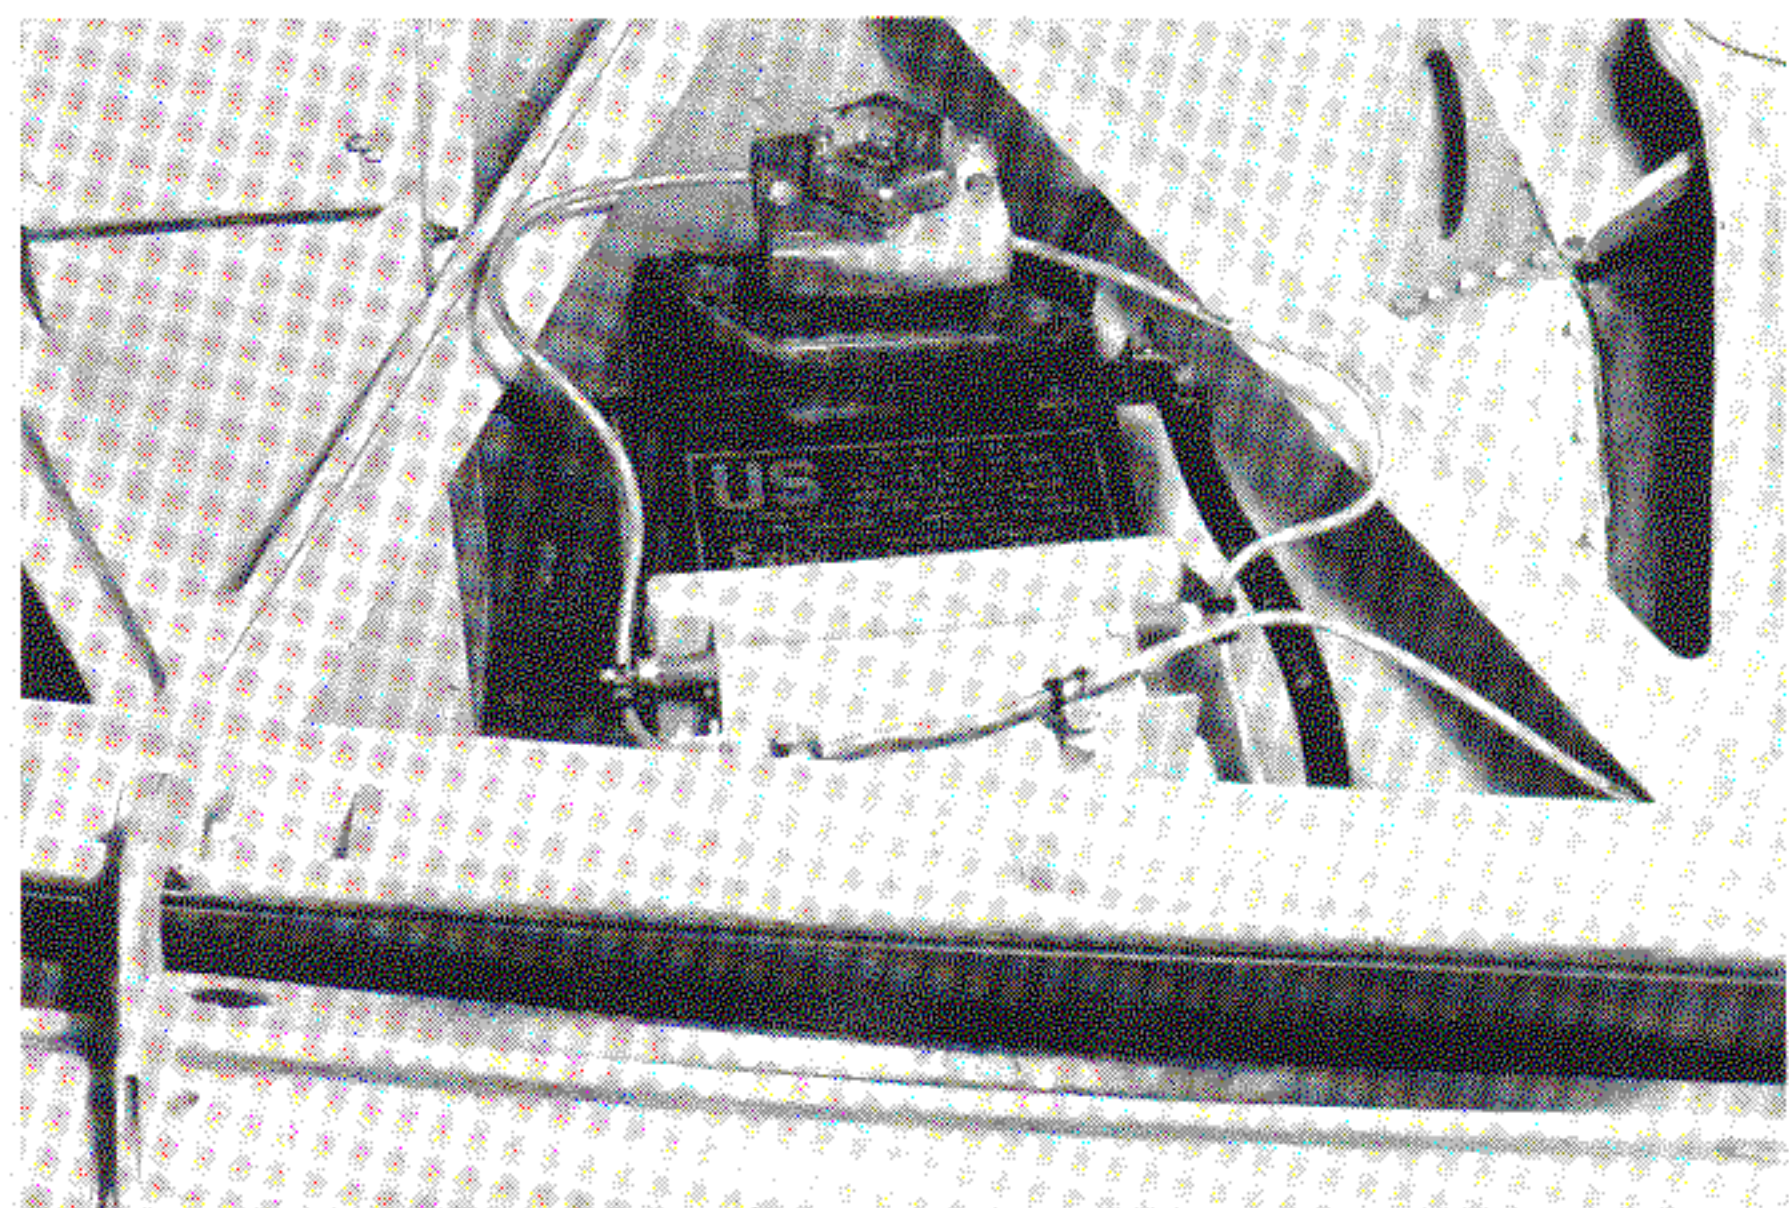
Figure 18 Battery Installation on Earlier P-3 Aircraft. On later P-3's the battery is installed at the rear of the nose wheel well.

wheel well on aircraft incorporating the integral starting system. The battery is housed in a container with inlet and outlet vent lines, that provide circulation through the battery cover. The exhaust outlet protrudes from the lower right side of the fuselage on the early aircraft and from the bottom center of the fuselage on the later aircraft. Certain adverse operating conditions may cause the battery fluid to boil, and the vented acid or fumes may be deposited on the bottom of the airplane and initiate corrosion. When this happens, the affected area must be cleaned as soon as possible.

Removal Any evidence of battery acid attack dictates immediate maintenance action. A solution of water and as much bicarbonate of soda as can be held in suspension should be generously applied to the affected surface, using a soft brush or saturated rags. Rinse the solution from the surface with soft water. Apply a second dose of the soda solution, and if any bubbling is detected continue the rinsing and soda application until all corrosive activity has been neutralized.

After the area has been treated for corrosive attack, clean and inhibit the surfaces and restore the protective finish as required.

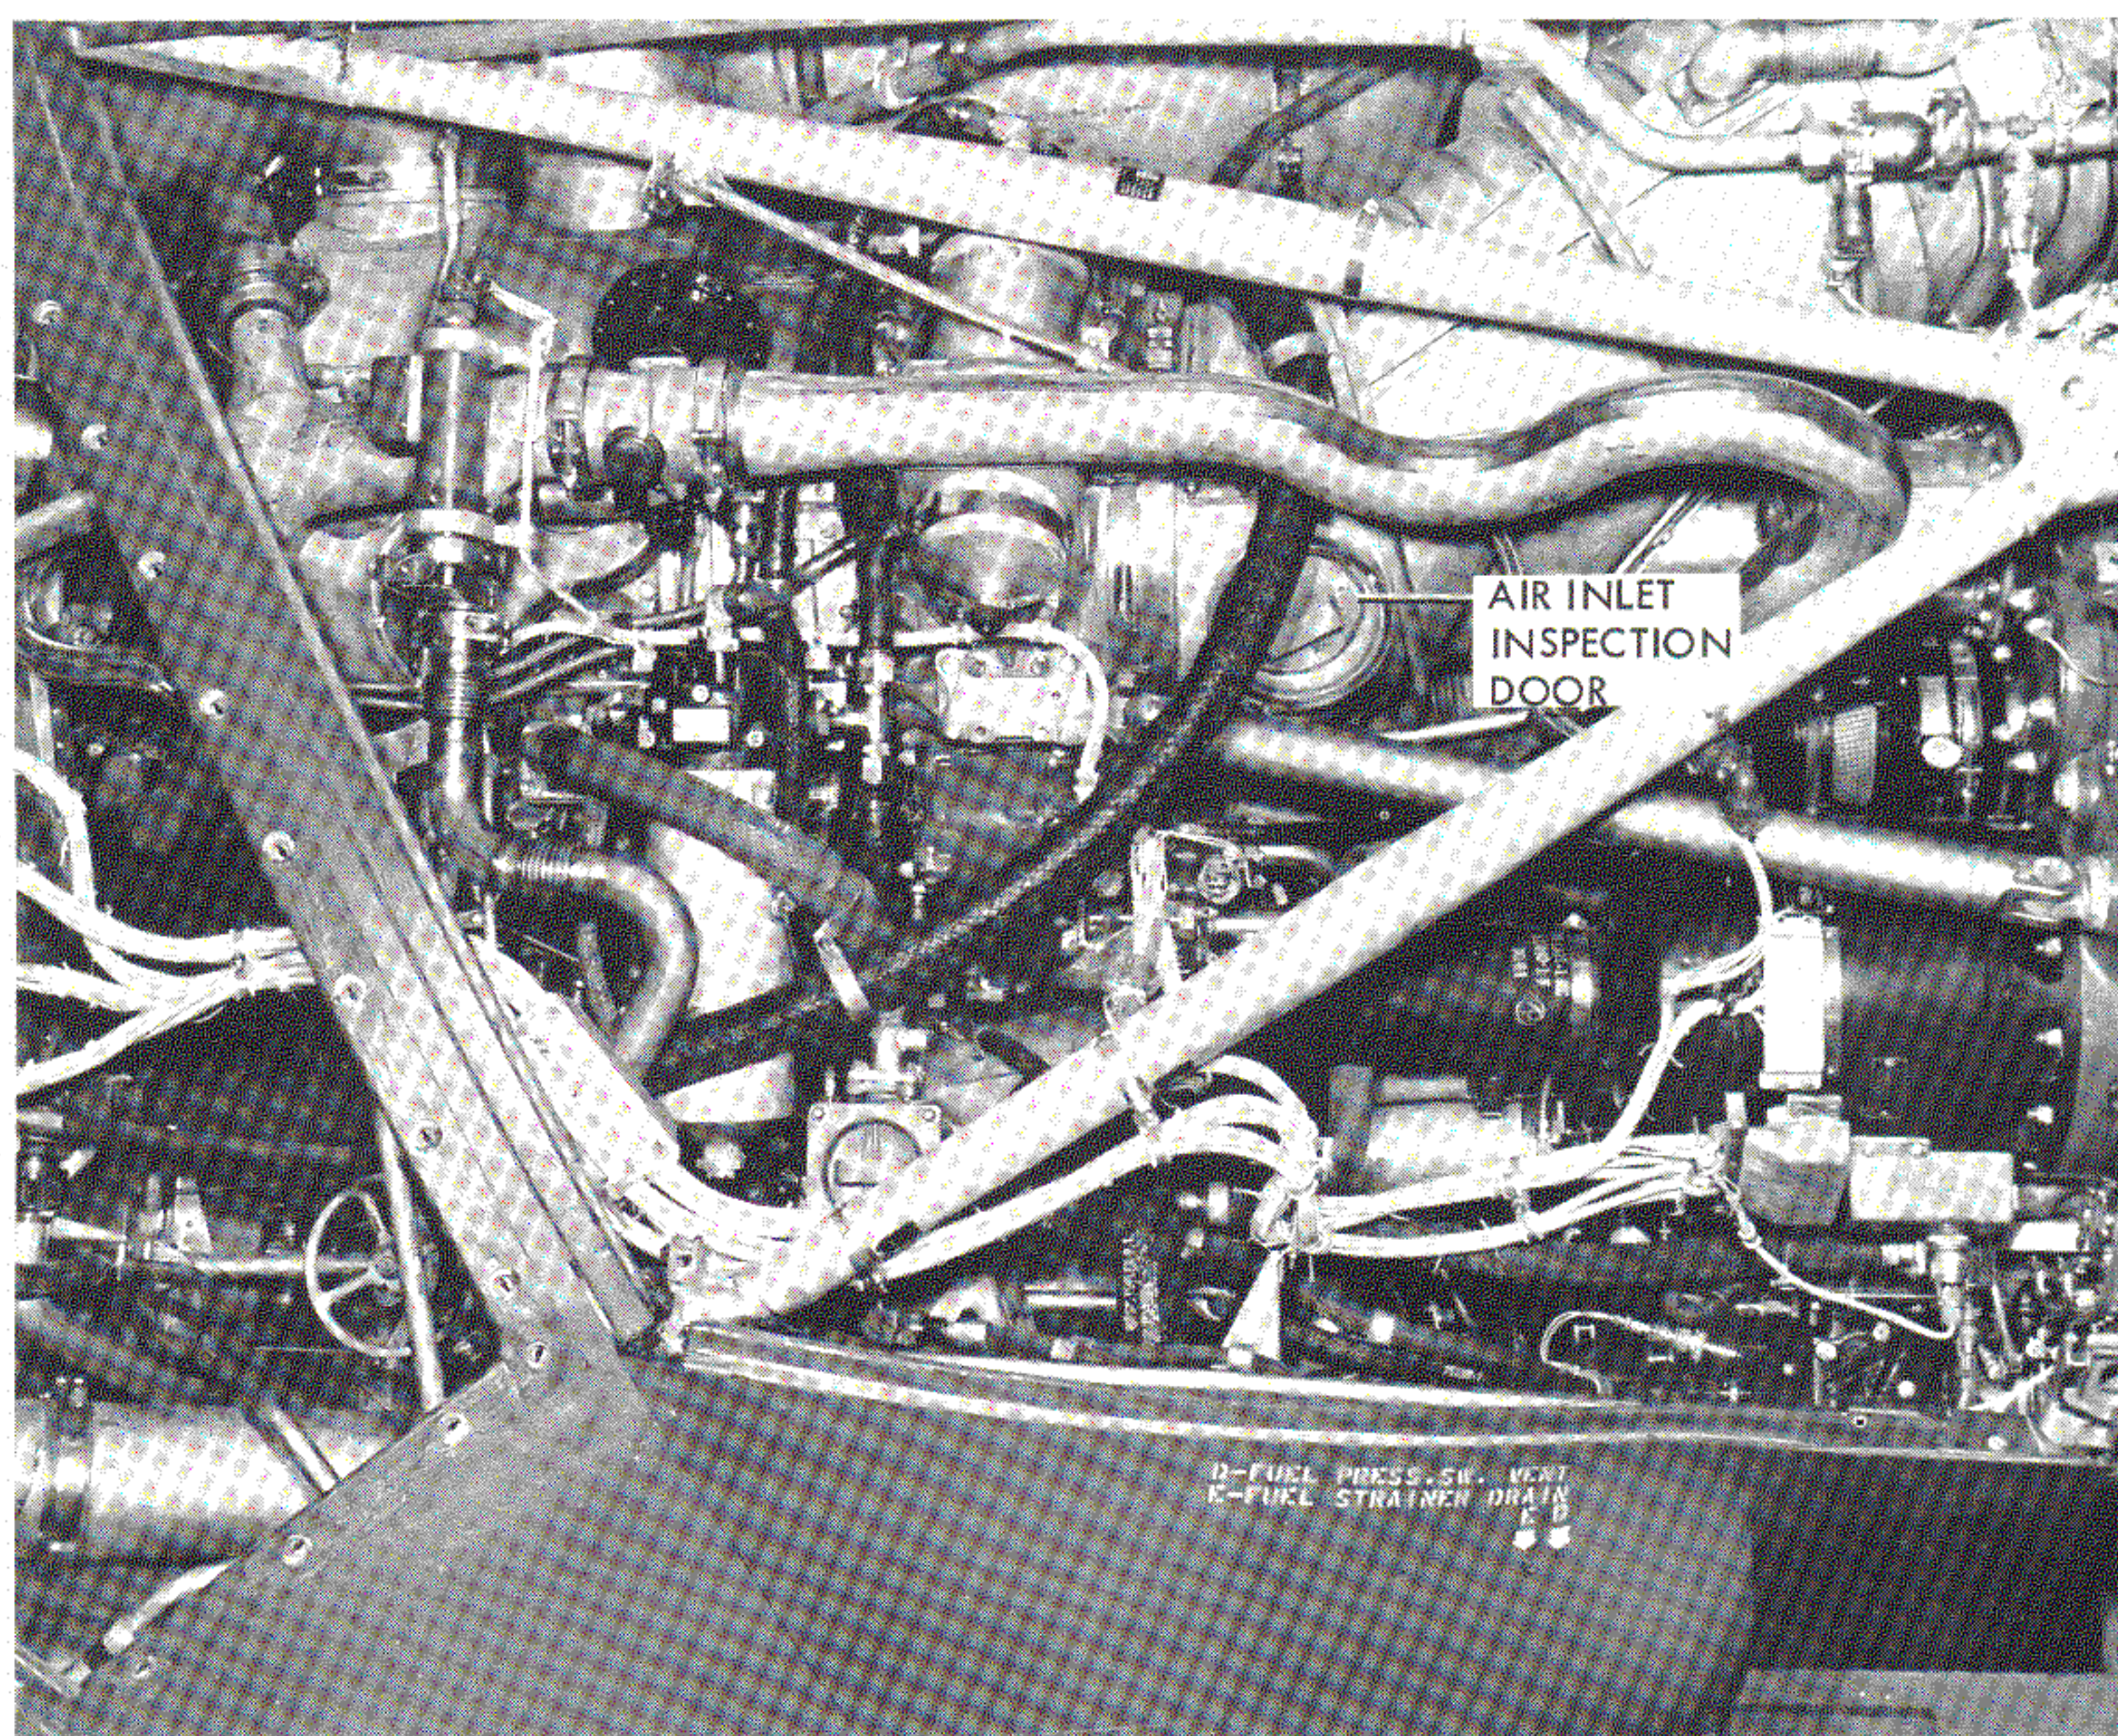
Figure 22
Location of the
Engine Air
Inlet Inspection Door

ENGINE AIR INLET HOUSING The T56-A-10W engine air inlet housing is of cast magnesium construction, with a special erosion/corrosion protective coating. However, due to the severe atmospheric environment in which the airplane operates, this protective coating did not prevent corrosive attack of the magnesium. The problem was considered severe enough to warrant the replacement of the housing with one of cast aluminum alloy, which imposes a weight penalty of approximately 19 lbs. per engine. This change is effective on the T56-A-14 engine. The aluminum inlet housing can be retrofitted on the A-10 engine, and is at present being considered on a future spares procurement basis.

- a. Use a strong light and an inspection mirror and inspect upper struts and upper portions of housing through the air inlet duct.
- b. Inspect lower struts and lower portions of housing by removing the air inlet inspection door P/N 803566-1. See Figure 22.
- c. Note any evidence of corrosion, visible pitting and/or corrosion products, paying particular attention to the leading edges of struts and the upper surfaces of horizontal struts.
- d. Upon completion of inspection, any engine found with evidence of corrosion should be reported for follow-up action on the appropriate discrepancy form.
- e. Not later than the next calendar inspection, remove those engines in which evidence of corrosion has been found for a more detailed inspection and repair at the Intermediate maintenance level.

Inhibiting Immediately after all evidence of corrosion has been removed, the reworked area should be treated as follows:

- a. Tilt the engine at a slightly nose-down attitude when the inlet housing is installed to assist in preventing the chrome-pickle solution from entering the compressor section.
- b. The chrome pickle treatment shall be accomplished by using 12% chromic acid solution MIL Spec. FED O-C-303, FSN G6810-264-3939. Apply one coat of the solution to the wire brushed areas and allow to stand for fifteen minutes. Wash the areas with fresh water or clean them thoroughly by wiping with a wet rag, and allow the surfaces to dry.

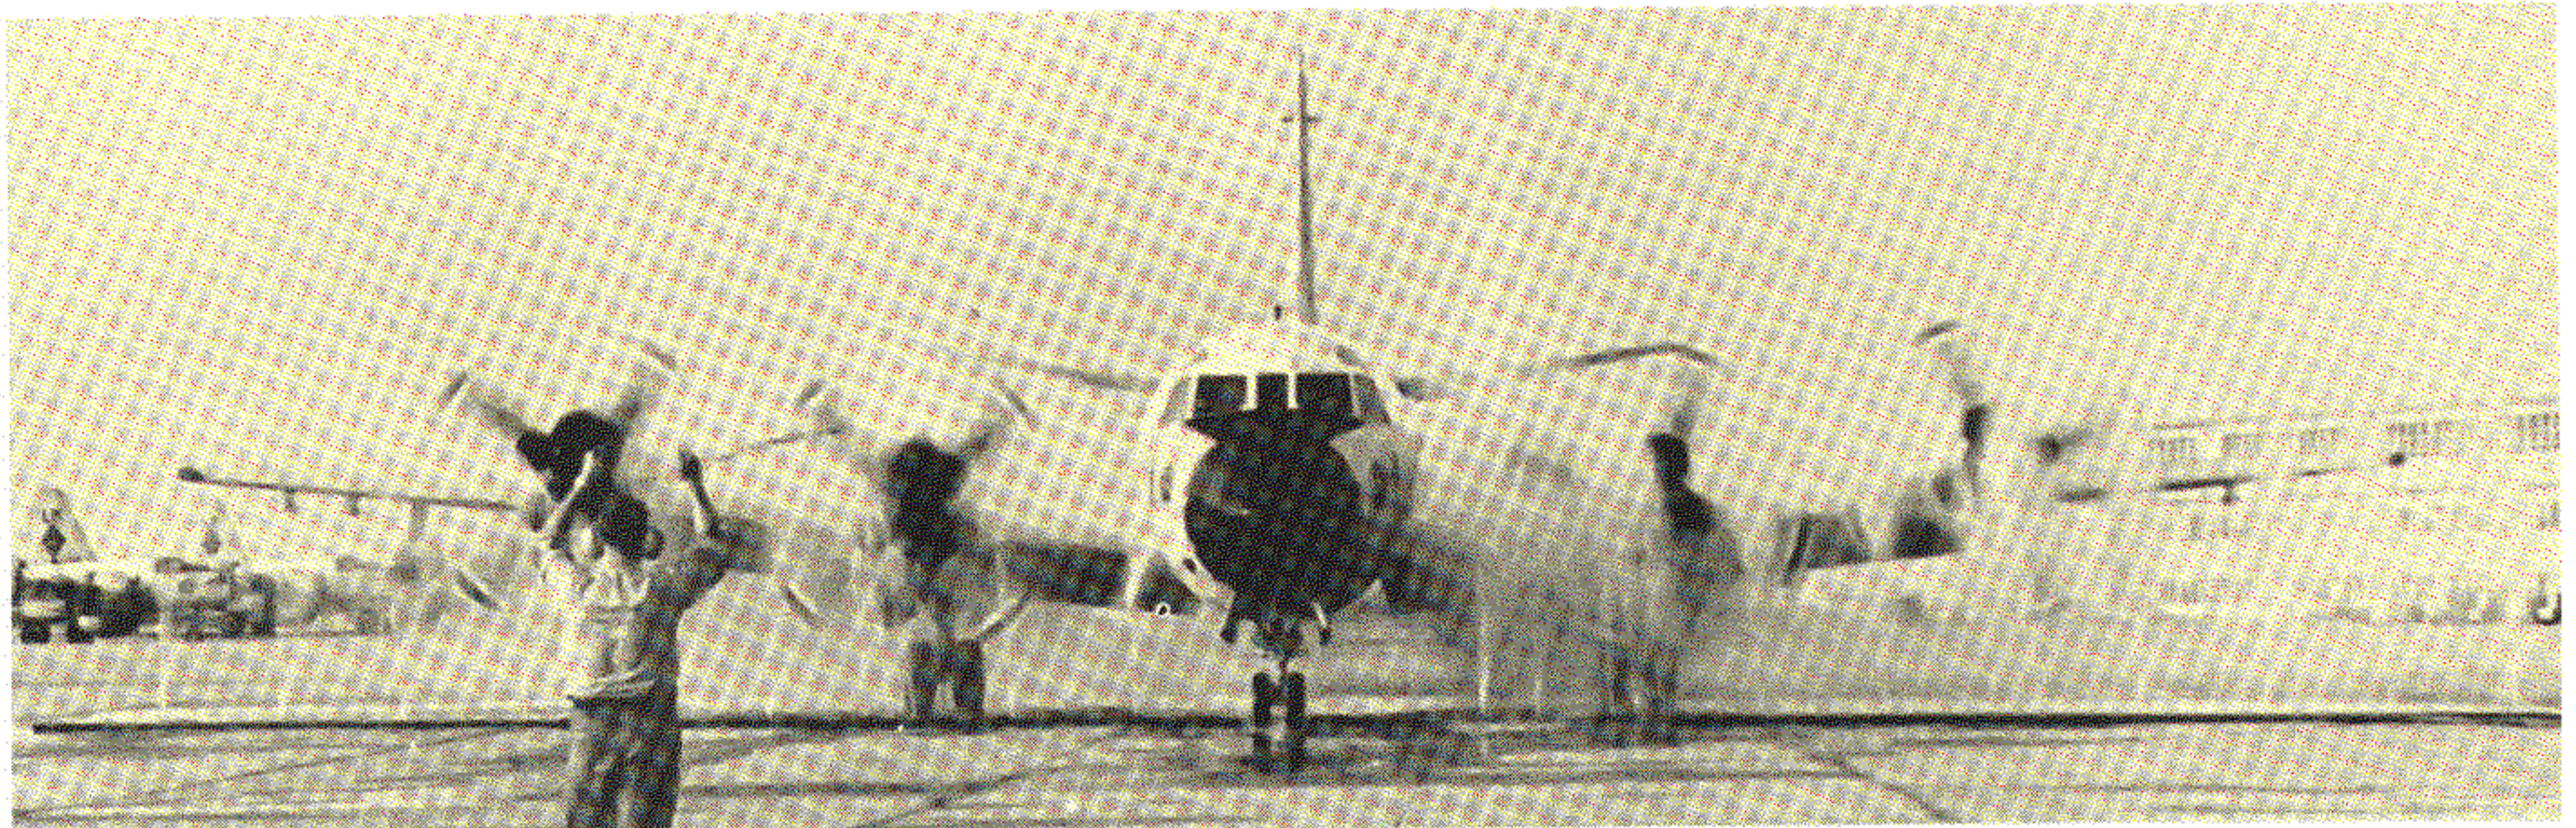
Figure 4 Rinse Rack Installation at Brunswick NAS

The rinse rack concept has also generated interest at other Naval facilities. An interim rinse rack installation (see Figure 4), built through the efforts of Mr. Sam Webster of NAS Brunswick's Public Works Department, has been in use at that base for some time. Assessment of the rinse rack's worth in their corrosion control program has resulted in Brunswick's submission of plans to BuWeps for funding a permanent rinse rack installation.
