# ORION

# digest

issue **29**

## TURBINE INLET TEMPERATURE AND TURBINE LONGEVITY

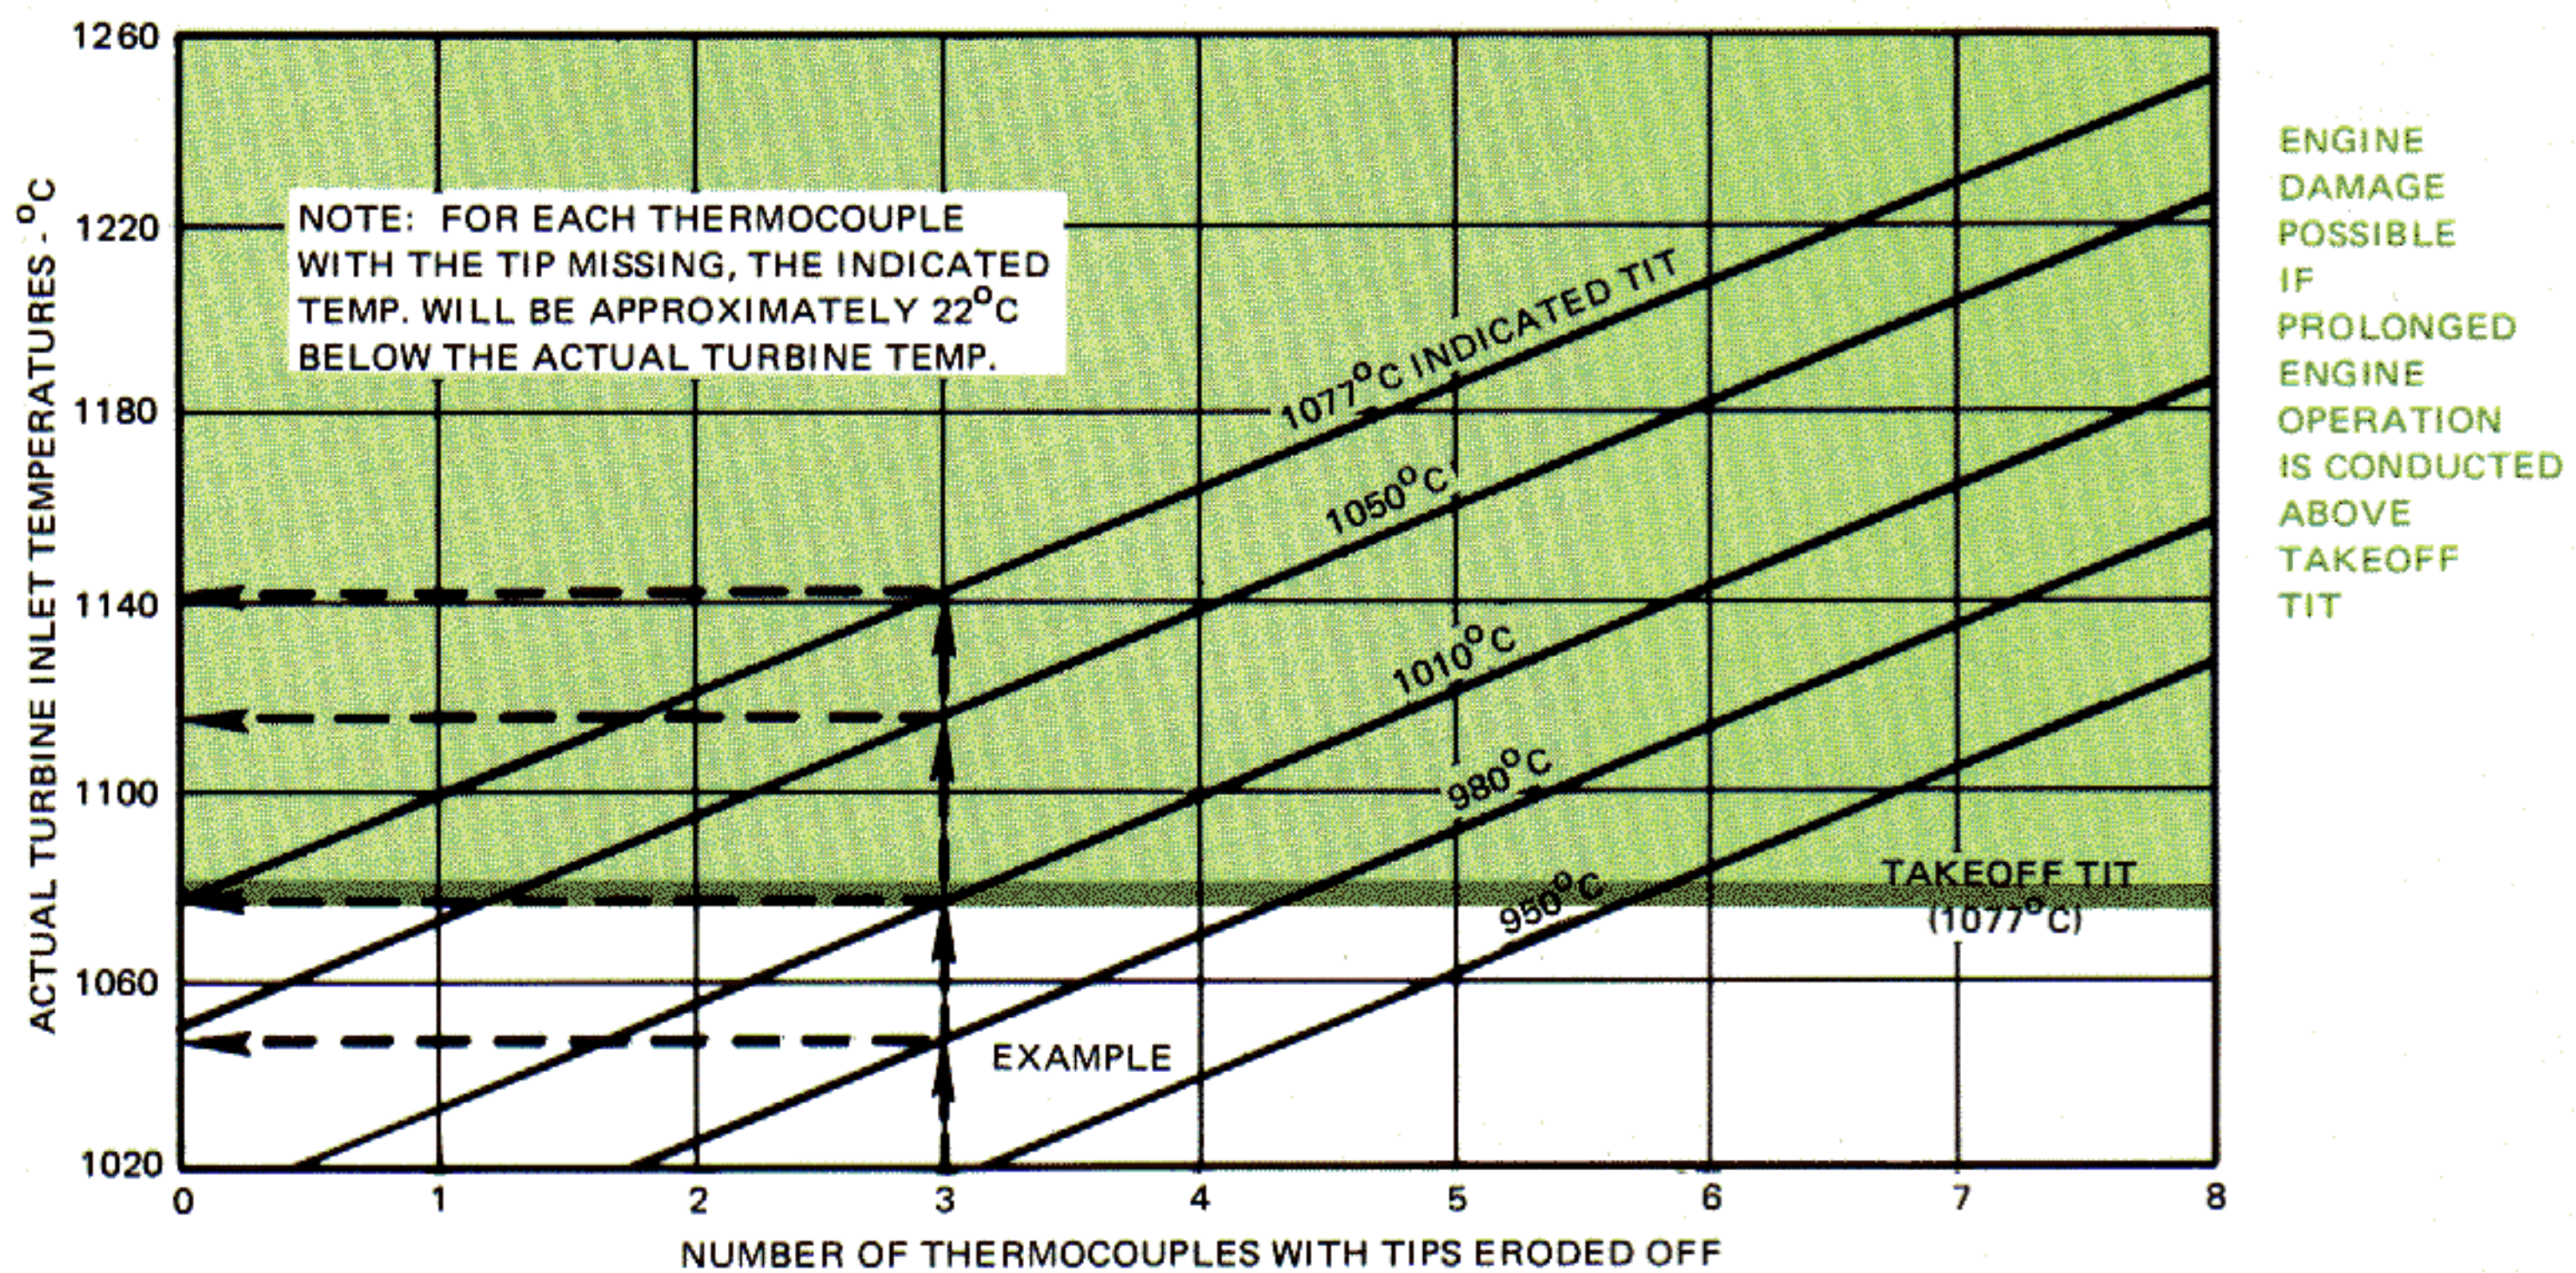
To illustrate this condition, let us assume that we have a properly functioning T56-A-14 engine, except that three of its thermocouples have probes with missing tips. Bear in mind that each thermocouple with a missing tip introduces an error of about 22°C below the actual averaged gas path temperature. Since the error is cumulative and there are three thermocouple probes with missing tips, the engine's indicated TIT is approximately 66°C below the actual TIT. Thus, at an indicated takeoff TIT of 1077°C, the actual TIT will be on the order of 1143°C. Even at an indicated

“Normal” TIT of 1010°C, this engine's actual TIT would be approximating that for takeoff. Figure 6 shows the correlation between the indicated and actual TIT of an engine that has one or more thermocouple probe tips missing.

Figure 6 Correlation Between Indicated and Actual Turbine Inlet Temperatures of T56-A-14 Engine with One or More Thermocouple Probe Tips Missing. Example Shows Difference at Selected Temperatures for Engine with Three Thermocouples with Missing Probe Tips.

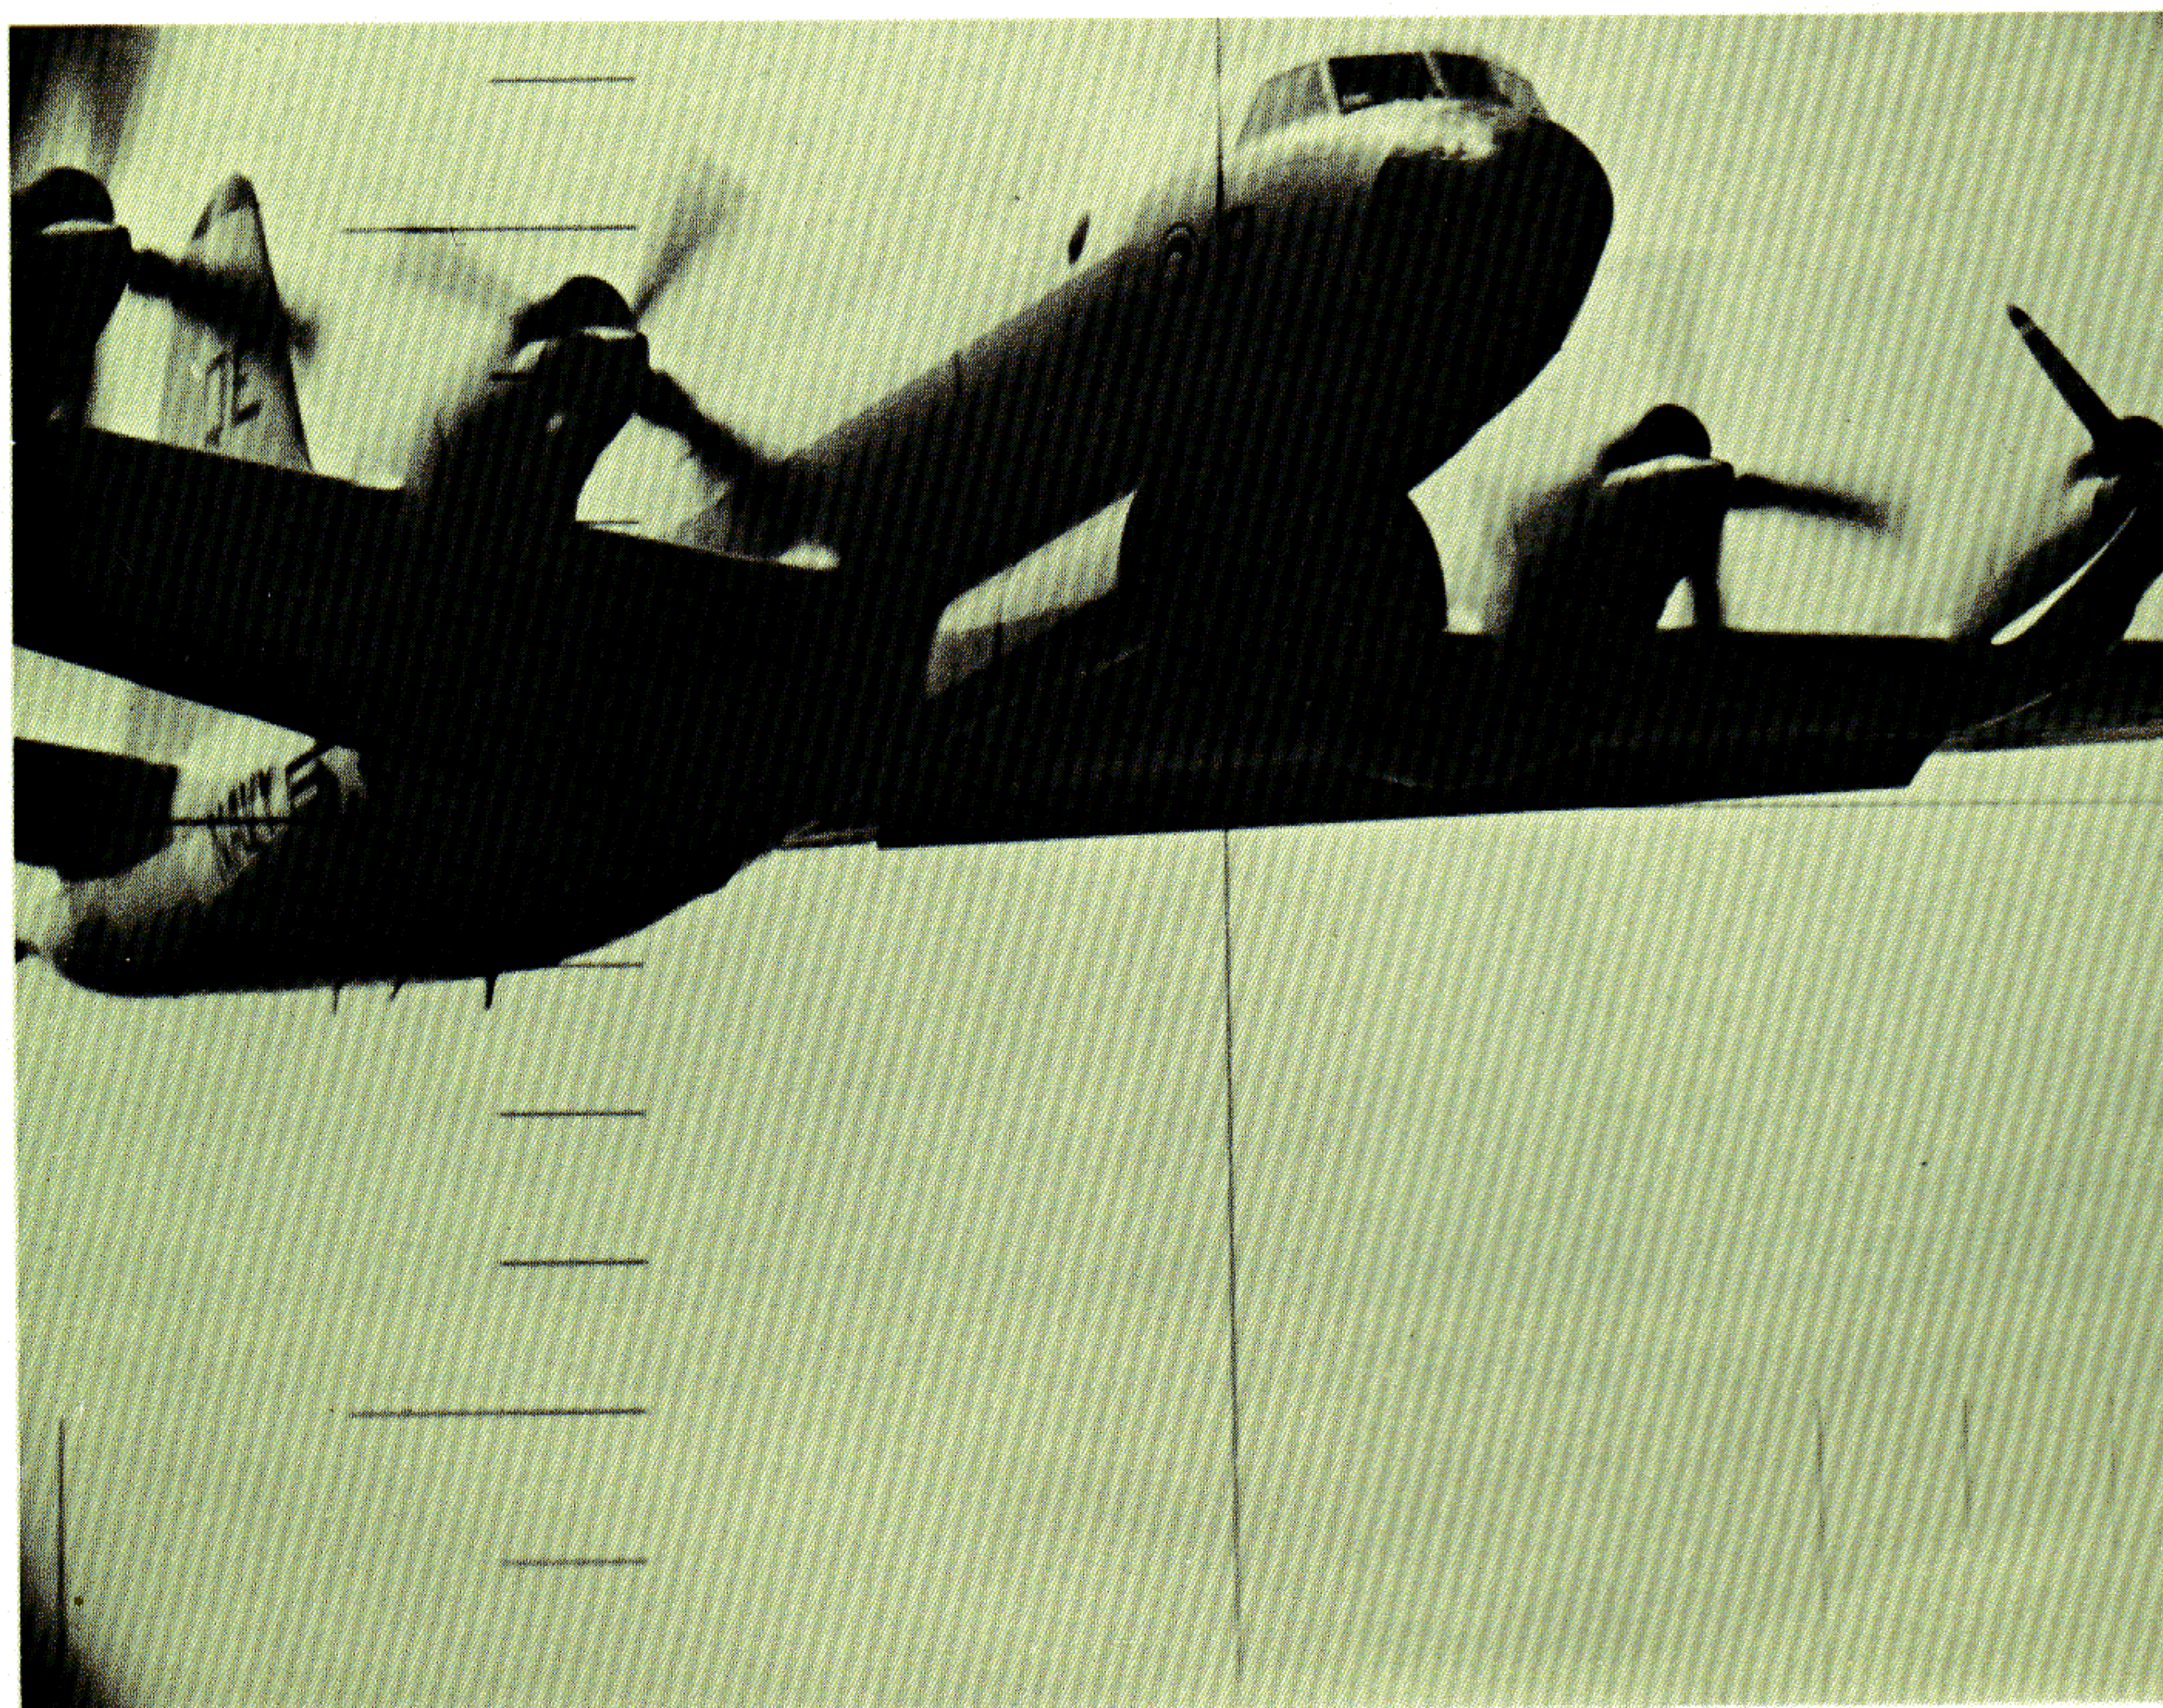
*Figure 8 Views of Alpak-Coated Turbine Blade with Sulfidation Damage. Blade was Removed from the First Stage Turbine of a T56-A-14 Engine.*

Naturally, if the eroded Alpak coating is not renewed, the bare portion of the part will be exposed to sulfidation. Figure 8 shows views of a first stage turbine blade made of Alpak-coated Alloy 713C that is from a T56-A-14 engine. Both the concave and convex sides of the blade are shown, and material loss due to sulfidation is readily apparent. Note that sulfidation generally attacks the airfoil edges first, since the Alpak coating on these surfaces is subjected to the greatest erosion. After the protective Alpak coating has been removed by erosion, sulfidation of the base material can commence.

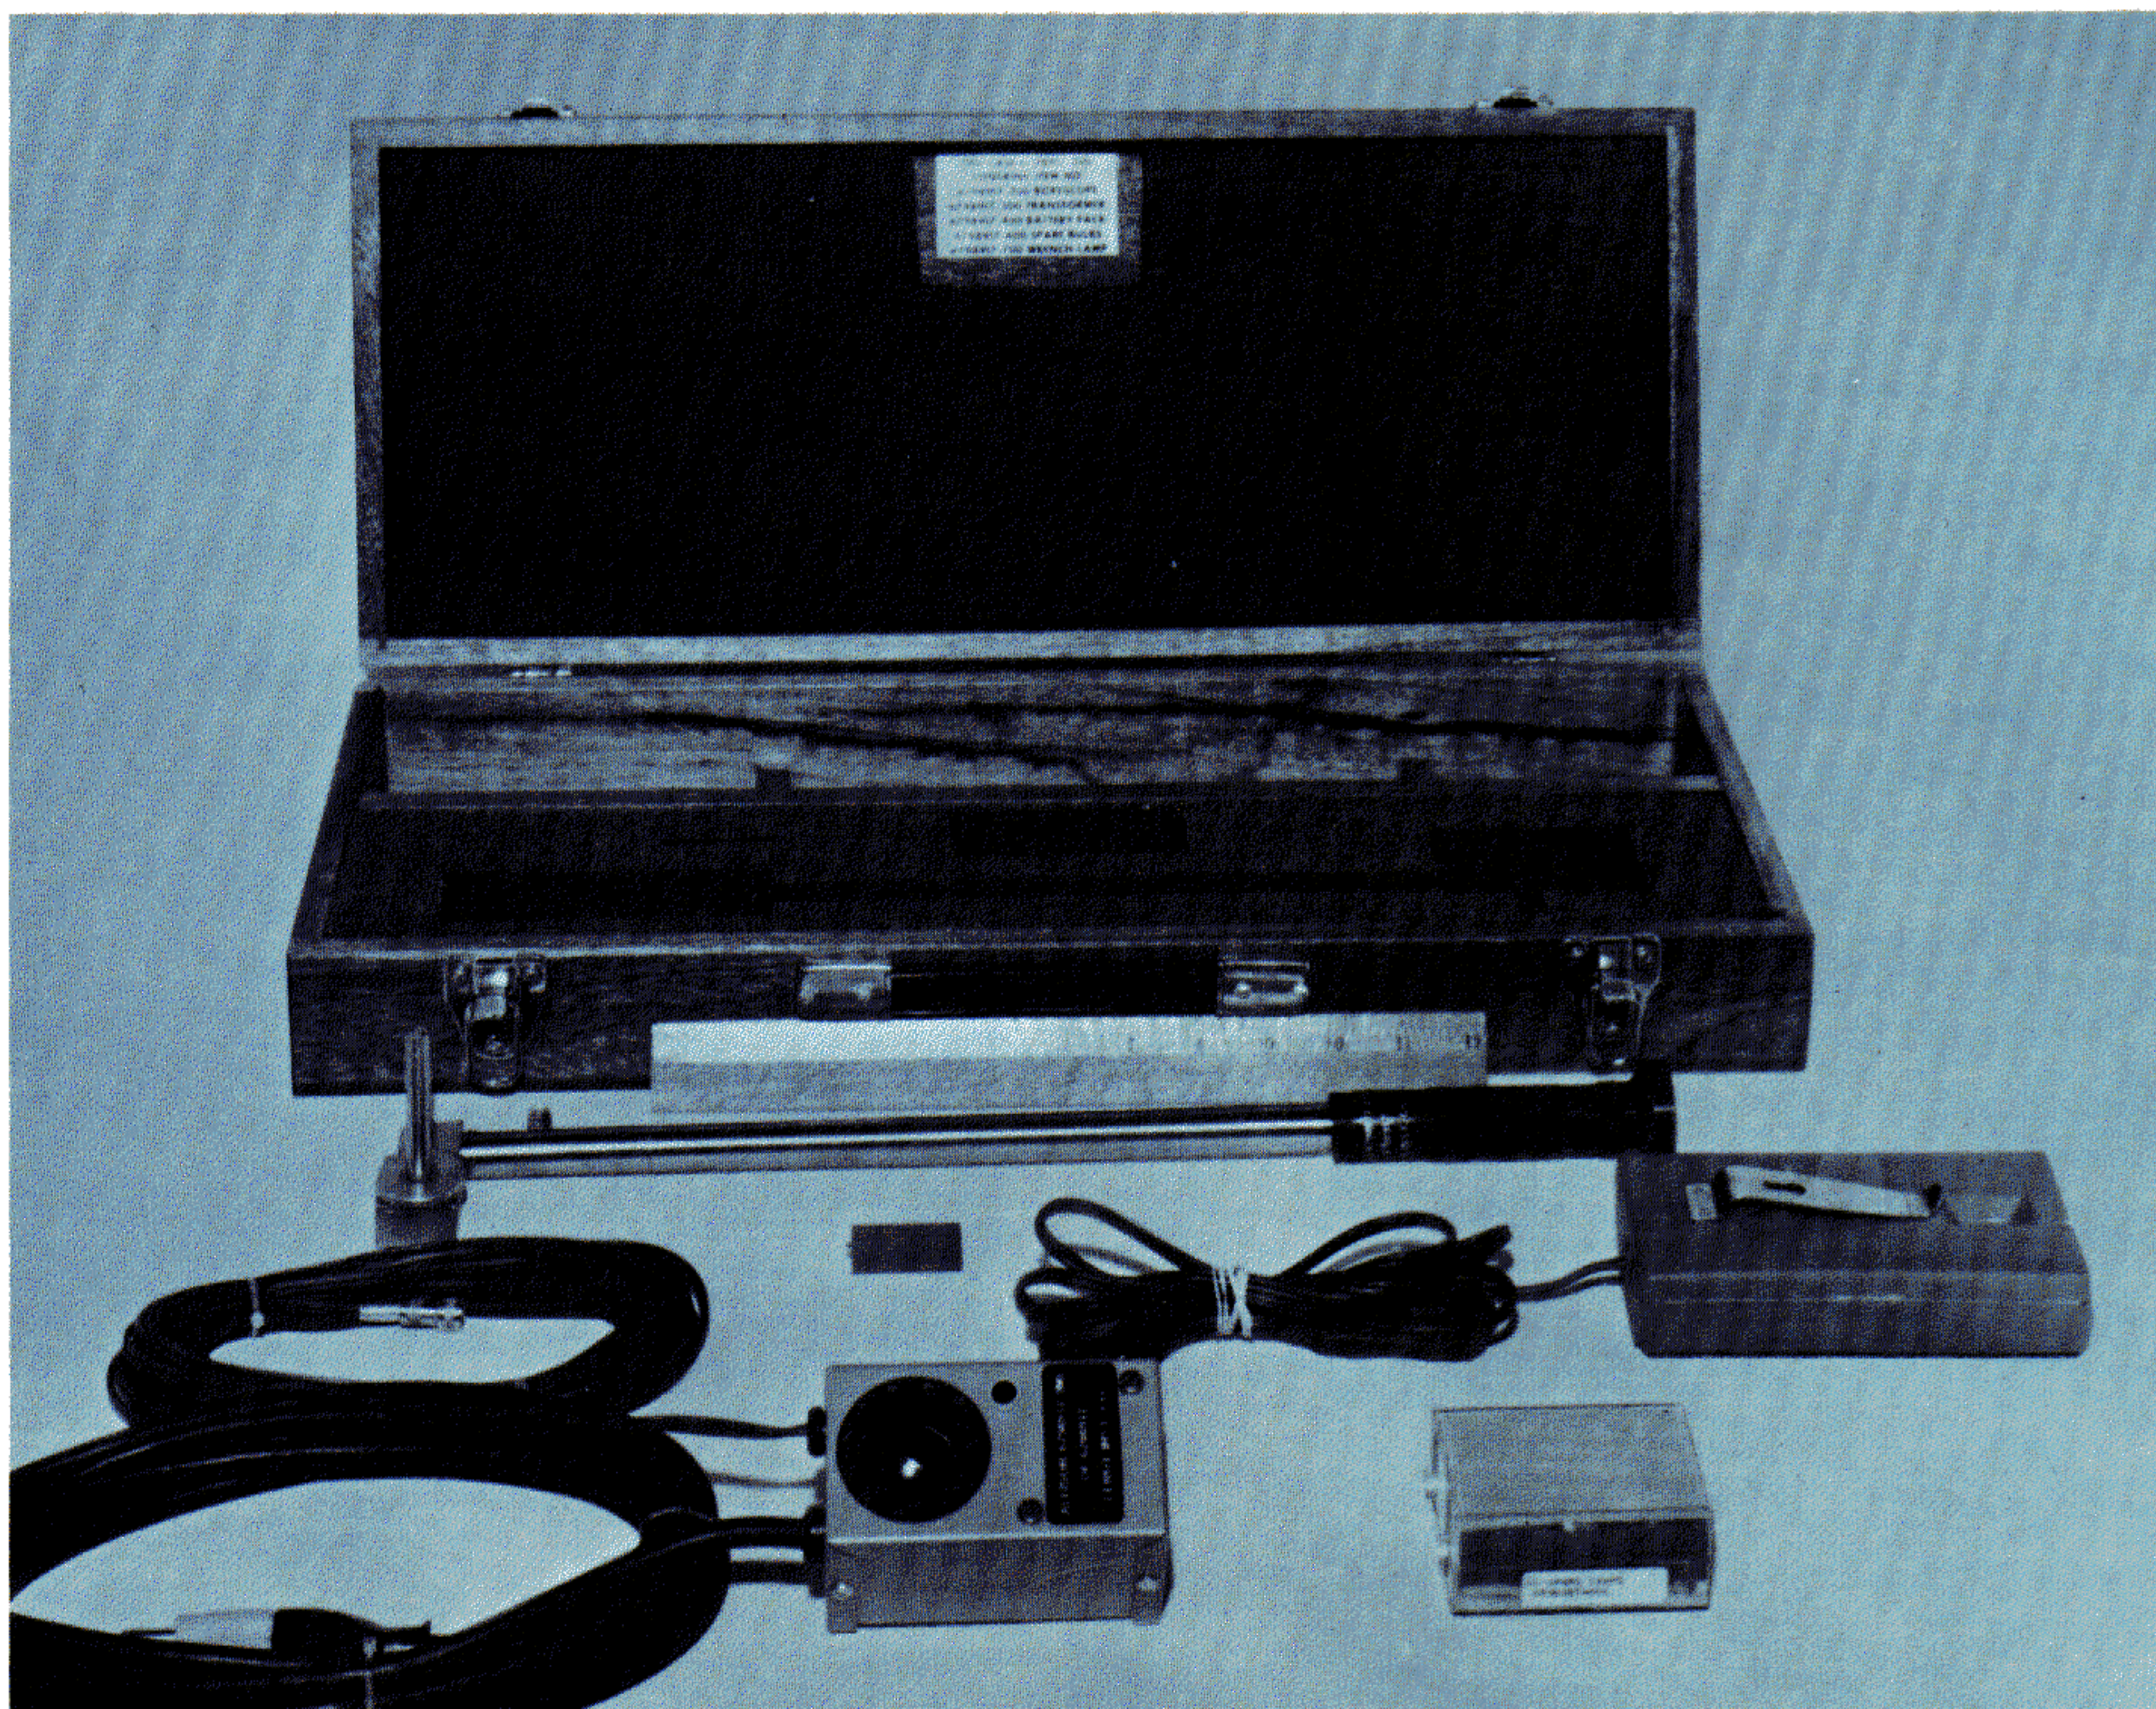
*Figure 10 P/N 6798917 Borescope Kit*

**Perform Regular Inspections Of The Engine Hot Section As Specified By The Applicable Periodic Maintenance Requirement Publications** Fleet maintenance personnel report that the latest borescope kit, P/N 6798917 (FSN 6650-438-3982), can be a valuable tool for inspecting the T56's turbine first stage and the combustion liners. They state that the first stage blades and vanes and every liner position can be viewed with the borescope through the thermocouple mounting holes. The borescope kit is shown in Figure 10.
